Structural analysis of a Rc building failure caused by the earthquake of 26th November in Durrës, Albania

Anjeza Gjini¹, Hektor Cullufi², Princ Xhika³

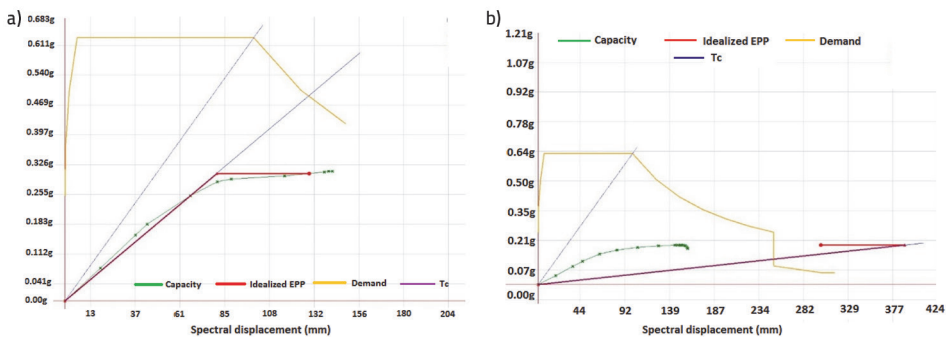
Figure 9. Structural capacity and demand curves for a) X direction; b) Y direction

Regarding ULS, analyses show that some of the columns in ground and first stories are overstressed, which means that the required reinforcement exceeds the maximum allowed. Furthermore, by comparing required longitudinal reinforcement of frames to the reinforcement provided by the designer, we can see that this design is insufficient and presents major structural issues (table 3). This is also demonstrated by pushover analysis results where structural capacity is smaller than structural demand by a large margin.

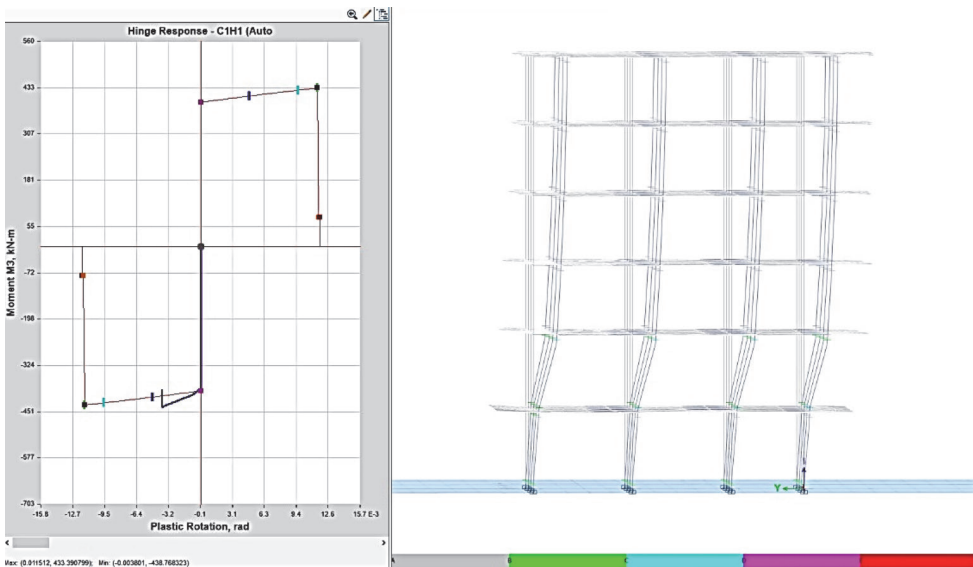
Figure 10. Typical plastic hinge development for ground story columns

Plastic hinges are developed in a brittle manner as showed in figure 10. This phenomenon was also observed by in-situ investigations where near column joints on ground and first floors there were large cracks and concrete crushing of compression areas.

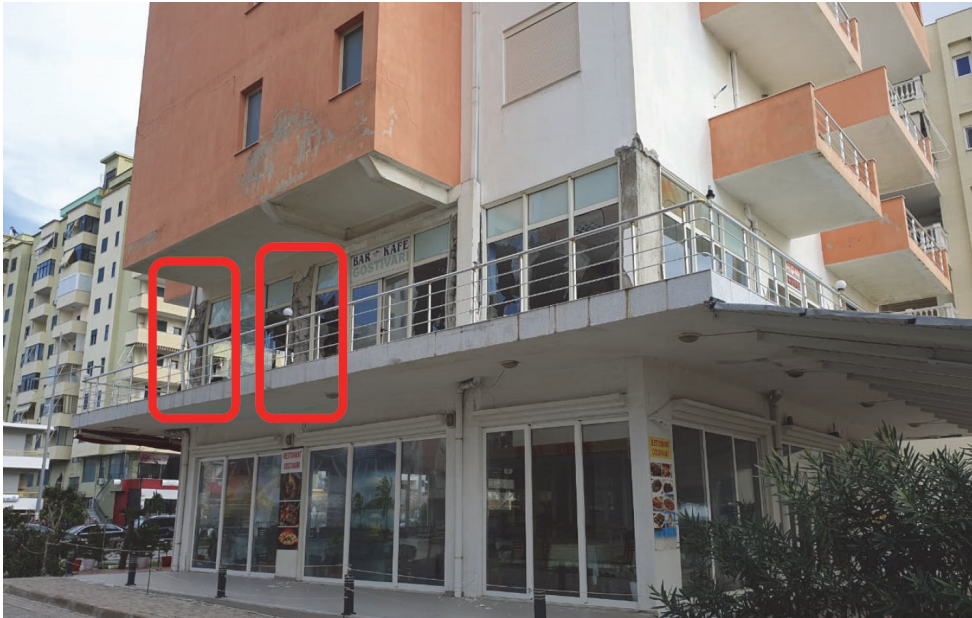
Figure 11. Structural damages by the November 26, 2019 earthquake

The collapse (damage) mechanism, resulting from the structural analysis, shows that the damage is localized on the first two floors. The first floor is the most damaged, due to the reduction of the dimensions of the columns and also the reduction of the amount of reinforcement. The 3-dimensional structural calculations and the collapse (damage) mechanism resulting from the modelling, generally match the way the building was damaged by the November 26, 2019 earthquake. This technical interpretation clearly expresses the evidence of serious damage, with a plastic character, but not the collapse of the building.
