Role of blasting tehnology in removal of the part of Northern tower of Zagreb Cathedral

Mario Dobrilović¹, Vječislav Bohanek², Vinko Škrlec³, Siniša Stanković⁴

Key words: blasting, Zagreb earthquake, cathedral, northern tower

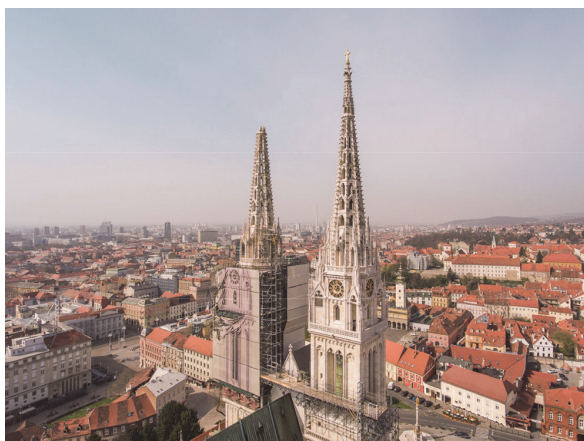
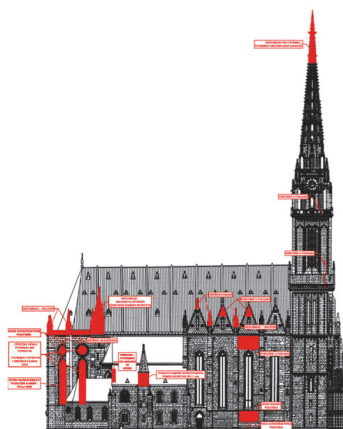
Immediately after the earthquake, it could be seen that the Cathedral doesn't have the upper part of its southern tower anymore (as shown on figure 2).

Figure 2. Zagreb cathedral without its southern tower and damages on Zagreb Cathedral [3]

Few days after the earthquake, Cathedral renovation designer and supervising engineer, Mr. Damir Foretić, made a detailed report where all damages on the cathedral were noted. The southern tower broke at height of 92 m, where a 10,3 m long piece fell and caused significant damage during the fall. One part of the tower fell on the roof of the Cathedral, damaging and piercing it in several places with most of the stone elements falling into the courtyard between the Cathedral and the Archbishop's Palace [3]. There were a lot of other damages and all of them had been marked and described in the report. During the inspection, a drone had been used in order to take pictures of the northern tower. After reviewing the videos from the drone, significant damage was confirmed, and after another drone recording the conclusion of members of the expert commission and colleagues from the working group was unanimous - part of the north bell tower should be removed as there is a serious possibility of collapse [3]. The part of the bell tower that could collapse weighted about 36 tons, with a total height of 13.47 meters together with its cross. Damages parts are shown on figure 3.

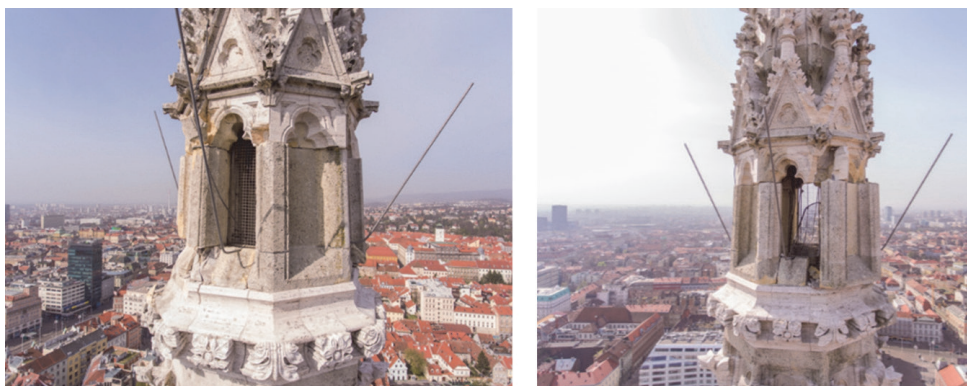
Figure 3. North-east and north part of northern tower (photo by Josip Ninković)

Immediately, the first plan for northern tower removal was made by Mr. Foretić and other members of the working group. The plan was to lower the tower using a 500-ton crane, then tower was to be secured as shown in the figure 4.

Prior to the descent, it was necessary to separate the top of the tower from the rest of the building, as it was badly damaged and statically disturbed it represented a threat to the people who will work on removing. The solution for a safe way of separation was controlled blasting.

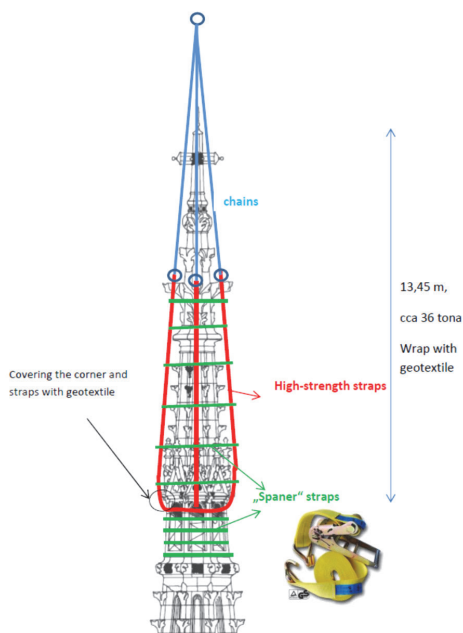
Figure 4. Preparation of northern tower for lowering by 500-tons crane [4]

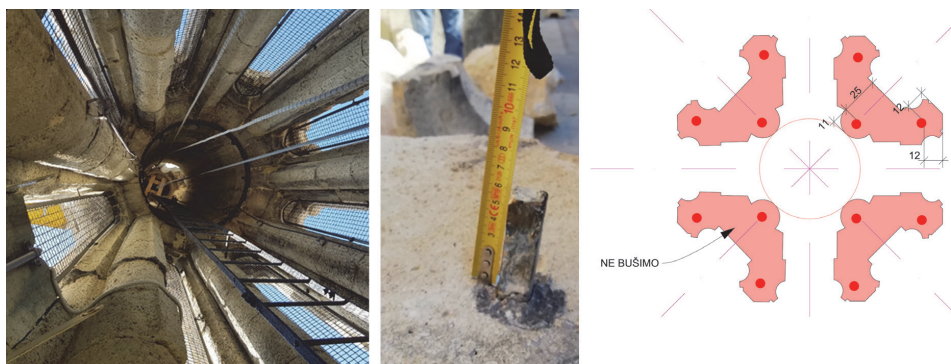
In order to remove the upper part of north tower, the blasting team had two main tasks to carry out. First task was explosive cutting of a steel rope, 15 mm in diameter, that connects the top of the tower to a counterweight of about 4 tons. The role of wire rope was to stabilize upper part of the tower. The second, even more complicated part, was to perform a blast that would release the metal wedges that connect the two rock segments of the Cathedral. There were four rock segments and each of them had three metal wedges. As can be seen in figure 7, some of them were already released as a result of earthquake. Both tasks had to be performed simultaneously. Steel wire rope and metal wedge and the positions of metal wedges in the cross section of the tower are shown on figure 6.

Figure 6. Steel wire rope, metal wedge and positions of metal wedges

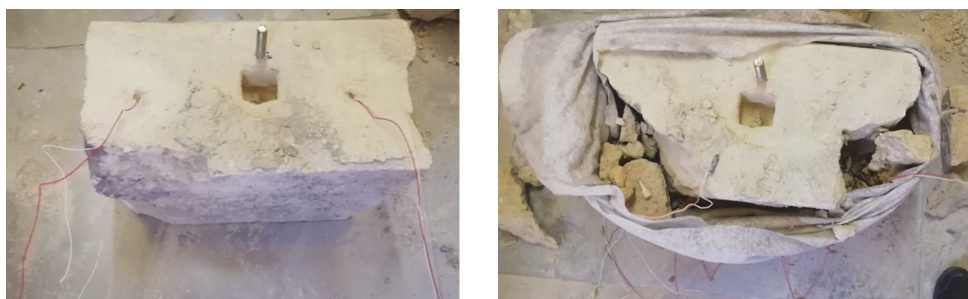
Obtained samples of stone were smaller than those on which blasting was supposed to be performed. The quantity of explosive and the position of explosive charge were calculated in order to cause fragmentation where the metal wedges are, but not to damage the rest of the stone block. Also, different materials had been tested in order to prevent fly rock or debris damage during the blasting.

Figure 7. Stone block testing [6]

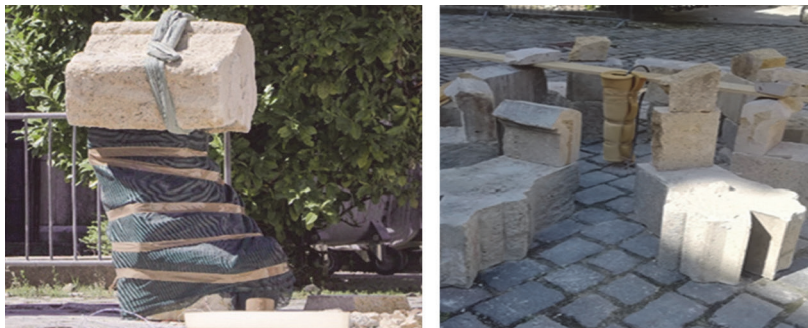
Figure 8. Stone block and steel wire test setups

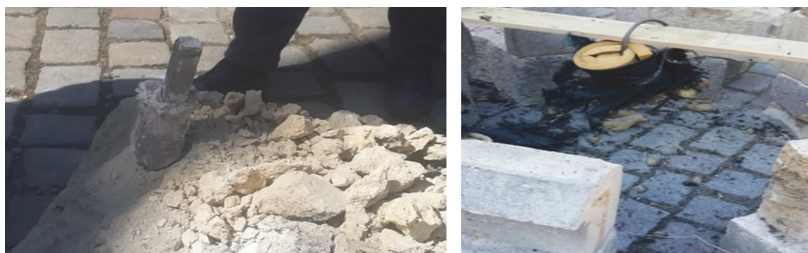
Figure 9. Results of trial blasts

Last trial blasting was done on 16th of April and the final conclusion was made. Quantity of explosive for cutting of steel wire rope is 15 g, and two different charges would be used for demolition of the metal wedges, 5 g for middle wedges, and 3 g for side wedges of each element. Chosen explosive was PEP 500 plastic explosive and electric detonators were used for their initiation. After the last trial blasting, the team was again lifted by crane to the upper part of the cathedral to check once again for the number of holes and the position for drilling.

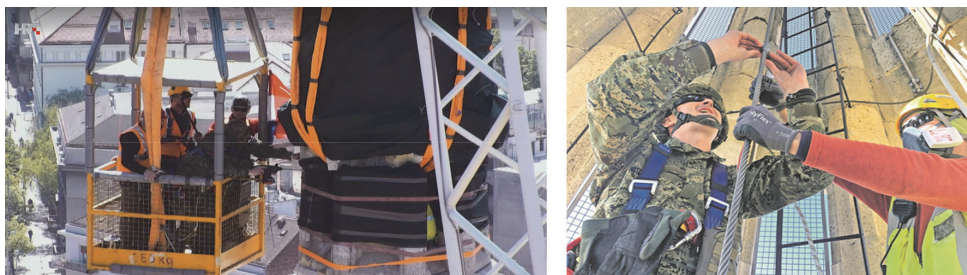
Figure 10. Preparation for blasting

Preparation for the demolition was planned to start at about 8 o'clock on April 17th but it was postponed to 11 o'clock. The reason for this delay were gusts of very strong wind in the morning and due to safety reasons, it was not possible to lift the blasting team on the top of the Cathedral. The blasting team was divided into two groups - the first group was in charge of drilling the holes and setting the explosives in the stone block of cathedral and the second one for placing the explosive charge on the steel wire rope inside the Cathedral. Together with the blasting team in the crane basket was Mr. Tomo Capan who was informing the crane operator about their position.

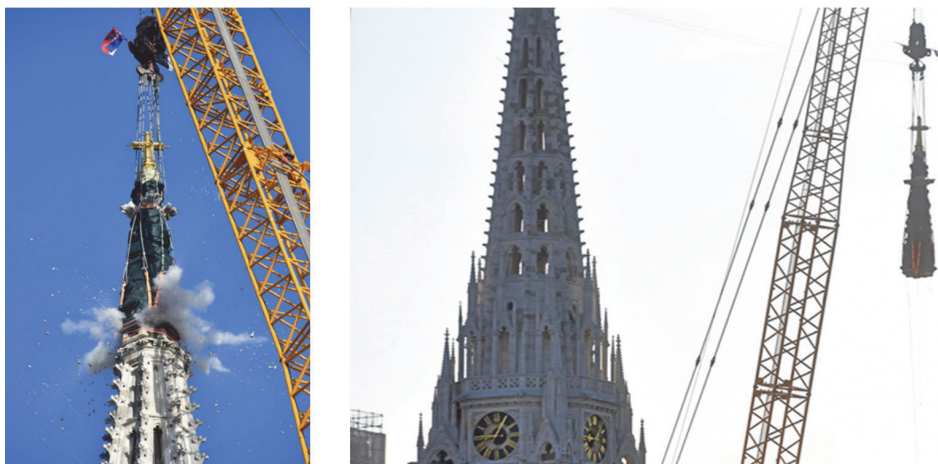
Figure 11. Blasting and lowering of northern tower (Photo: MORH/F. Klen)

After the placing of the explosive charge, a big role was played by alpinists who set up the cables and attached them to the crane. Also, police had to distance all people and journalist to secure the area and to secure the perimeter. Finally, after the long preparation, everything was ready for blasting and at about 6 pm Colonel Car gave the order for blasting.
