## Post-earthquake mission in Durres, Albania, from science to practice

Following the M=6.4 earthquake that hit Durres in Albania on 26.11.2019, at the request of the Government of the Republic of Albania to the Government of R.N. Macedonia, in coordination with the deputy Prime Minister of the Government of R. N. Macedonia and the Director of the Bureau for Forensic Expertise of the R. N. Macedonia as operational coordinator, teams of experts were established for assistance and support to the local teams in rapid assessment on the structural safety of damaged buildings in the most affected areas. The Institute of Earthquake Engineering and Engineering Seismology – IZIS (Ss. Cyril and Methodius University in Skopje) was leading the Macedonian mission with four teams composed of 11 experts. Most of the structures that were the subject of inspection were residential, mainly constructed as reinforced concrete structure and flat-slab systems prior the year 2000. Most of these structures suffered major nonstructural damage with negligible structural damages and extensive repairable structural damages. The cause of incurred damages was inconsistent application of recent knowledge in des

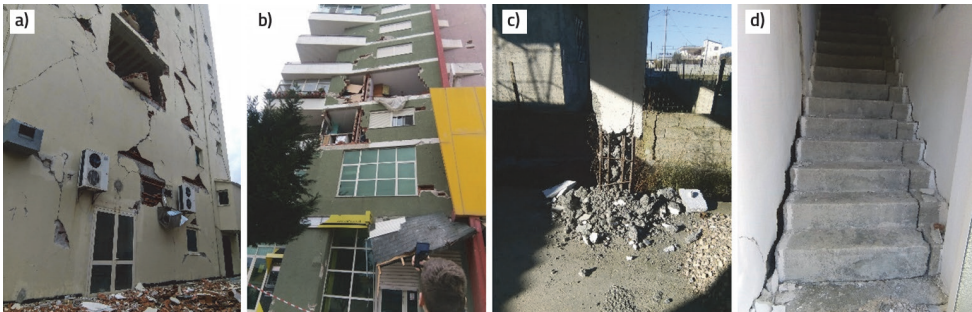
Figure 3. Structures with major non-structural damage (a, b) and Residential structure GF+1 with major structural and non-structural damage, unsafe for habitation (c, d)

According to assessments made by the commissions (in accordance with Table 1), the expert teams concluded that 6.1 % of the structures suffered slight non-structural damage (Grade 1). 20.4 % of the structures account for those with moderate damage to non-structural elements. However, each third structure suffered major nonstructural damage with negligible structural damages most frequently in the form of hairline cracks in the columns (Grade 3). Almost 35 % of the structures suffered major structural damage that was mainly concentrated in the columns and 9.6 % of the total number of inspected structures were assigned grade 5, meaning that they have to be torn down (Figure 5 right). Photos of damaged structures assigned Grade 3 and Grade 4 are shown in Figures. 3 and Figure 4. More photos of structures are given in IZiIS Report 2019-73.

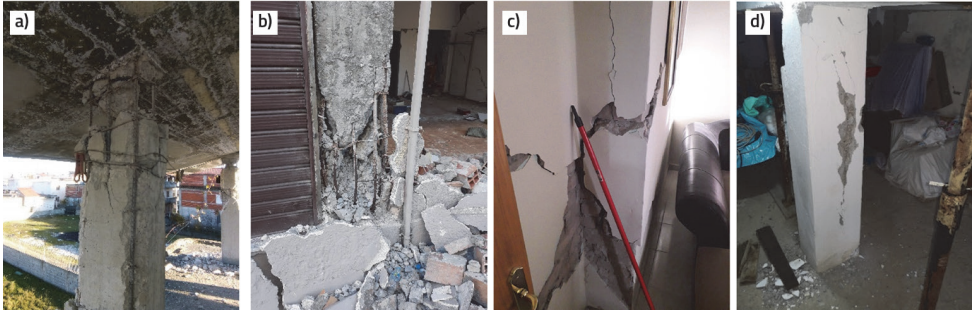
**Figure 4. Residential structures: GF+2 (a, b); GF+3 with RC frames at the ground floor and masonry along storeys – visible damages to columns at the ground floor (c, d)**

The main reasons for the occurred plastic hinges in residential buildings columns is the unsuitable dimensions or great distance between the stirrups.
