Damage assessment after the Zagreb earthquake – the case study of the educational building

The Case Study

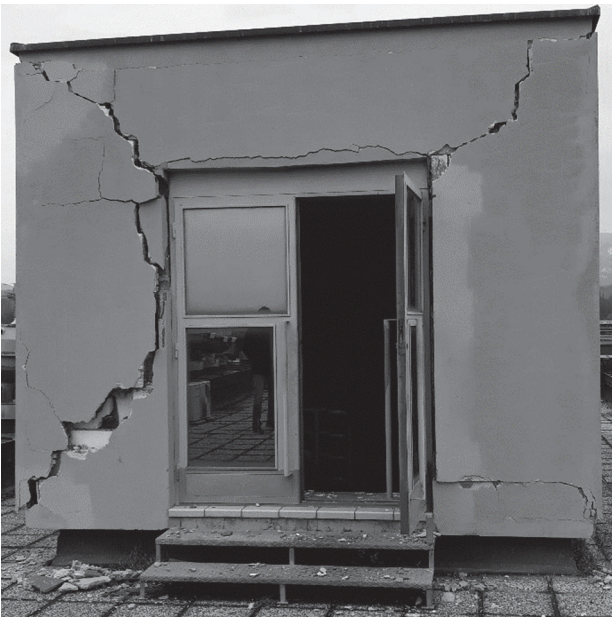
2020 was a tough year for Croatia, which experienced two significant earthquakes [1] during an ongoing global pandemic. Damage from those earthquakes was extensive and mostly concentrated in the old masonry buildings, as shown in Fig.1. Many of the mentioned buildings exceeded the usual service life span, with some existing for over a century. Earthquakes exposed Croatian building stock's vulnerability that should be mitigated as efficiently as possible in the coming years. Novel approaches in assessment procedures should be applied together with state-of-the-art repair and reconstruction of the damaged buildings [2].

Figure 1. Masonry building damaged in the Zagreb earthquake

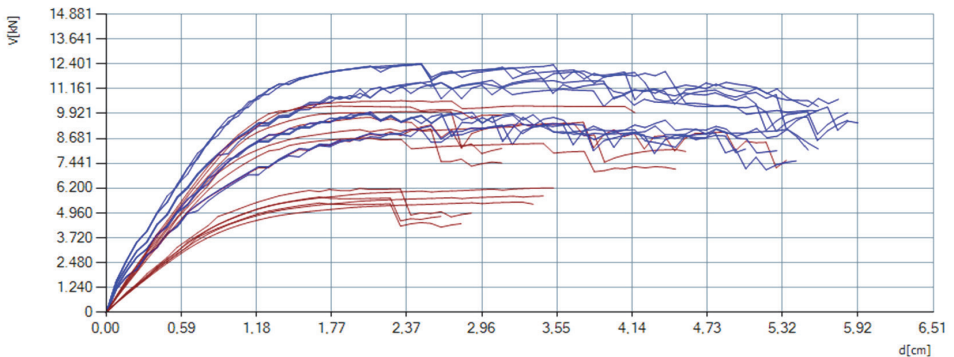
The results are as expected, where the building's behavior is in accordance with wall distribution. The obtained capacity curves can be seen in Fig.5, and target displacement determination is graphically explained in Fig.6.

Figure 5. Capacity curves for x-direction (blue) and y-direction (red)
