## The impact of non-compliance with code desings of structures in seismic areas

Drilona Disha<sup>1</sup>, Altin Bidaj<sup>2</sup>, Hektor Cullufi<sup>3</sup>

### Abstract

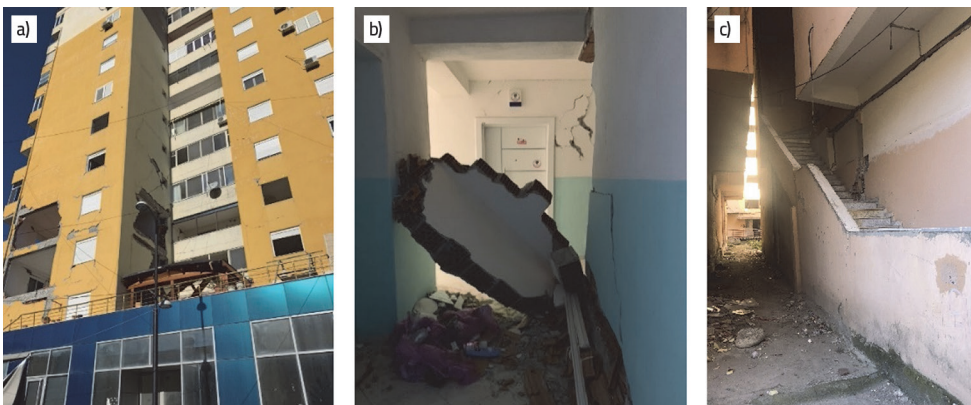
**Figure 3. a) Filling walls completely destroyed; b) partitions walls completely destroyed; c) Inclintion and short roblem**

The inspected structures, in general were with large damages and declared uninhabitable. The most frequent damages are in the filling and partition walls destructed or exit from their plane, meanwhile the primary structural elements such as columns, beams, diaphragms or reinforced concrete cores do not show signs of destruction. Another serious problem is the inclination up to 2% of some of the 6-12 stories buildings due to the differential settlement of soil. Fig. 3.

A hould buildings due to irregularity in the plan and predominantly in their height and due to seismic action have caused extremely large inclinations of the structures Figura 3.a.

Probably the differential settlements of soil may have occurred over time due to the weak characteristics of soil, the irregularity in the plan and in the height of the structures and as well as the  $P-\Delta$  effect, but we think that the determining cause to lead to almost catastrophic situations have been seismic actions and especially the earthquake of November 26, 2019.

The question of allowable settlements and the influence on the performance and serviceability of structures has received little attention. In order to solve the problem of allowable settlements and criteria of damage successfully it is necessary to define the types of movements and deformations experienced by foundations. The ground hould be treated by some suitable technique to provide appropriate stiffness and strength. [8]

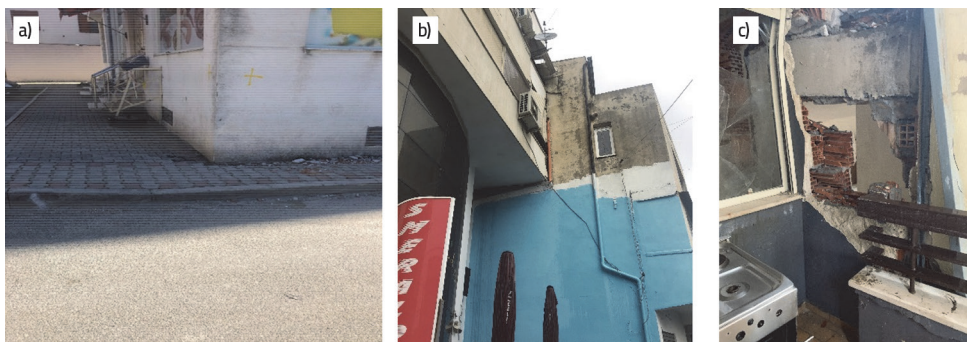
In many buildings which are composed of several sections on the same level on slab or buildings that are level to other buildings seismic joints are incorrectly designed or are not taken into account at all causing the effect of the collision and bumping of the structures. This is a very dangerous phenomenon that often leads to major damages and collapse of buildings. Figure 4.b.

Designing the stairs incorrectly by halving the height of the vertical structural element (columns) and causing the "short column" effect.

**Figure 4. a) Differentiated settlements 1.6% inclination of building. B) Collusion between two buildings different high. C) Bumping effect**
