Out-of-plane behaviour of loadbearing and non-structural masonry walls during recent earthquakes

Key words: loadbearing masonry, infills, earthquake damage, Albania earthquake, Croatia earthquake

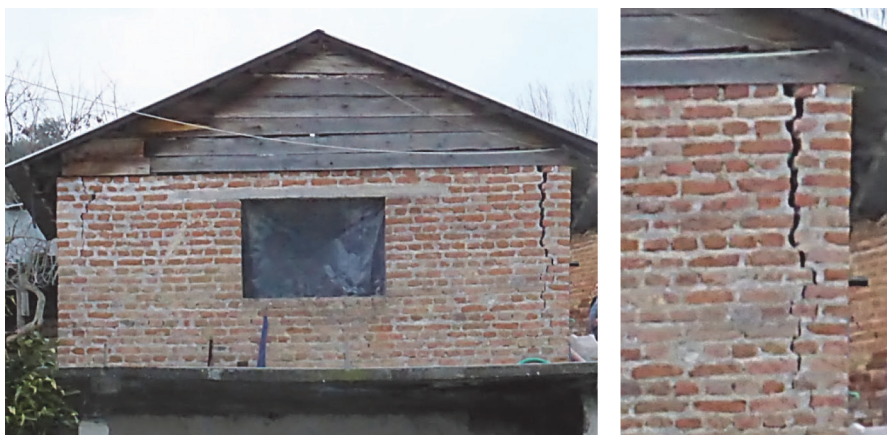
In Albania, masonry is a traditional construction technology for low-rise single-family residential buildings 1 to 3 storeys high. However, from 1960 to 1990 this technology was also used for the construction of multi-family residential buildings (mostly 3 to 5 storeys). Based on the field reconnaissance of several affected towns and villages in Albania, the members of the SUZI-SAEF team concluded that masonry buildings did not suffer extensive damage due to these earthquakes (except in place Thumanë). One of the causes of damage to masonry buildings in Albania is the low quality of materials and construction and the resulting low loadbearing capacity of the walls, which primarily depends on the mechanical characteristics of the masonry compressive and shear strength, as well as the wall thickness. An example is the single-storey URM house in the Bubq village with a wooden roof structure (Figure 4) that was damaged in November 26 earthquake. It can be seen that the transverse wall suffered damage due to the OOP earthquake action. The damage is in the form of vertical cracks at both ends of the wall, with the crack on the right side extending over the entire wall height at the first floor. The absence of a horizontal RC confining element at the roof level can be noticed, which is critical for maintaining the integrity of the building during an earthquake. This type of damage can lead to the collapse of individual walls and culminate in partial or complete collapse of the entire structure.

Figure 4. Out-of-plane damage of URM building with flexible floor [4]

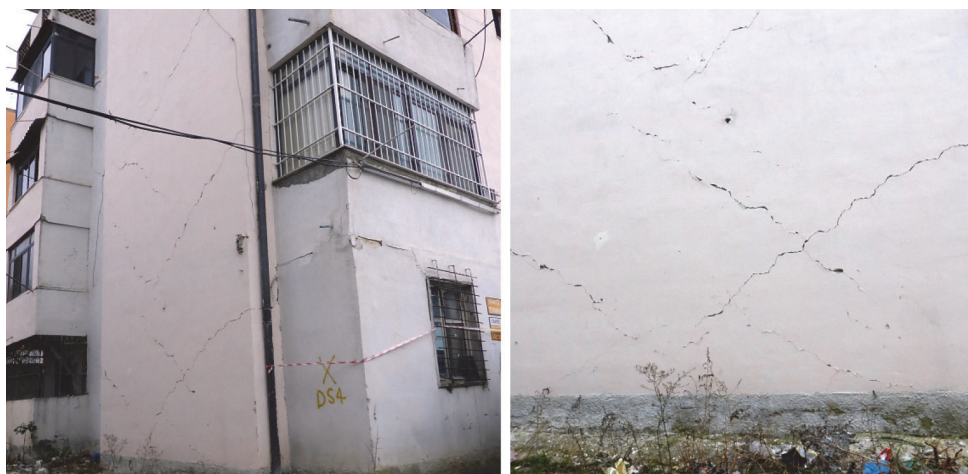
Multi-family apartment URM buildings with RC floors cast-in-situ were either not damaged or they suffered minor damage in the Albanian earthquakes. This can be explained by the presence of rigid floors and the regularity in plan configuration. Figure 5 shows minor damage to the building of this type. Diagonal cracks caused by the earthquake can be noticed in the plane of the wall, mainly at the level of the lower three floors.

Figure 5. Damage of five storey URM building in Fushe Kruje [4]

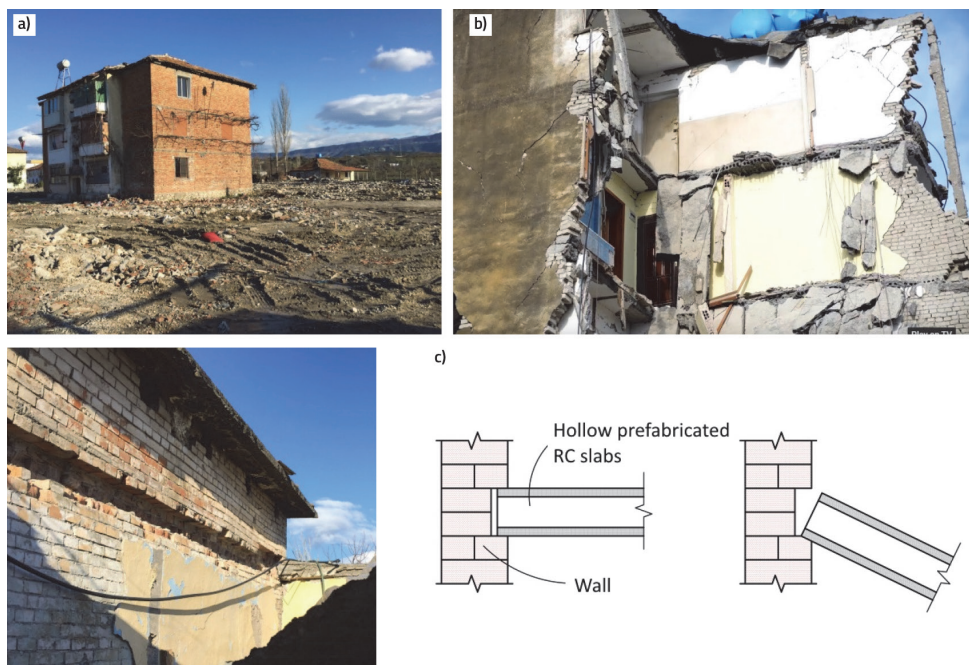
Figure 6. Collapse of 5-storey URM residential buildings in Thumanë, Albania: a) a low-rise masonry building in the background of the cleared area of demolished URM buildings; b) partial collapse of the demolished building; c) detail of the slab-wall connection [4]

In the town of Thumanë, four 5-storey URM buildings with hollow prefabricated RC slabs collapsed in the November 26, 2019 earthquake, causing 24 casualties. Note that these buildings were damaged in the September 21, 2019 earthquake. It is important to

note that in the immediate vicinity there were other URM buildings with monolithic RC slabs that did not suffer any structural damage. We believe that the collapse of these buildings was caused by simply supported slabs, as well as the lack of integrity of pre-fabricated RC elements due to the absence of a reinforced concrete topping cast in-situ after slab installation, as well as inadequate or absent RC ring beams at the floor level. Definitely the major culprit was insufficient slab support length, which led to the total slab collapse (Figure 6). In addition, it appears that the solid silicate bricks used for the wall construction were of poor quality, which contributed to the low strength of the masonry.

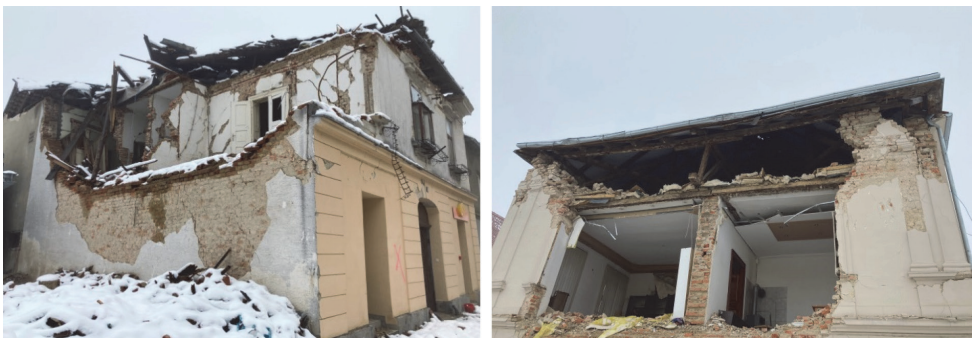
Low-rise masonry residential buildings (either single-family or multi-family buildings) are the most common form of housing construction in Petrinja. The December 29, 2020 Petrinja earthquake and its aftershocks affected low-rise masonry buildings, which experienced damage or collapse. Older two-storey URM buildings with wooden floors experienced damage or failure of walls due to OOP seismic effects (Figure 7). Excessive horizontal displacements of flexible floors caused these walls to act as vertical cantilevers and experience damage or collapse (toppling). In some cases, wall collapse induced the roof collapse. Damage of masonry gable walls was prominent in mid-rise masonry buildings exposed to the March 22, 2019 Zagreb earthquake. The damage can be attributed to inadequate wall-to-roof connections. Figure 8 shows collapse of URM gables in Petrinja and Zagreb.

Figure 7. OOP Collapse of URM walls and timber floors in older buildings in Petrinja, Croatia (SUZI-SAEI)

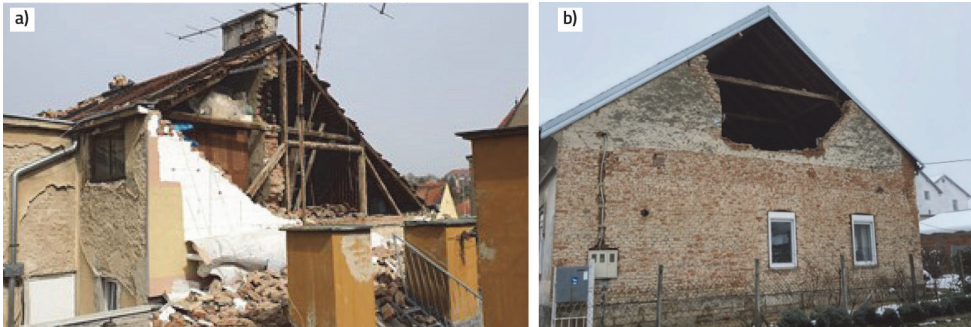
Figure 8. OOP failure of URM gables in the Croatian earthquakes: a) Zagreb (author: Karlo Jandrić) and b) Petrinja (SUZI-SAEI)

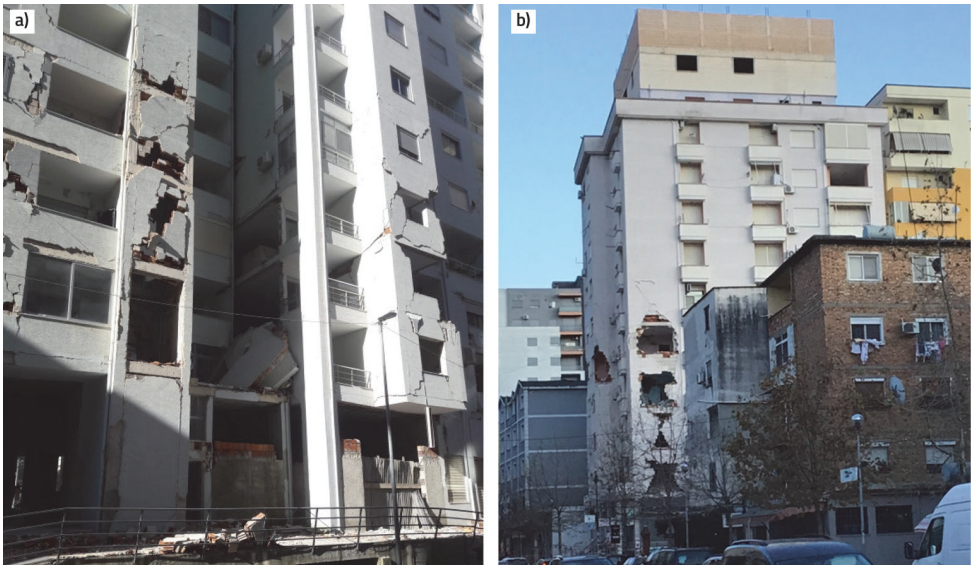
Masonry infills are very common treated as “non-structural elements” in RC frame buildings in Albania. Figure 9 shows typical damage of masonry infills, while the RC structures remained undamaged. Figure 9b shows collapse of infill walls in a RC building behind an undamaged URM building.

Figure 9. Failure of infills in RC high-rise buildings in Durrës, Albania: due to OOP earthquake effects [4]

It is believed that infill walls experienced damage due to combined in-plane and OOP earthquake effects. Floor accelerations induced OOP inertial forces in infill walls. In a large number of RC buildings, infills experienced OOP damage at the lower floors, while

the infill walls at the upper floors remained intact. OOP damage of the infills at the lower floors of building is not expected because floor accelerations increase at higher floors.

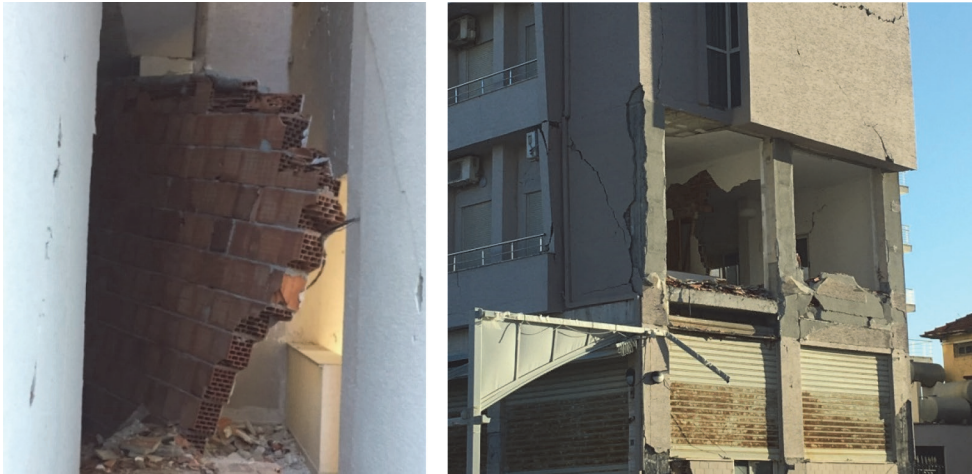
Figure 10. Collapse of masonry infills in RC buildings in Durrës, Albania [4]

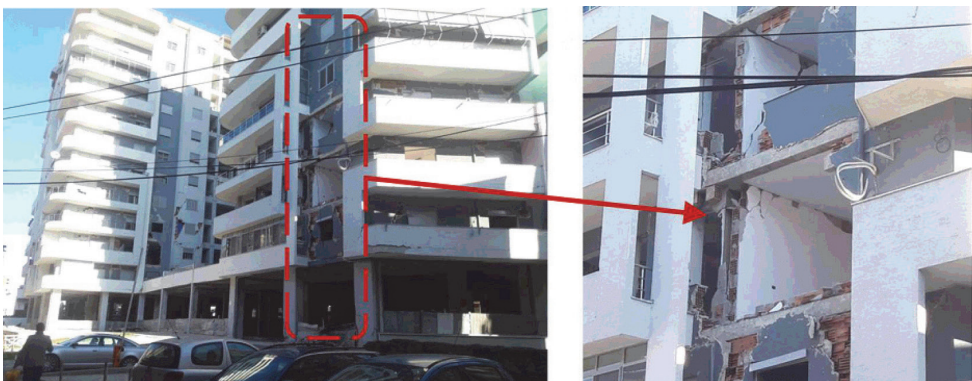
From a simplified perspective, a higher level of in-plane damage may be expected at lower floors due to the higher in-plane deformation of the frame, but more significant OOP damage is expected at higher floor levels, due to higher floor accelerations. Therefore, the OOP damage of infills on lower floors can be explained by the fact that during an earthquake, the infill walls are simultaneously exposed to the in-plane and OOP deformation, where the in-plane deformations weaken the infills making them more susceptible to OOP failure [3]. Such a combination may lead to extensive damage of masonry infills, as observed after the November 26, 2019 earthquake (Figures 10 and 11). Also, it is important to mention that a lot of interaction of infills with the surrounding frame was observed in Albania, leading to the formation of soft stories and other damages to RC elements (short columns, etc).

Figure 11. OOP damage and collapse of masonry infills in RC buildings in Durrës, Albania [4]

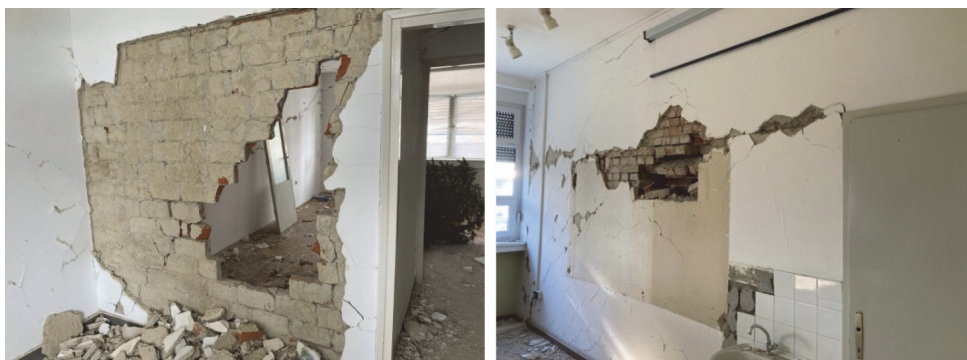
The March 22, 2020 Zagreb earthquake caused damage mostly to URM buildings. In general RC frame buildings with masonry infills were not significantly affected by the earthquake; however some hospitals and schools experienced damage [5]. Although damage and collapse of loadbearing URM walls was dominant in Petrinja [6], SUZI-SAE team documented damage and failure of URM partitions (Figure 12a) and infills in residential buildings and schools (Figure 12b), and a retirement home (Figure 13). The damage of partitions and infills in Dec. 29, 2020 earthquake can be attributed to high ground accelerations in the epicentral area.

Figure 12. OOP damage of masonry infill walls in RC buildings in Petrinja, Croatia (SUZI-SAE)

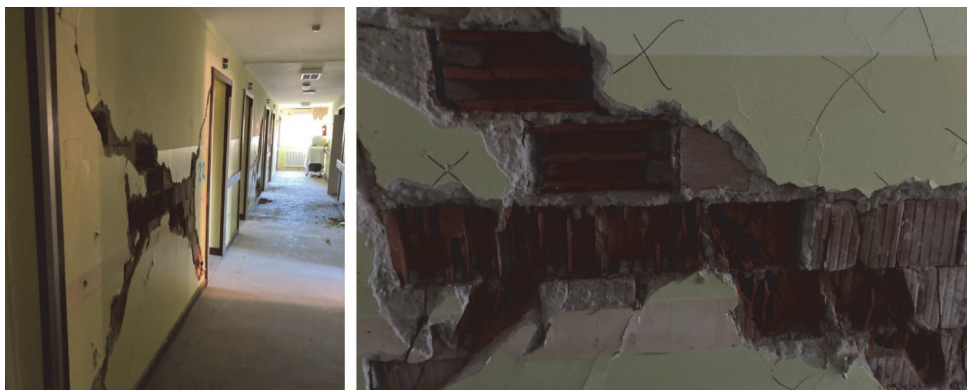
Figure 13. Combined in-plane and OOP damage of infills in retirement home in Petrinja, Croatia (SUZI-SAE)
