Petrinja M6.2 earthquake in 2020 damaged also solid linear infrastructure: are there similar active faults in Croatia?

Tvrtko Korbar¹, Snježana Markušić², Davor Stanko³, Davorin Penava⁴

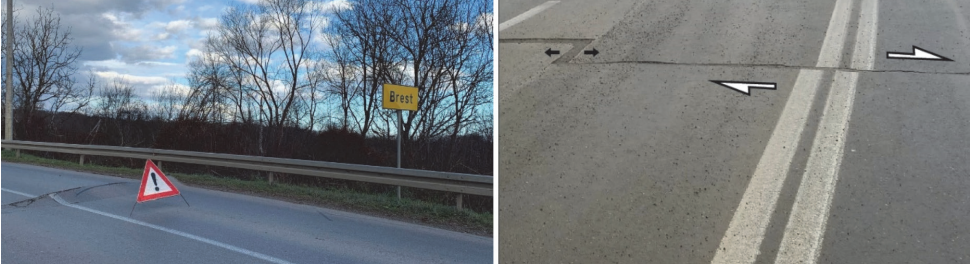
tions on the Petrinja-Brest road (Figure s 2a and 2b). A quick field inspection revealed that cracks on the road, built on the bedrock of Hrastovička gora at Župič, appeared mostly along Pokupsko Fault, and revealed the clear dextral coseismic strike-slip displacements (Figure 2c).

Figure 2. a) Coseismic cracks and small transpressional structure (mole track) along one of the fault lines of the creeping sinistral Petrinja Fault crossing Petrinja-Brest road north of the Brest Bridge over Kupa river (CREDIT: Public media), b) Coseismic dextral ~10 cm displacement (white arrows) and tensional cracks (black arrows) along one of the fault lines of the Pokupsko Fault crossing Petrinja-Glina road west of Župič. (CREDIT: M. Vukovski, HGI)

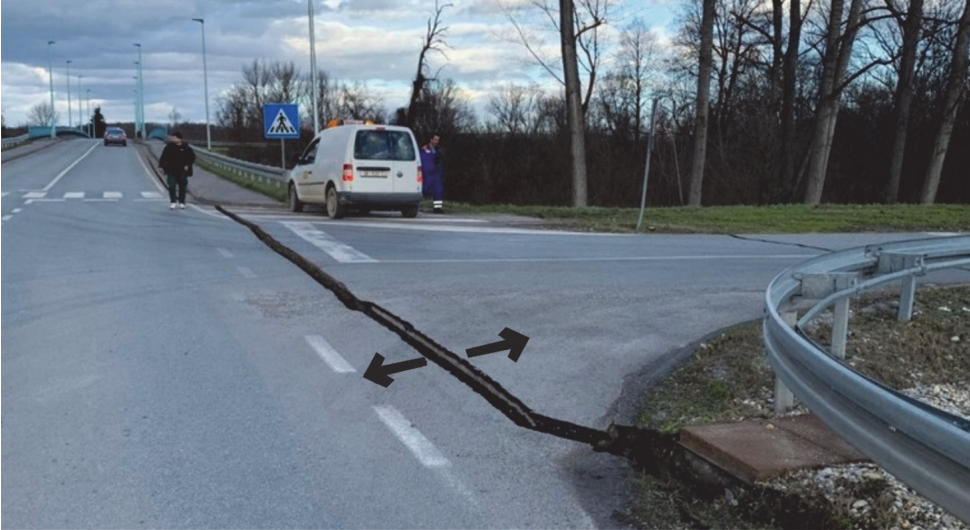
Beside the cracked road along the Petrinja Fault north and south of Brest Bridge on Kupa River, there was a significant damage on the bridge itself, since the bridge was in a tension zone between the two closely spaced sinistral faults that belong to Petrinja Fault zone (Figures 1 and 3a).

Figure 3. a) Coseismic tensional cracks south of Brest Bridge located between two fault lines of the creeping sinistral Petrinja Fault (CREDIT: Public media), b) Coseismic sinistral displacement along generally N-S fault line of the activated complex fault system crossing the Galdovo Bridge over Sava river (Sisak), c) shifted construction of Galdovo Bridge (thick arrow) because of a sinistral movement (thin arrow) of the blocks along the fault line crossing eastern tip of Galdovo Bridge, d) Coseismic fractures along the main sinistral Sisak-Petrinja-Glina-Topusko Fault line crossing Prekopa Bridge over Glina river (CREDIT: D. Palenik, HGI).

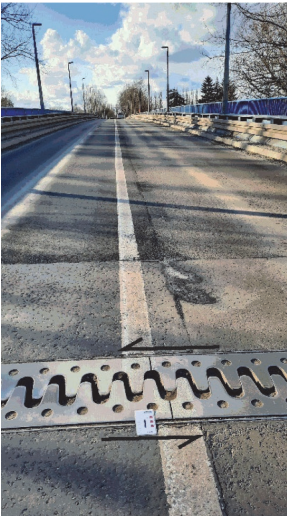
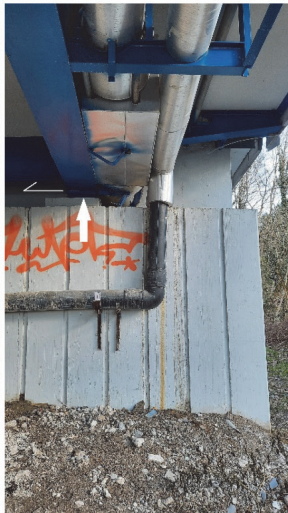
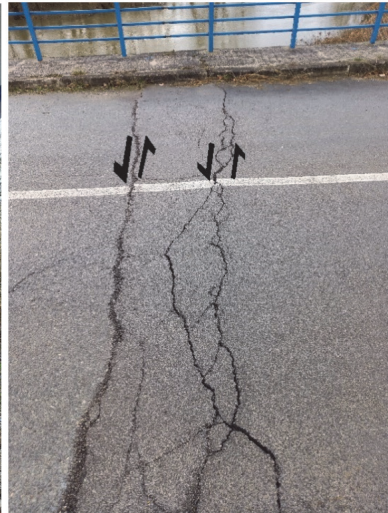
The new bridge at Galdovo (Sisak) on Sava River has been displaced along a left-lateral fault line striking N-S that is still not mapped (Figure 3b). The bridge is displaced for ~10 cm over the eastern basement (Figure 3c). The bridge on Glina River at Prekopa was cracked and displaced left-lateral for a few cm along the Petrinja-Glina Fault line (Figure 3d).

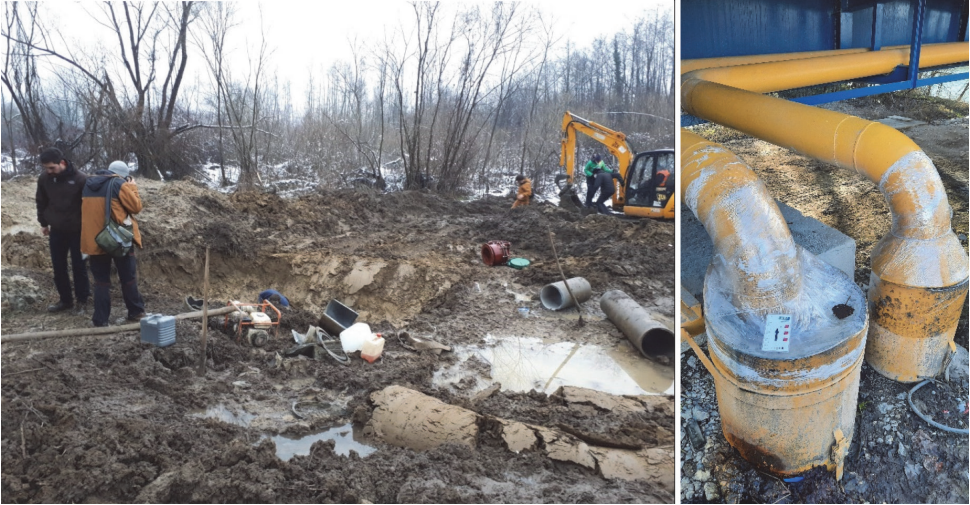
Water pipeline at Cepeliš was broken due to coseismic dextral movement of the fault blocks along dextral Pokupsko Fault (Figure 4a). The gas pipeline at Galdovo Bridge (Sisak) was damaged during the Petrinja earthquake, as well (Figure s 3b and 4b).

Figure 4. a) Reconstruction works on water pipeline at Cepeliš that is crossed by regional Pokupsko Fault (CREDIT: HGI EQ Team), b) Temporarily repaired Gas pipeline damaged because of sinistral coseismic displacement of Galdovo Bridge over Sava river (Sisak).

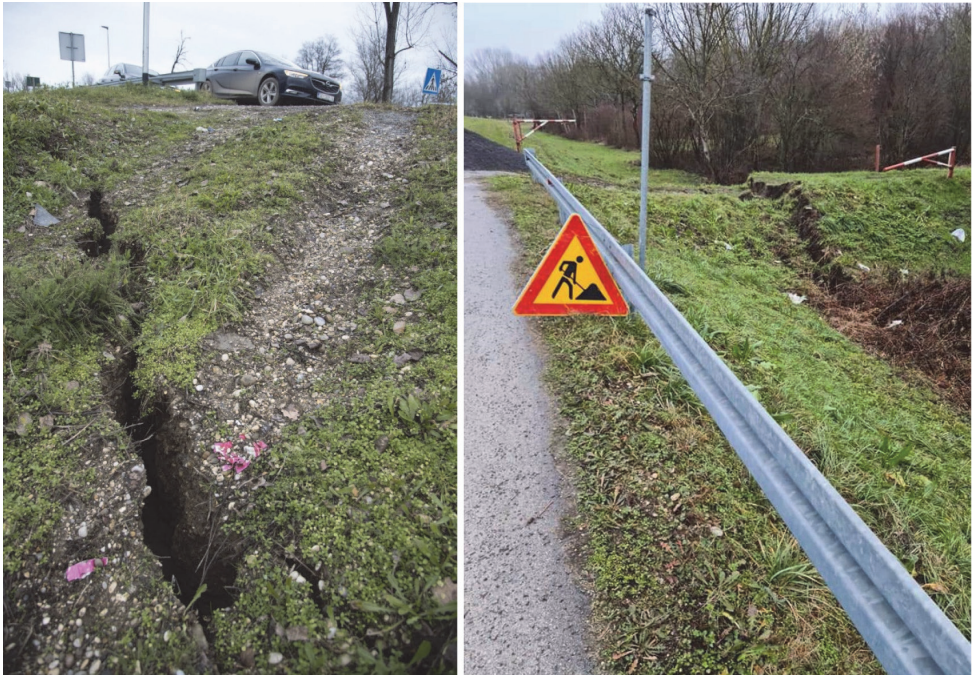
There were numerous cracks along the activated Petrinja Fault that crosses Kupa and Sava river's artificial riverbanks at Brest (Figure 5a) Drenčina, Pračno and Tišina. Besides, some conjugated faults from the system, possibly a horsetail splay termination at the tip of the activated segments of the main faults, damaged the Sava riverbanks at Palanjek (Figure 5b), Bok Palanječki, Hrastelnica and Galdovo.

Figure 5. a) Surface fault crossing the Kupa riverbank at Brest Bridge, b) Surface fault rupture crossing the Sava riverbank at Palanjek (CREDIT: Public media).
