A job and study site: A decade of studies and interventions on ROCCA DE Terzi of Sissa

Elena Manzoni¹, Alberto Dusi²

Key words: historical structure, masonry, Parma, non-destructive Inspection, interdisciplinary studies

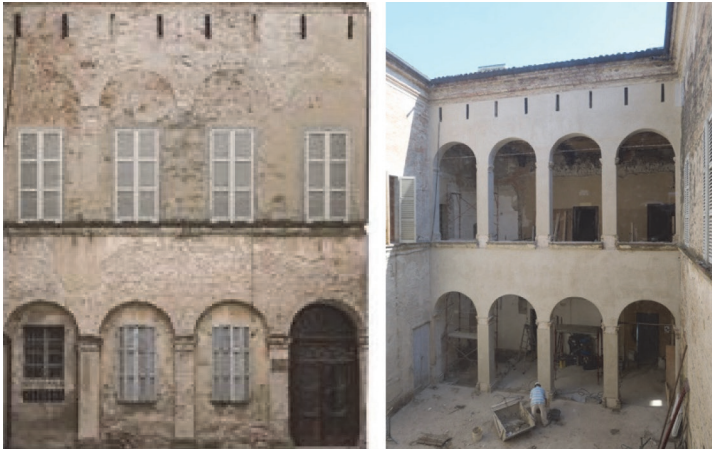
Figure 5. Rocca of Sissa, Inner prospect on the galleries, before (left) and after (right),

es. After that, they were strengthened against earthquake by small diaphragms walls. UHTSS steel nets were use as modern extrados tie roads. Cracks were repaired with cuci-scuci technique and helicoidal steel bars. The upper gallery was closed during the long history of the building. In this job-site the lower and upper galleries were reopened, stairs and timber slabs were reinforced with steel profiles. The reopening of the galleries involved intervention in the masonry pillar, but overall it lightens the masses above the pillars of the courtyard. The columns were reinforced with UHTSS steel net and lime mortar.

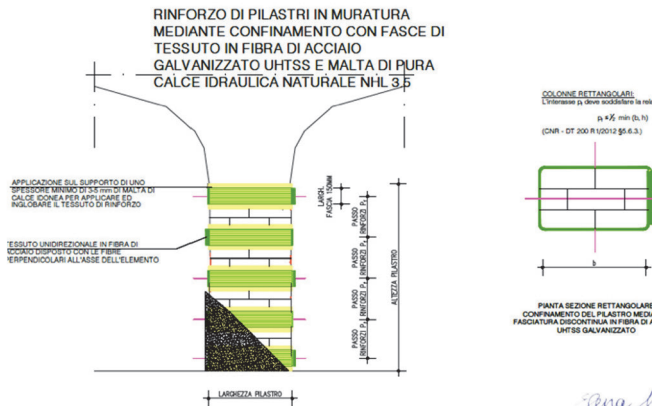
Figure 6. Rocca of Sissa, pillar strengthening

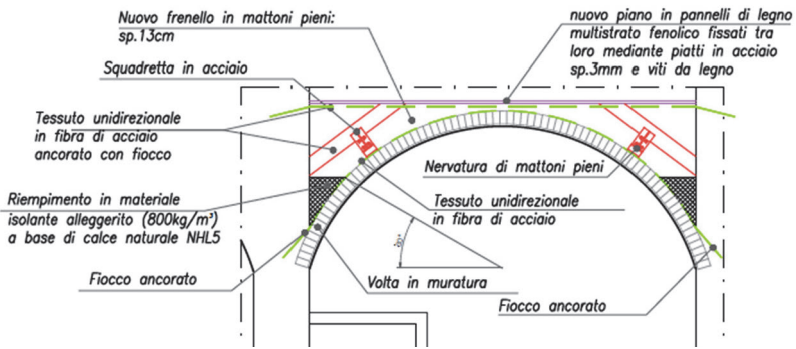
Figure 7. Rocca of Sissa Diaphragm walls on vaults-design

In 2018 a new job site opened and it close in February 2020. This intervention involved a bigger economical effort and a big area of the castle was repaired and strengthened. The vault was repaired by traditional techniques with lime mortar and hardwood wedg-

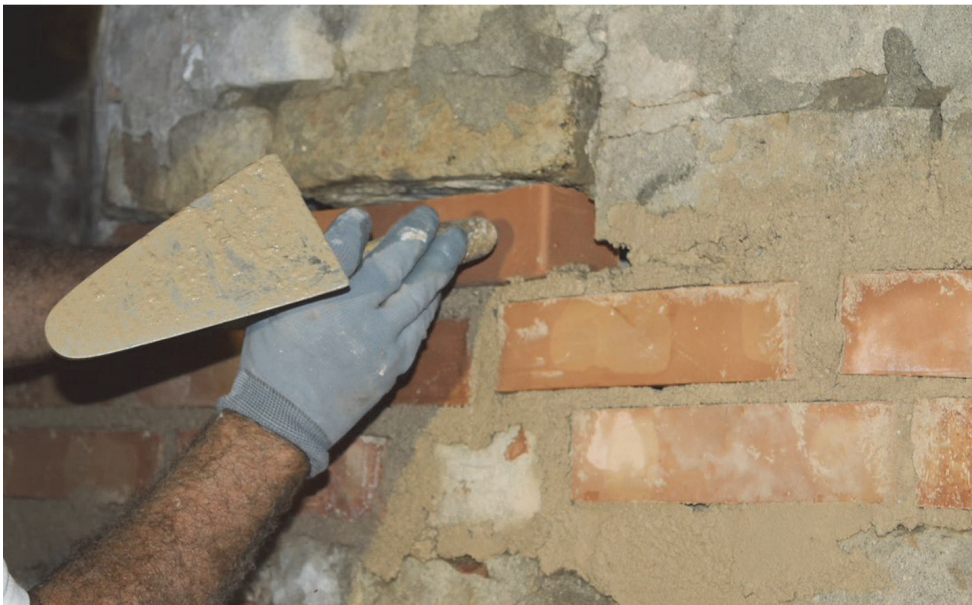
Figure 8. Rocca of Sissa cuci scuci with brick and lime mortar

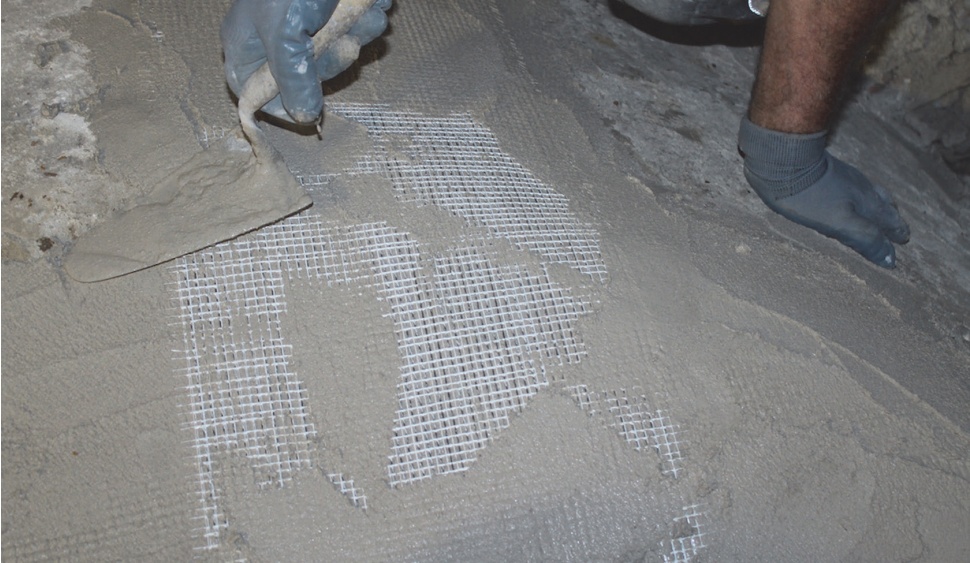
Figure 9. UHTSS steel net and lime mortar on the vault

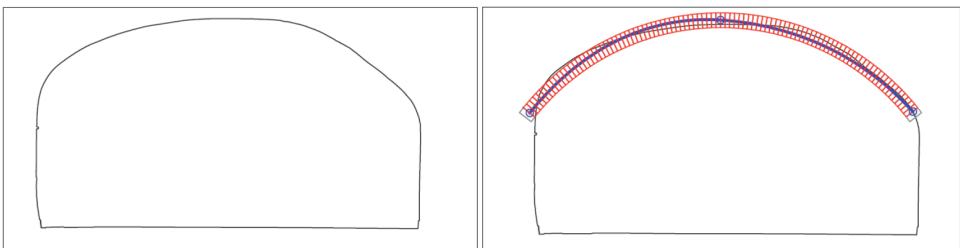
Figure 10. Vault O.G - laser-scanner geometric survey shape and Mery analysis over the shape (right)

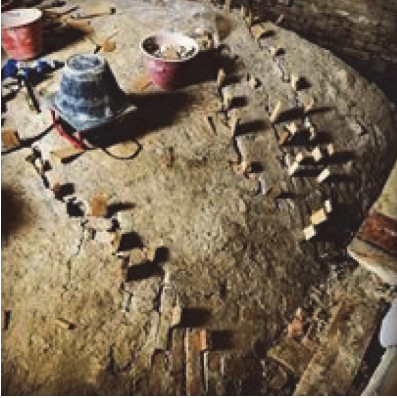
All the floors were removed, and the extrados part of the vault was visible and could be repaired. In spite of the number of diagnostics carried on the building, only after the opening of the job site it was possible to learn about the copious presence of cracks in the vault that had been repaired in the past. Some of them is impressive for the dimension of the crack, in some cases more than 7 cm, that had been repaired with uncut stones. The clue that permitted to imagine that something had occurred on the vault was the deformation on the vault that cannot be seen without precise and detailed survey as laser scanner can give. The vault texture is mainly at 45° with thicknesses of 12 cm, but sometimes they have different geometries, with weaving parallel to the generatrix. On the vault only lime mortar was found.

Figure 11. Rocca of Sissa Cracks in the extrados of O.G vault
