The identification of damages occurred in reinforced concrete structures during Durres earthquake 2019

Drilona Disha¹, Hektor Cullufi²

Abstract

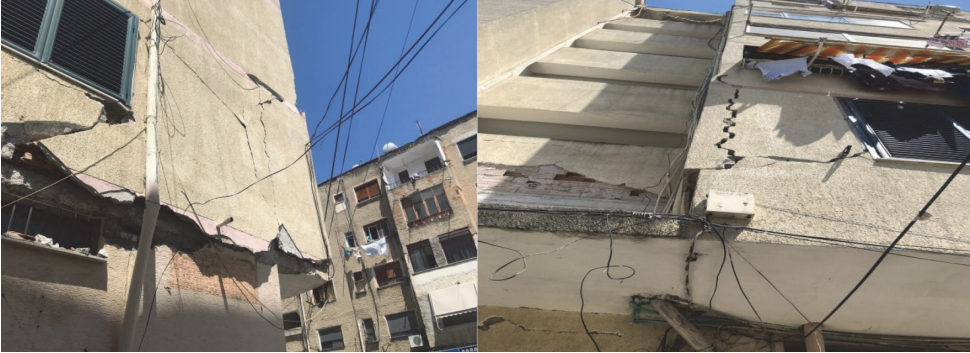
Most of RC frame structures without core with masonry infill experienced huge damages by this Earthquake. Before 1990 in Albania the most common buildings were built using masonry structural systems. The buildings with combined structure (RC frame with masonry infill) were the first built shortly after 1990. The structural systems are called combined because they have a RC frame and masonry exterior walls (38cm). These buildings exhibited many problems connecting to non structural elements such as partition walls, doors, plaster, stairs etc: Figure 1.

Figure 1. Exterior damages on 6 story building with combined structure

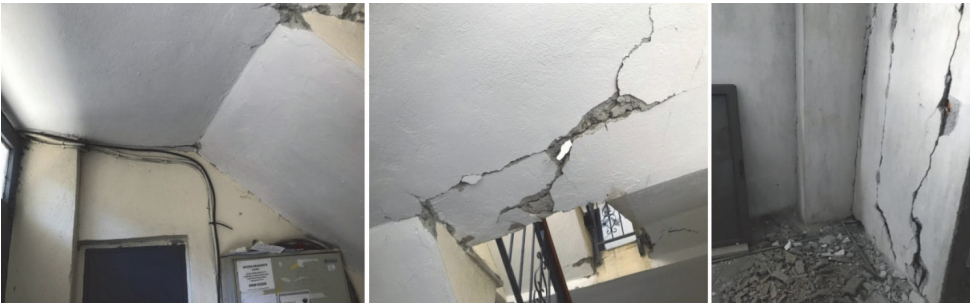
Such buildings were designed by Albanian Code KTP which does not give exact rules on how masonry infill should be modelled in the openings. The out of plane displacement of the walls from the frame were observed maybe because the wall follows the out of plane movement in the direction of seismic wave propagation. Sometimes the connection between walls and concrete frame was inadequate or totally missing. The materials also had a significant role in the seismic behaviour especially the concrete quality (which was very poor in most cases) and the adherence with steel bars. During the investigations the steel bars used in this building could be seen through the cracks. They were smooth and significantly affected in the bearing capacity of constructive elements. The stairs were another element damaged by the earthquake. In the structural system without a concrete core the stairs are the only connection between floors, so their bearing capacity was exceeded (Figure 2) the column damage is observed also because of exceeding bearing capacity.

Figure 2. Damages in stairs and columns

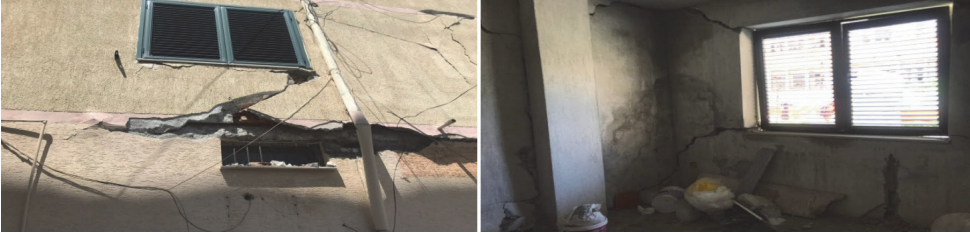
Exterior and partition walls have sustained huge damages by the earthquake, due to the inappropriate way of designing and constructing. Poor detailing of exterior and interior walls could be observed. Because of that, fracture of infill walls was quite a common sighting after the earthquake, as shown in Figure 3.

Figure 3. Damages in masonry exterior walls

The damages occurred affected the bearing capacity of the entire structure, so the building was demolished by explosion.

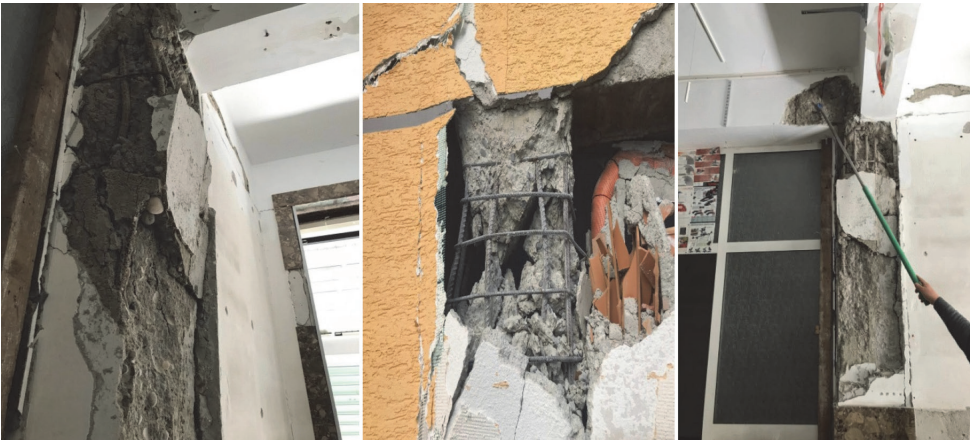
The structure observed have a structural system with RC type without core. These types of structures show defects especially in columns and beams. Another problem that has caused damages was the absence of shear walls. The poor quality of the concrete used was the most important element leading to serious damages. This reason is presented in Eurocode 8, recent finding on collapse vulnerability of nonconforming concrete columns [1]. Visual investigations revealed damages in some parts of the column and imperfection of reinforcing steel. The handmade concrete used onsite in some buildings was non homogeneous and with low compressive strength. The aggregates used with improper granulometry and the corrosion of steel, has resulted in decreased bearing capacity. Most of the columns damaged were the ones at the ground floor because of exceeding their bearing capacity, Figure 4.

Figure 4. Damages in columns in RC frame structures

In case when the joints were realized according to technical norms the building did not sustained a lot of damage of column because of the plastic hinges did not occur. The stirrups in the critical zones of the damaged columns were positioned at a distance larger than 20 cm and the hooks were short.

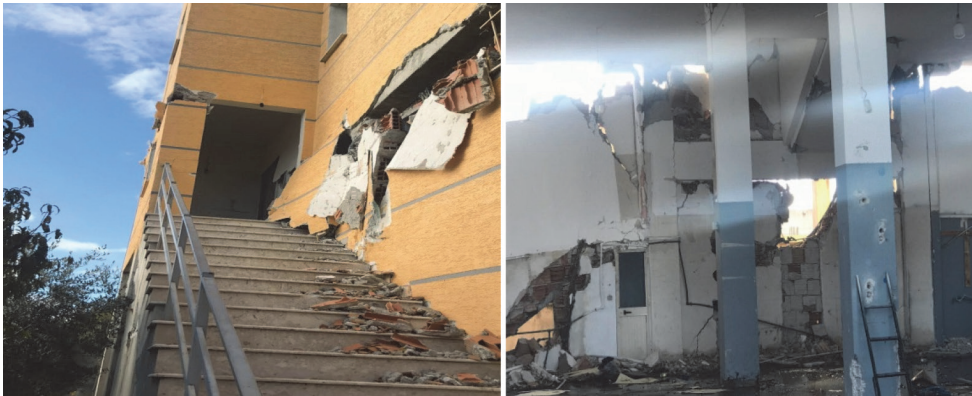
The building shown in Figure 5 was built after 2000 and collapsed due to the earthquake. It was a 4 storey building, with a tall ground floor 5m height. The collapse occurred because of the soft storey effect and the plastic hinges created by non appropriate design of the joints and reduction of the general stiffness of the building. It was subsequently demolished by controlled explosion.

Figure 5. Damages occurred in a RC frame structure

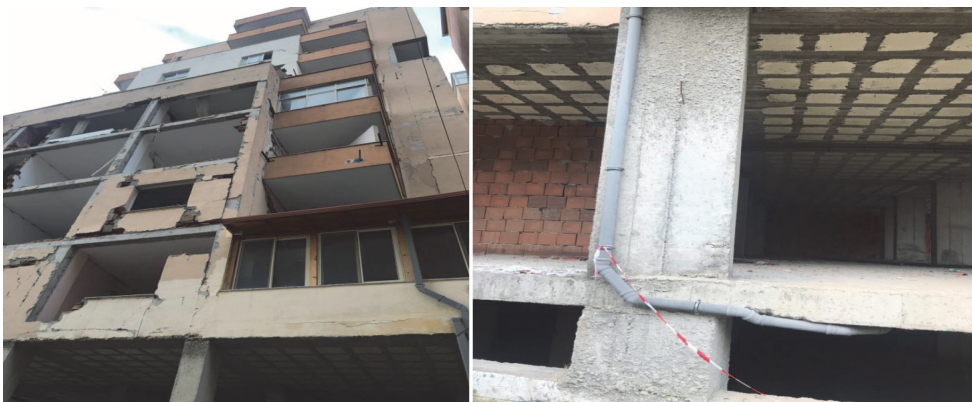
For the object shown in Figure 6 the structural elements were not affected. The structural system was a RC frame with central core. The only problem was the in and out of plane movement of the walls because of the absence of right connection with the frame. The columns and beams did not suffer any damage.

Figure 6. Damages in a RC frame structure with central core

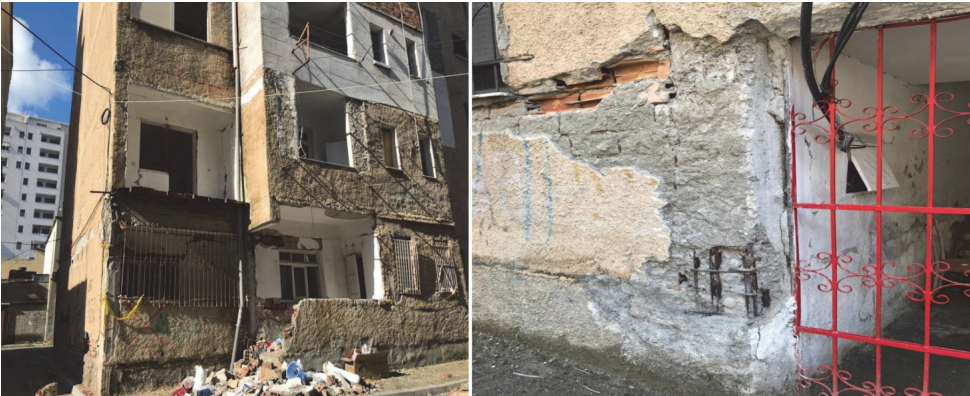
The buildings using load-bearing masonry type of structure were built before the 1990. The example presented in this paper is a 5 storey building with damages located primarily in the exterior walls because of the absence of reinforcement. The extent of damage in such buildings was not significant with cracks only in the exterior walls that did not affect the general structural stability, Figure 7.

Figure 7. Damages in a masonry structure
