Case-study of the out-of-plane wall failure of a typical downtown building in Zagreb

Matea Sruk¹, Marija Demšić², Maja Baniček³

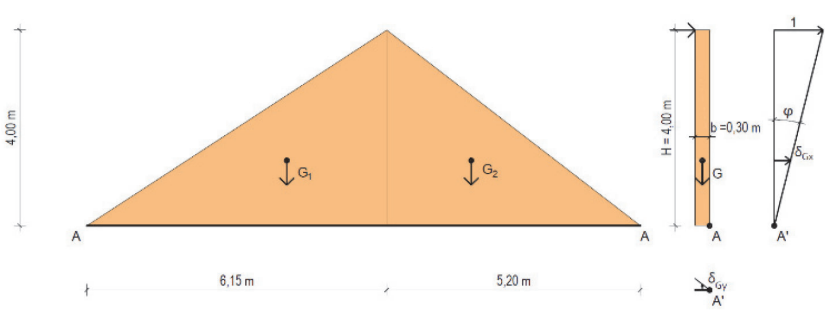
Table 1. Mechanism 1 – attic gable wall

Model parameters	Linear model parameters	Nonlinear model parameters
$G_1 = 66,42 \text{ kN}; G_2 = 56,16 \text{ kN}$ $\delta_{G1,x} = \delta_{G2,x} = 0,333, \delta_{G1,y} = \delta_{G2,y} = 0,037$ $z = 17,50 \text{ m}$	$\alpha_0 = 0,11; a_0^* = 0,81 \text{ m/s}^2$ $a_{0,\min}^* = 4,75 \text{ m/s}^2$ $a_0^* / a_{0,\min}^* = 0,17$	$d_{k,0} = 0,45 \text{ m}; d_0^* = 0,15 \text{ m}$ $d_u^* = 0,66 \text{ m}; d_s^* = 0,024 \text{ m}$ $T_s = 1,18 \text{ s}$ $d_{u,\min}^* = 0,3 \text{ m}$ $d_u^* / d_{u,\min}^* = 0,2$

For mechanism 1, only 17 % of the linear model demand and 20 % of the nonlinear model demand is fulfilled. This wall, however, only partially collapsed in the earthquake in March 2020. The model used in the analysis assumes complete separation of the wall from the rest of the structure, but it can be seen from the photographs on Figure 5. a) and b) that in the thirds of the length the wall was thickened with an additional layer of bricks, that certainly helped to prevent complete separation. It should be noted that cracks exist in these parts of wall that are visible from the outside (Figure 5.b). We also emphasize here that the main direction of the earthquake that happened, was approximately parallel to the gable wall plane, which certainly influenced the maximum value of the acceleration that affected this wall. The same wall was analysed in mechanism 2 where it includes the part of the wall on the storey below the attic. In the linear model, there is the fulfilment of 12 % of the demand, while the displacement capacity demand is fulfilled with 47 %. For this wall the connections with perpendicular walls is not completely impaired, so there are some reserves in terms of friction force that is present at the junction of the walls that was not considered in the analysis. The results of street façade wall considered in mechanism 3 showed that the wall should have been most likely activated during earthquake since linear model had fulfilment of 30 %. However, in the nonlinear model, the model had almost complete fulfilment of the demand that was 98 %. This wall, unlike the gable wall, was exposed to a greater acceleration values when considering the main direction of the earthquake. The façade wall on the courtyard side, mechanism 4, have satisfied requirement of the linear model so it was concluded that it was not activated in earthquake, therefore, the nonlinear model was not considered.

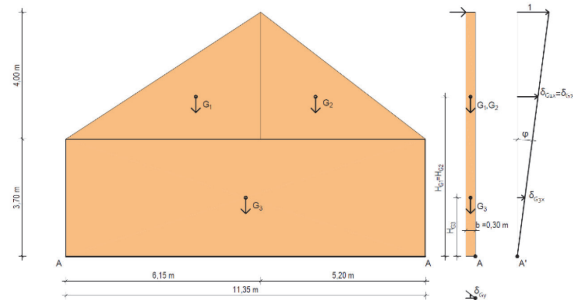
Table 2. Mechanism 2 – gable wall of 3rd floor including attic

Model parameters	Linear model parameters	Nonlinear model parameters
$G_1 = 66,42 \text{ kN}; G_2 = 56,16 \text{ kN}; G_3 = 214,98 \text{ kN}$ $\delta_{G1,x} = \delta_{G2,x} = 0,653, \delta_{G1,y} = \delta_{G2,y} = 0,019$ $\delta_{G3,x} = 0,240, \delta_{G3,y} = 0,0019$ $z = 13,70 \text{ m}$	$\alpha_0 = 0,049; a_0^* = 0,451 \text{ m/s}^2$ $a_{0,\min}^* = 3,74 \text{ m/s}^2$ $a_0^* / a_{0,\min}^* = 0,12$	$d_{k,0} = 0,385 \text{ m}; d_0^* = 0,19 \text{ m}$ $d_u^* = 0,08 \text{ m}; d_s^* = 0,03 \text{ m}$ $T_s = 1,77 \text{ s}$ $d_{u,\min}^* = 0,17 \text{ m}$ $d_u^* / d_{u,\min}^* = 0,47$
