Albania 2019 Earthquake: Building damage assessment

Tomaž Pazlar¹, Egon Milost²

Abstract

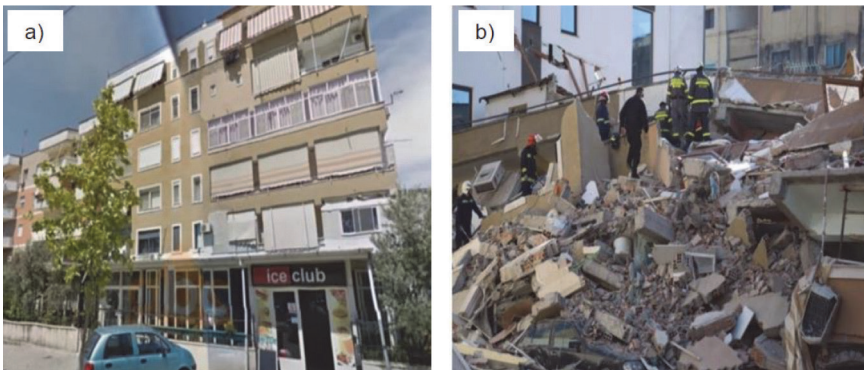
Figure 4. USAR search and rescue operations on six story reinforced concrete building in Durrës built in 1996: Before and after earthquake [10]

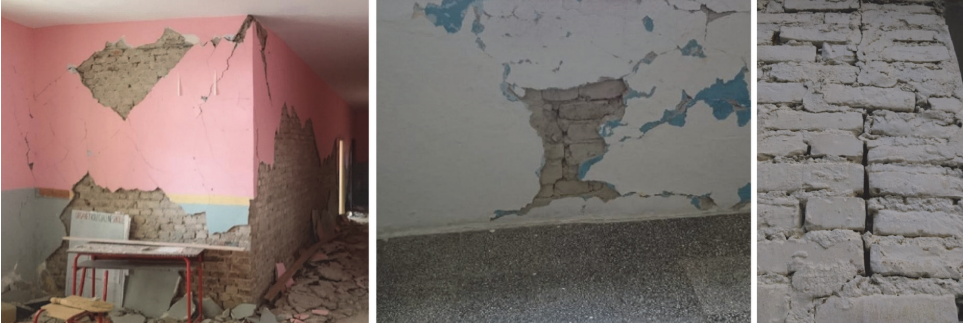
In Durrës unreinforced masonry (URM) structures with various types of concrete slabs performed in general well, but in other areas (Thumanë) - where flexibility limits of structures were exceeded - complete or partial collapses occurred, also due to poor connection between walls and floors, non-authorized interventions and poor materials / construction / maintenance (Figure 6a). As shear force increases shear stress develops in walls which leads to cracking, commonly observed near the openings (cracking of pears) (Figure 6b). Out of the plain cracks / failures also occur when connection between walls and slabs is poor. Similar reason is the cause for corner failures if connection between walls is in question (Figure 6c). Regardless the general performance of URM in Durrës, the vulnerability of unreinforced unconfined masonry structures, built according to Albanian authorities standardised design templates, has to be highlighted due to their brittle non-ductile behaviour. Poor performance is critical in cases where used hollow strap slabs are not properly connected into a rigid diaphragm.

Figure 7. URM structures: a.) Heavily damaged URM [9]. b.) Pier cracks. c.) Corner failure

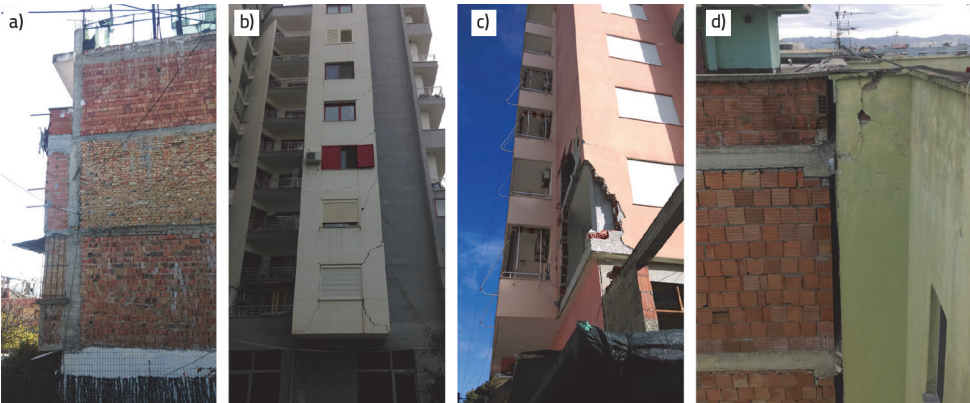
Figure 8. a.) Incremental construction. b.,c.) Damage in lower storeys. d.) Insufficient gaps

Although 1/3 of collapsed buildings were constructed round 1990 the modern multi-storey RC frames also proved to be problematic due to still used combination rigid infills and too flexible load bearing RC structure as Albanian technical codes do not define drift limitations. Consequently gaps between adjacent buildings are inadequate or even do not exist (Figure 7c). The soft story effects were also noticeable since the majority of these types of buildings were in mixed use with open street façade causing torsional eccentricity. Due to aggressive costal environment too thin concrete covering layer proved to be problematic (Figure 8c). Buckling of longitudinal reinforcement, concrete core crushing, and shear cracking of short span beams and columns in RC buildings were also noticed (Figures 8a and 8b). Relatively short extension of steel rebars in problematic incremental construction have a negative effect in structural performance (Figure 7a).

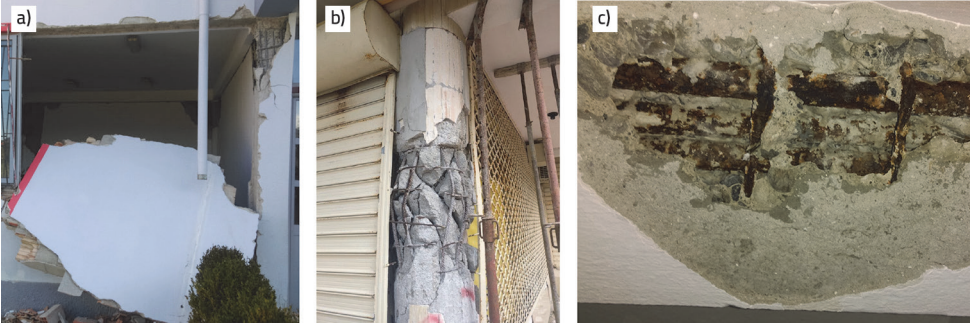
Figure 9. a.,b.) Buckling of reinforcement. c.) Corrosion of steel reinforcement.

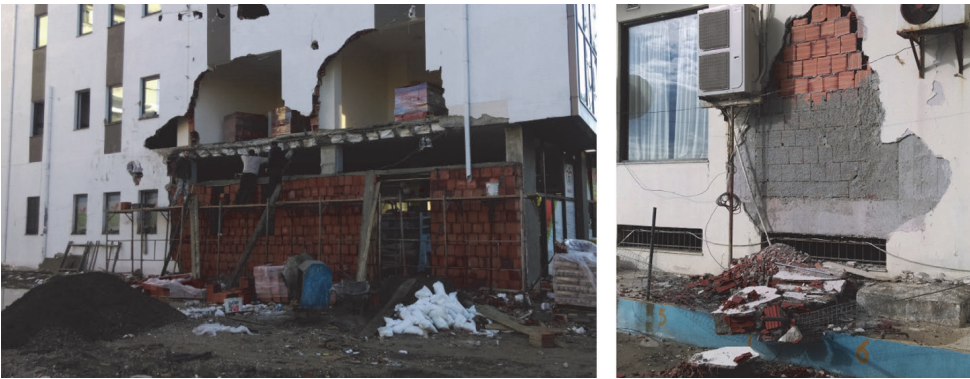
Figure 10. Non efficient attempts for damage remediation.
