# RETROFITTING OF SACRAL BUILDINGS AFTER THE RECENT EARTHQUAKES IN CROATIA

## Abstract

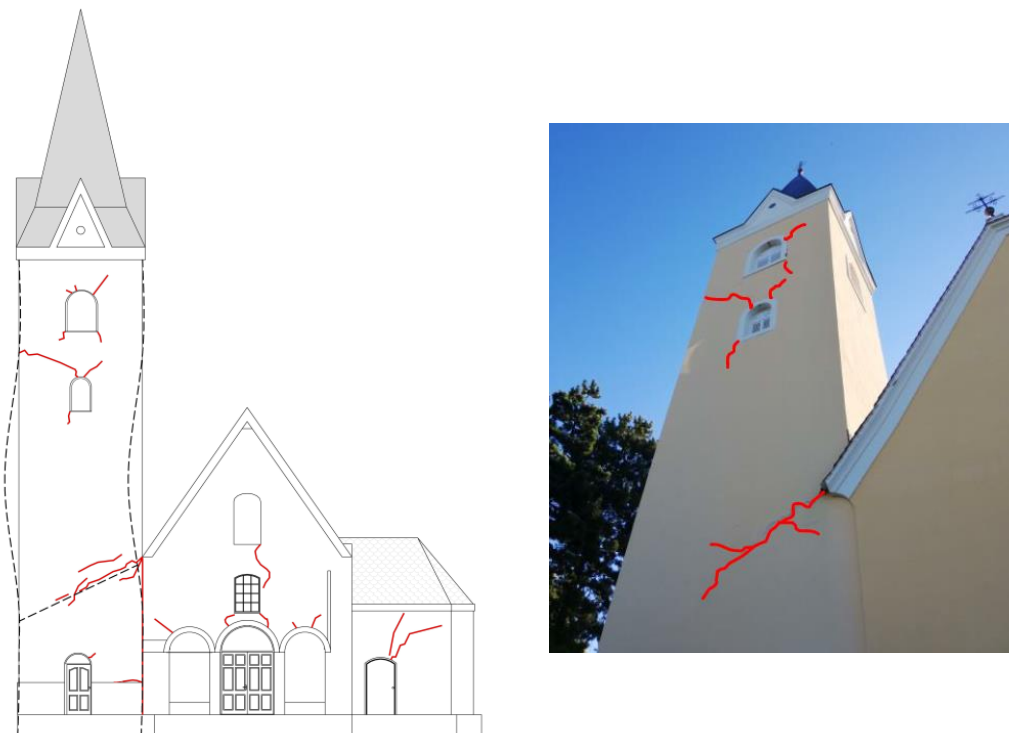
The church of Saint Michael in Gračani (Zagreb) has suffered substantial damage to the tower. Diagonal cracks and local deviation from the verticality of the tower, Figure 5, clearly suggested the main failure mechanism, in-plane shear/tension failure of the tower walls. The damage was classified as level 3 in EMS-98.

Figure 5. The main failure mechanism of the tower

The strengthening of the bell tower due to a shear failure at the level of the church cornice is conceptually predicted by the interpolation of a new shear resistant structure along the inner side of the bell tower walls. Considering its importance for the global stability of the entire structure, the proposed concept can be implemented in two ways: with an interpolated steel grid discretely connected with anchors to the basic masonry structure or with a reinforced concrete insert in the form of unilaterally concreted wall adjacent to the inner wall at the critical height of the bell tower. The steel option is extremely complex to install, but it is a reversible design that does not significantly compromise the original stiffness of the historic structure, Figure 12. However, in conjunction with external horizontal clamps and stainless steel connection anchors, this steel structure upgrades the earthquake resistance capacity and prevents a whole range of premature local out-of-plane wall failures. The steel structure partially takes over the tensile component of the global bending resistance of the bell tower as a cantilever with steel tensile flanges at the corners of the bell tower. In principle, the reinforced concrete version is easier to implement than the steel version. However, this design has a significant effect on the global behaviour of the masonry tower, as new critical zones are created at the transitions between the reinforced and unreinforced segments. It is also important to note that this is an irreversible type of strengthening that irrevocably removes some of the historic value of the structure. Both options provide for strengthening of the foundation in the form of a grid of foundation strips, which are additionally anchored by vertical geotechnical anchors.

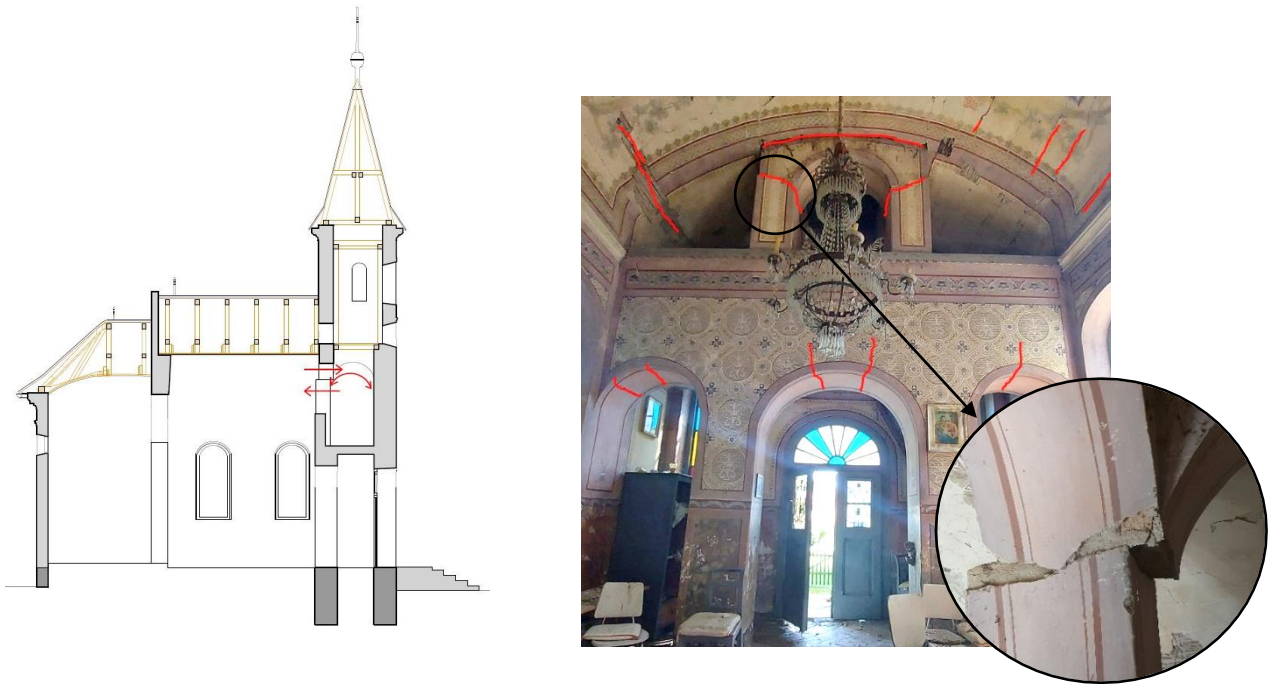
St. Mary's chapel in Mala Gorica sustained very severe damage of the tower (level 4 in EMS-98). The combined shear and tension failure of the tower columns resulted in horizontal deflection of the tower in the range of 10 cm at the top, Figure 6. The triumphal arch was also severely damaged and exhibited wide cracks on the intrados and at the crown of the arch, characteristic for cyclic seismic excitation. Ground slab deflections were noted, indicating possible liquefaction of the soil.

Figure 6. The main failure mechanism of the tower

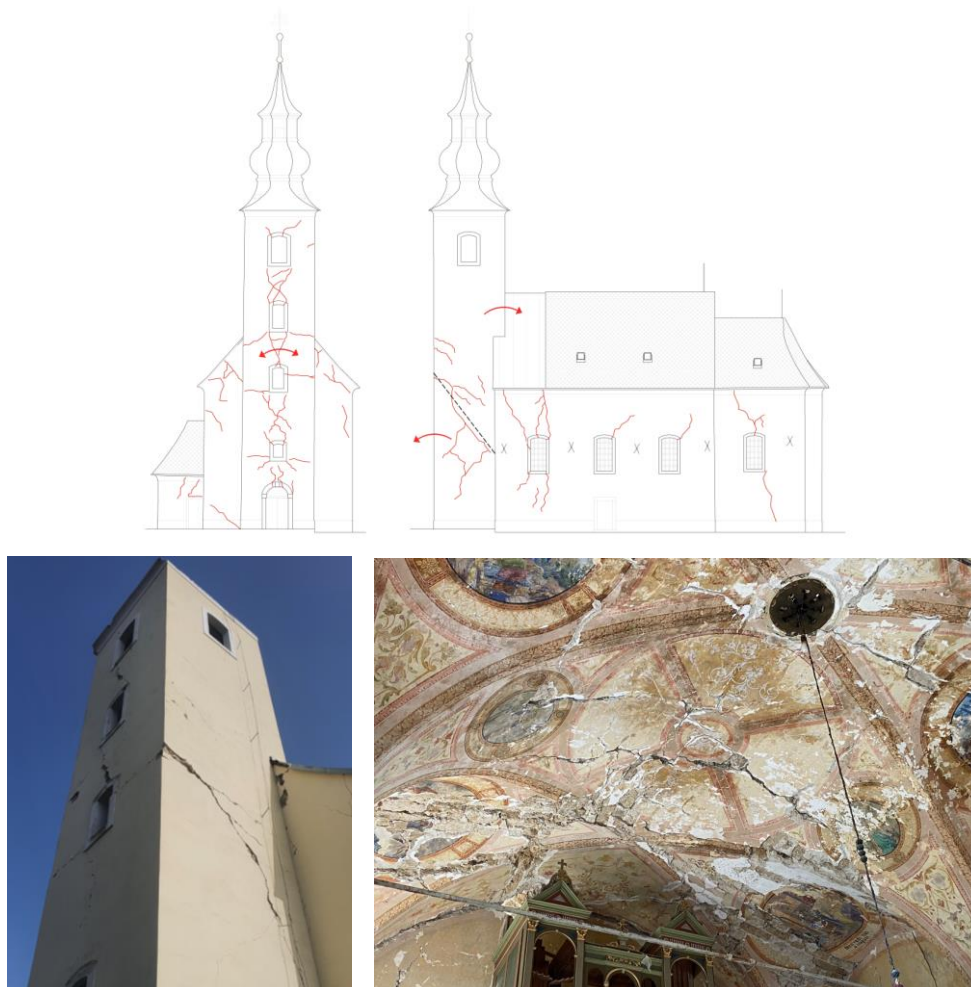
Figure 7. Main failure mechanism of the tower (left) and vaults (right)

On the northwestern façade of the tower, it is easy to distinguish two structural elements - vertical elements around the openings - piers connected with horizontal elements below/above the openings - spandrels. The damage pattern is shown in Figure 7. It refers to the extremely rigid spandrels that suffered shear failure. Diagonal cracks on the side walls form a clear sliding plane. Due to the very severe structural damage - level 4 on the EMS-98 scale - the upper half of the tower was dismantled as an urgent measure. The stone cross-vaults were significantly damaged by tensile failure on both the intrados and extrados. The walls, which were also of stone masonry, exhibited a number of cracks due to shear failure, out-of-plane bending failure (i.e. gable walls in the roof) and failure of the foundation soil. In this case, the timber roof structure was also affected by the earthquake – the failure of the gable walls caused mechanical damage to the timber columns and beams. In addition, the cyclic nature of an earthquake caused localized failure of timber connections, which is to be expected due to the low ductility of traditional carpentry connections.

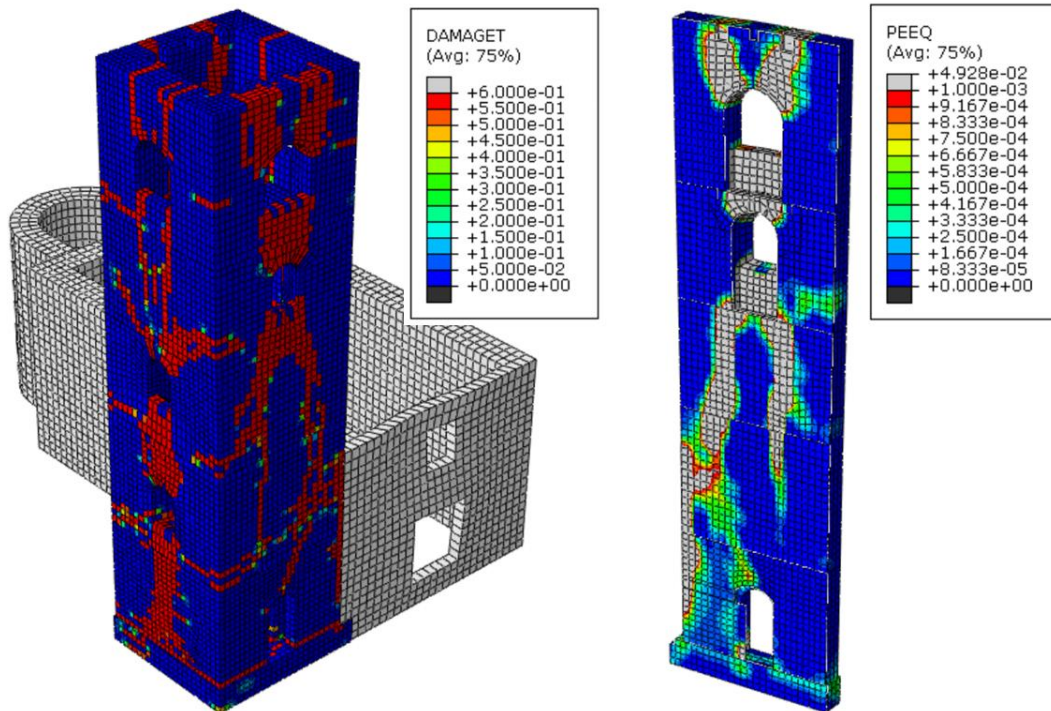
Figure 8. Bell tower damage distribution due to tensile stresses (a) and crack propagation area in the front wall (section through the front wall shown) (b) – existing condition

It can be seen that the numerical model complements relatively well with the cracks that appeared on the bell tower and the vault of the church, Figures 8, 9 & 10. It should be emphasized that a large part of the cracks in the structure is not visible due to the facade or because they are inside the wall. Areas of material damage (material crushing and tensile cracking) on the top of the church vault are more difficult to see visually because of the layers of the vault on the upper side. However, such damage is dangerous because it represents crack propagation sites even under dead load. Vaults are slender and very sensitive to any dynamic and horizontal influences.

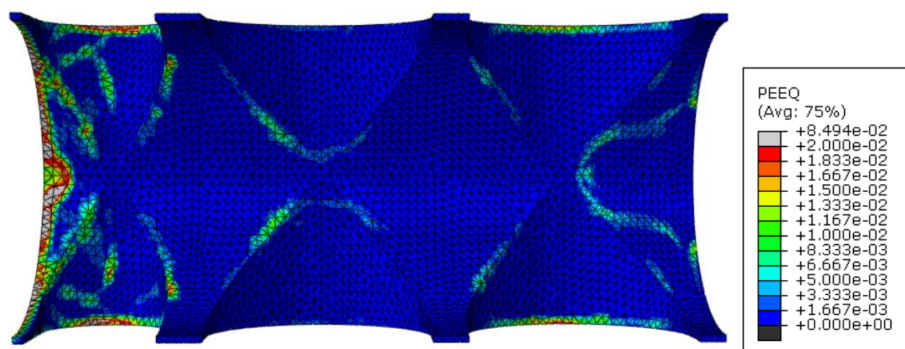
Figure 9. Area of propagation of cracks on the inside of the church vault shown through equivalent plastic deformations

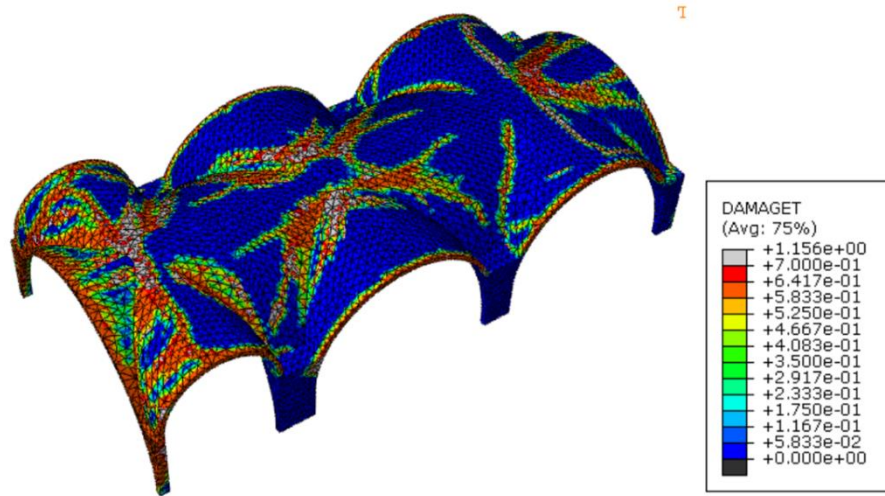
Figure 10. Propagation of material damage in the vault due to tensile stresses

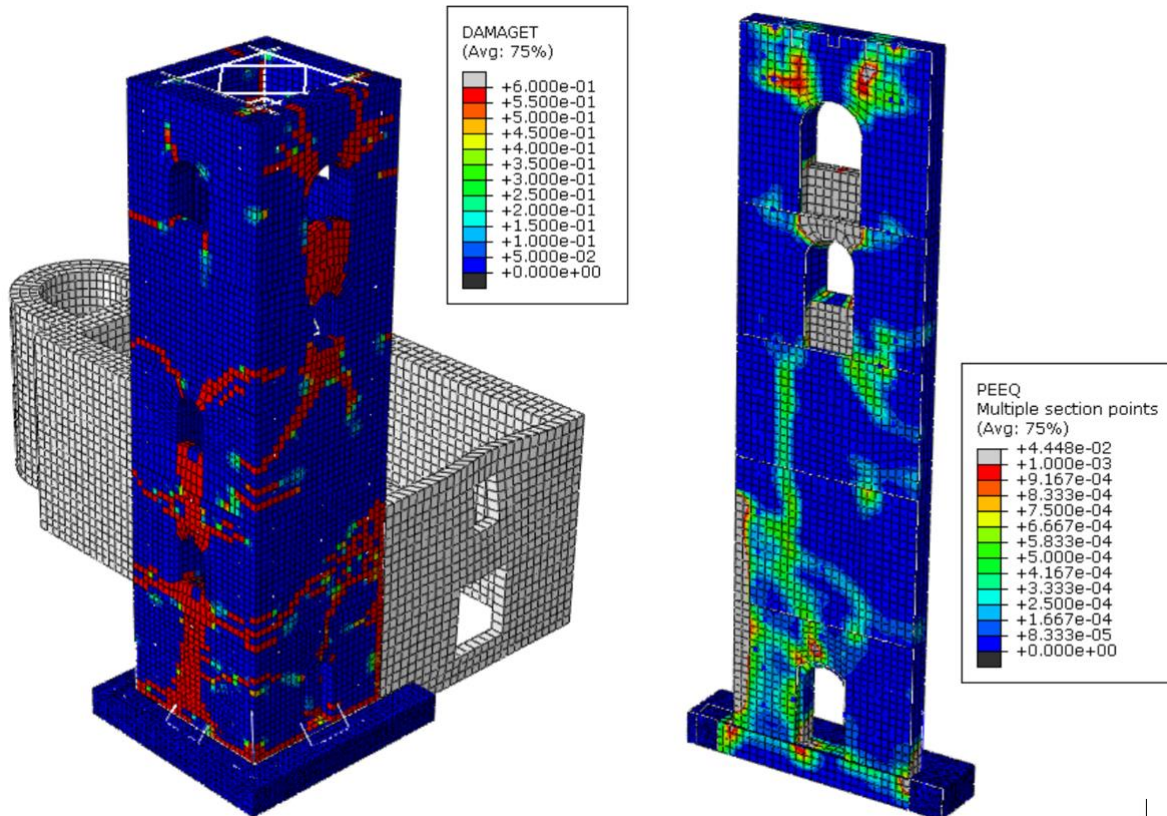
Figure 11. Bell tower damage distribution due to tensile stresses (a) and crack propagation area in the front wall (section through the front wall shown) (b) – reinforced condition

The calculation was also performed for the retrofitted model of the structure. The result of plastic deformation and damage of the tower is shown in Figure 11. There are still areas where cracks occur and propagate. However, this area is clearly localized and confined. Based on the amplitude of the plastic deformations, it can also be seen that they are much smaller and narrower. The area of damage is similar even after the strengthening of the tower, affecting similar critical elements dominated by microcracks of limited width, since thanks to the reinforcing elements, the stress is redistributed within the material, preventing the collapse of the wall or the lintel. Critical elements are the parts between the

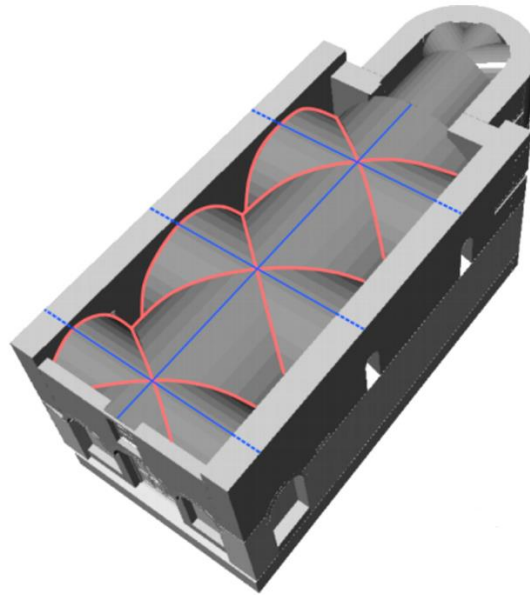
Slight separation of the longitudinal walls from the vault, leaves it in an unstable semi-restrained state, which can progressively result in partial collapse during stronger earthquakes. Therefore, both as a repair and strengthening measure, two groups of procedures are carried out, that would significantly increase the resistance of this masonry structure. As a stabilization measure, a system of orthogonal post-tensioned ties are installed in both main directions at the level of the top of the vaults. This reduces the possibility of detachment of the main support lines.

Figure 13. Strengthening of the masonry vaults (red line – uniaxial carbon fiber fabric, blue line – post tensioned steel ties)

The second strengthening method is linear strengthening of cross-sectional joists of cross vaults using carbon fiber fabric aligned in the direction of the joists, Figure 13. Both methods are reversible techniques that interfere minimally with the basic structure and can be performed effectively where monitoring and regular maintenance are performed.
