THE CASE STUDY OF PRINCE RUDOLF INFANTRY BARRACKS - ASSESSMENT, MODELLING AND RECONSTRUCTION

The procedure of a detailed condition assessment of the building under heritage protection in Zagreb is presented. A detailed historical background of the case study building is shown, and observed damage and conducted in situ tests are discussed. The nonlinear static seismic analysis performed in the 3Muri software is extensively elaborated. Four different levels of reconstruction according to new Croatian law are briefly presented. Additionally, several strengthening scenarios are proposed with various strengthening techniques. The renovation of the case study building is presented through extensive photo documentation. The problems in renovations of culturally protected buildings in a specific case study are raised.

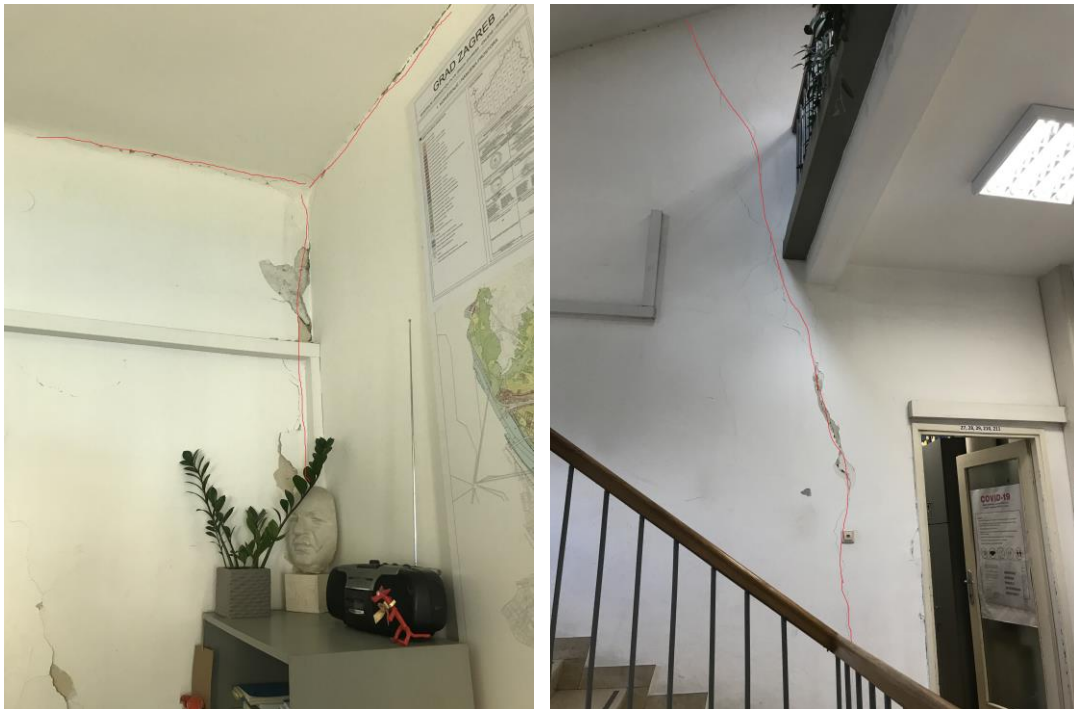
Figure 2. Observed damage

The particular case study was inspected after the earthquake on 22 March, 2020. It was assigned the usability mark PN2. The mark PN2 refers to buildings with moderate damage without the risk of collapse, but the usability is questionable due to the potential risk of collapse of some elements [9],[10]. The building did not experience severe damage, but several parts of the structure should be repaired. The more significant damage was observed at the connection of partition and load-bearing walls, as well as at the connection of walls and ceilings. The damage observed is not surprising since at the connections of partition and load-bearing walls, as well as walls and ceilings, there is a discontinuity of materials and contact of different materials with different behavior, thus causing different displacements that cause cracks (Figure 2). This inspection established a conservation guideline for repairing load-bearing and partition walls, staircases, and floor structures [6].

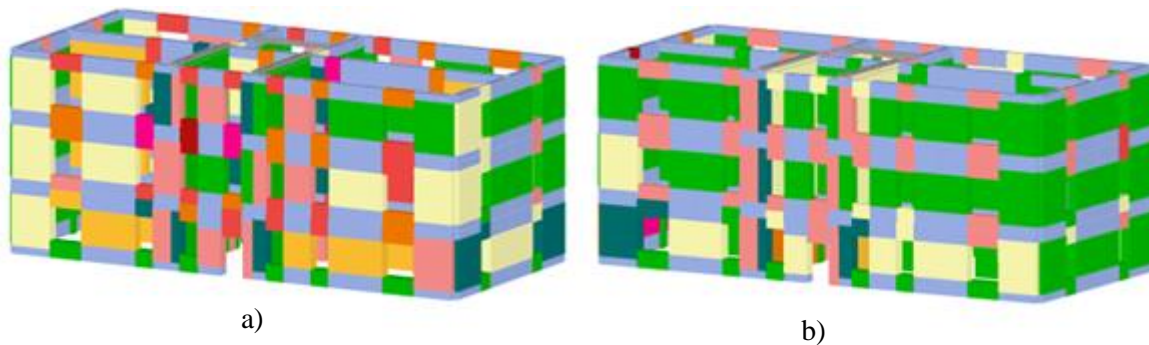
Figure 4. 3Muri model – observed damage in the model

Figure 3 shows a 3D model of the building in 3Muri. More about modelling can be found in the paper by Milić et al. [6]. Three-dimensional model with damage for the near-collapse limit state: (a) x-direction; (b) y-direction can be seen in Figure 4.

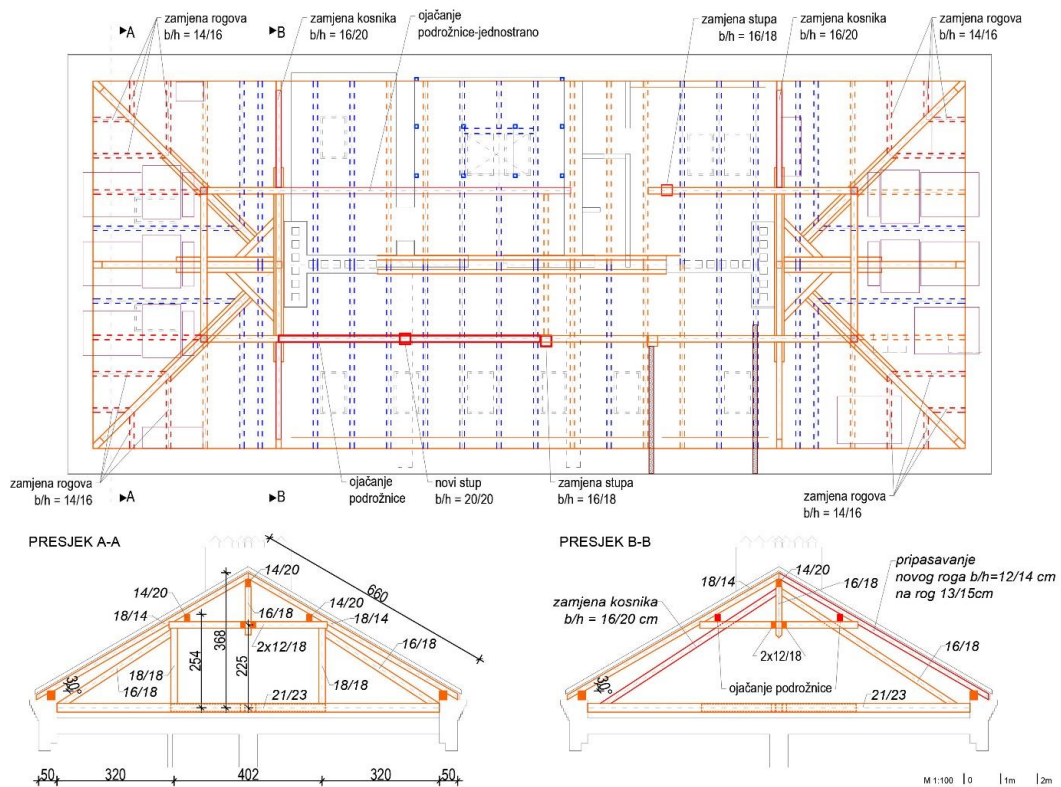
Figure 7. Strengthening of the roof structure

New bracing elements in longitudinal directions are included to improve the roof structure's lateral system. Some decay effects due to dry and wet rot on the roof elements are noted, which caused some rafters to be changed completely [21]. This retrofit was planned to change thermal insulation entirely and use a warm roof system to improve envelope performance.

As a measure of repair and reinforcement of the walls of the building, it is recommended to reinforce load-bearing walls by, e.g., FRCM system or concrete jacketing. Figure 5 shows a proposal for reinforcing load-bearing walls. To obtain good resistance in the transverse direction (y-direction), it is proposed to add new load-bearing walls with a minimum thickness of 38 cm. In addition, it is proposed to remove the brick partition walls and replace them with a drywall system. Figure 6 shows a proposal for the position of the new load-bearing walls and a proposal for the removal and replacement of partition walls. In addition to the above methods, it is necessary to strengthen the ceiling structure. Therefore, to repair and reinforce the wooden ceiling structure, a thin reinforced concrete compression slab is proposed to increase the load-bearing capacity and stiffen the structure (rigid). All vaulted elements and vaults in the basement are to be maintained in their original form, with the possibility of reinforcing them with carbon fiber and maintaining the original proportions of the vaults to preserve the building's original construction and design features. Figure 7 shows the strengthening of the timber roof structure.
