MOST AFFECTED TYPOLOGIES FROM THE 26 NOVEMBER 2019 EARTHQUAKE

Markel Baballëku ⁽¹⁾, Rikard Luka ⁽²⁾, Klajdi Shaholli ⁽³⁾

⁽¹⁾Civil Engineering Faculty, Polytechnic University of Tirana, Albania; e-mail: markel.baballeku@fin.edu.al

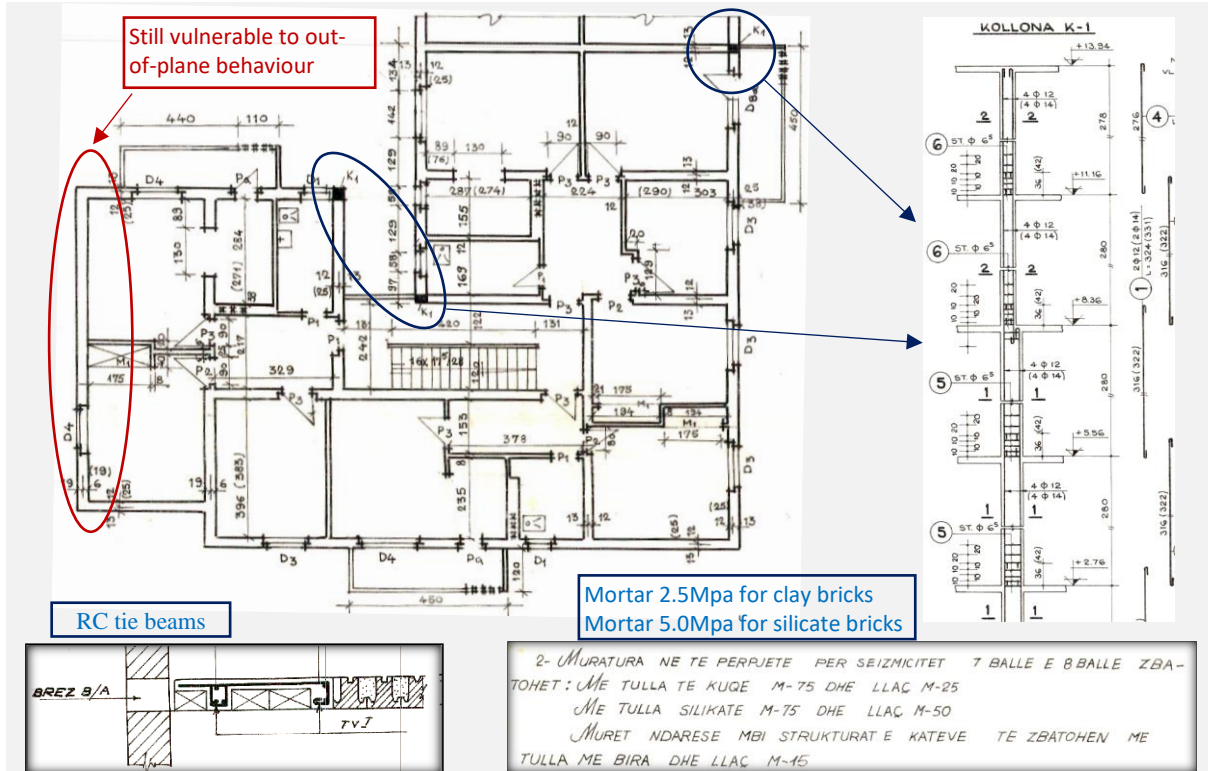
Fig. 3. Improved 77/5 Model, by adding at least 3 RC columns at the corners; improving the mortar strength; reinforced concrete tie beams were also added at the floor levels

2-) An improved typified design has been drafted for the model 77/5 after the April 15, 1979 Earthquake. The performance of buildings with improved model 77/5 during the 2019 Earthquakes should be assessed carefully in order to check the effectiveness of the improvements and to considered them during retrofiting strategy for buildings with unimproved model;

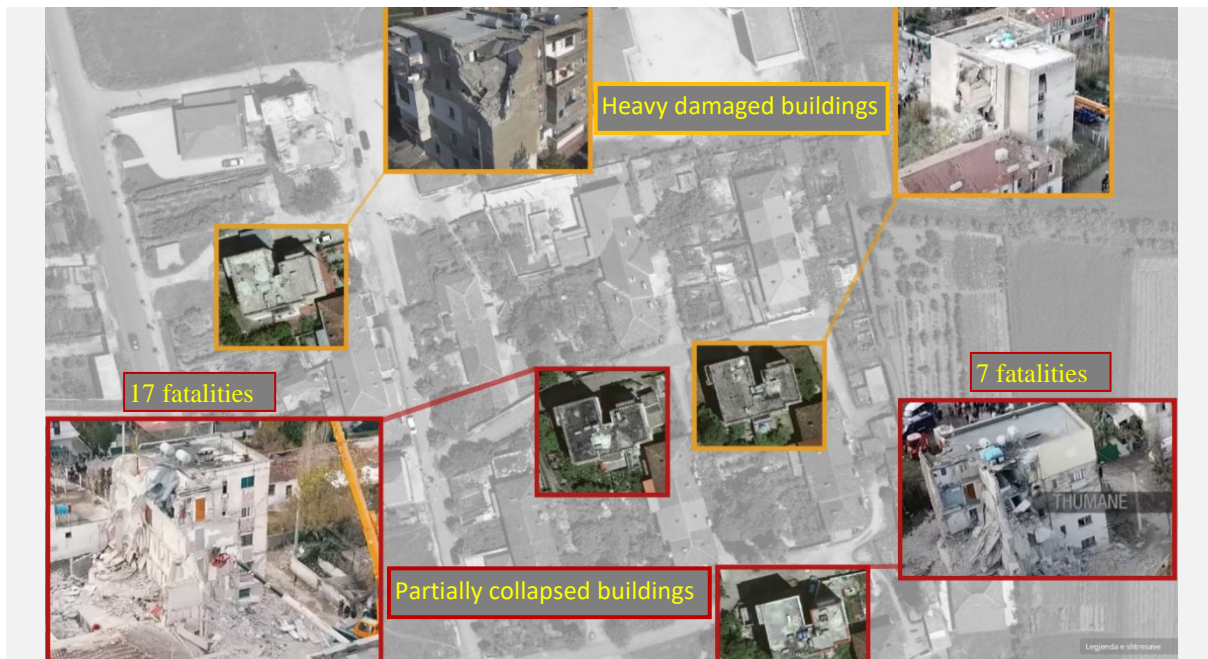
Fig. 4. Location of URM Model 77/5 in Thumana and their damage degree

Unfortunately, many buildings with URM 77/5 models has been constructed since its release and the improved 77/5 model in 1982 wasn't use to retrofit the existing building stock. During the 2019 Earthquakes many buildings belonging to this model suffer moderate-heavy damages. Four partially

collapsed buildings in Thumana belonged to this model as well and 24 people lost their lives in two of them Fig. 4.

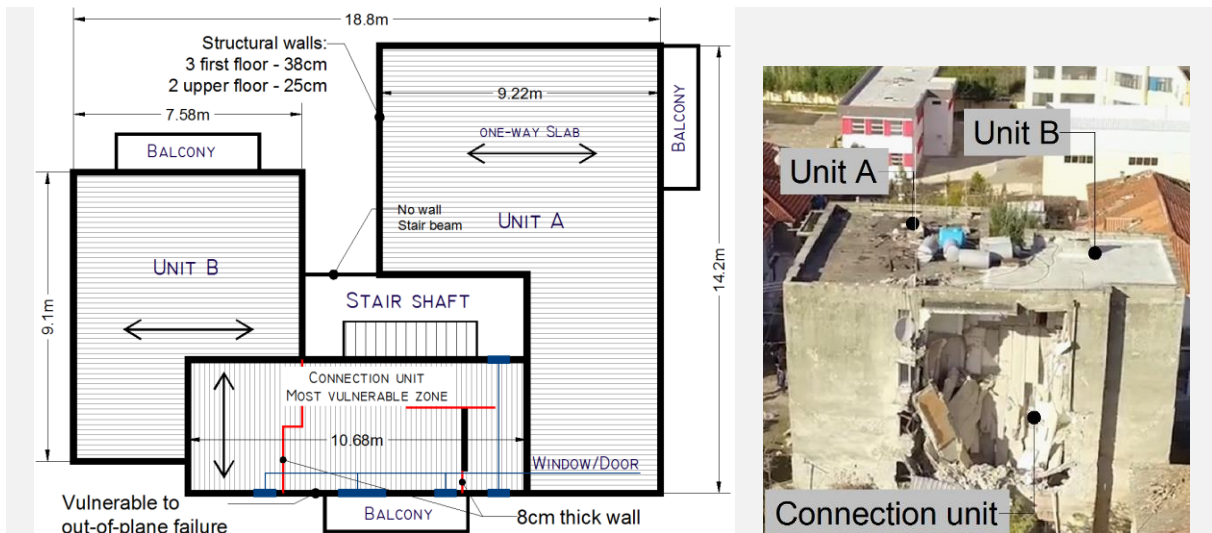
From the structural point of view, URM 77/5 Model can be considered composed of two “separate” structural units having a weak “connection unit” Fig. 5, comprising: low percentage of transversal walls and high potential of out-of-plane failure of longitudinal walls; stairs; longitudinal walls weakened by the presence of doors and windows. The prefabricated slab panels, placed in one direction and without tie beam connecting to the wall also affect the joint work of the units A and B.

Fig. 5. Structural unit composition of 77/5 URM Model

Due to the layout geometry, the weak “connection unit” and the distribution of the masonry walls and their openings, the torsion and the interaction of the structural units A and B increase the seismic effect to each other. The interaction may have contributed to the heavy damages and falling parts of the “connection unit” as well as to the collapse of the small unit B in two cases, during 26 November earthquake. The photos of the heavily damaged buildings clearly show the collapse of small units in two buildings and damage to the connecting area in the two others.

3-) The following vulnerable elements should be remember for retrofiting of the 77/5 model: the low quality of the mortar (when documented); connection unit with high damage potential; low resistance of piers and spandrels; the missing diaphragm behaviour of the slabs and their connections to the masonry walls; large spacing and lack of uniformity of some transversal walls;

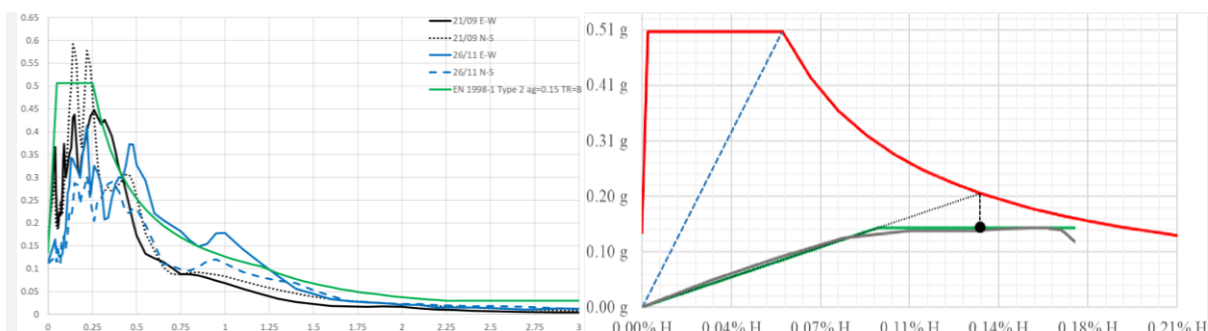
- 1-) Using as demand, the fitting response spectrum of all 2019 earthquakes recorded at Tirana station (Fig. 6-a), the URM 77/5 model suffer significant damages, but no collapse (Fig. 6-b). The buildings with URM 77/5 model situated in "Kombinat" area, periphery of Tirana have suffer moderate-heavy damages and fit quite well with analysis results;
- 2-) Other factors i.e.: damages from previous earthquakes (July 2018 Mw=5.2 and 21 September 2019 Mw=5.6), lower mortar quality, out-of-plane failure or unknown interventions, may have increase the damages, leading to the building collapse in Thumana.

Fig. 6. Target displacement in ADRS format: a-) demand spectra fitting all 2019 earthquakes records in Tirana station (Type 2, SC B and ag=0.15g); b-) target displacement (performance point) of the URM model 77/5

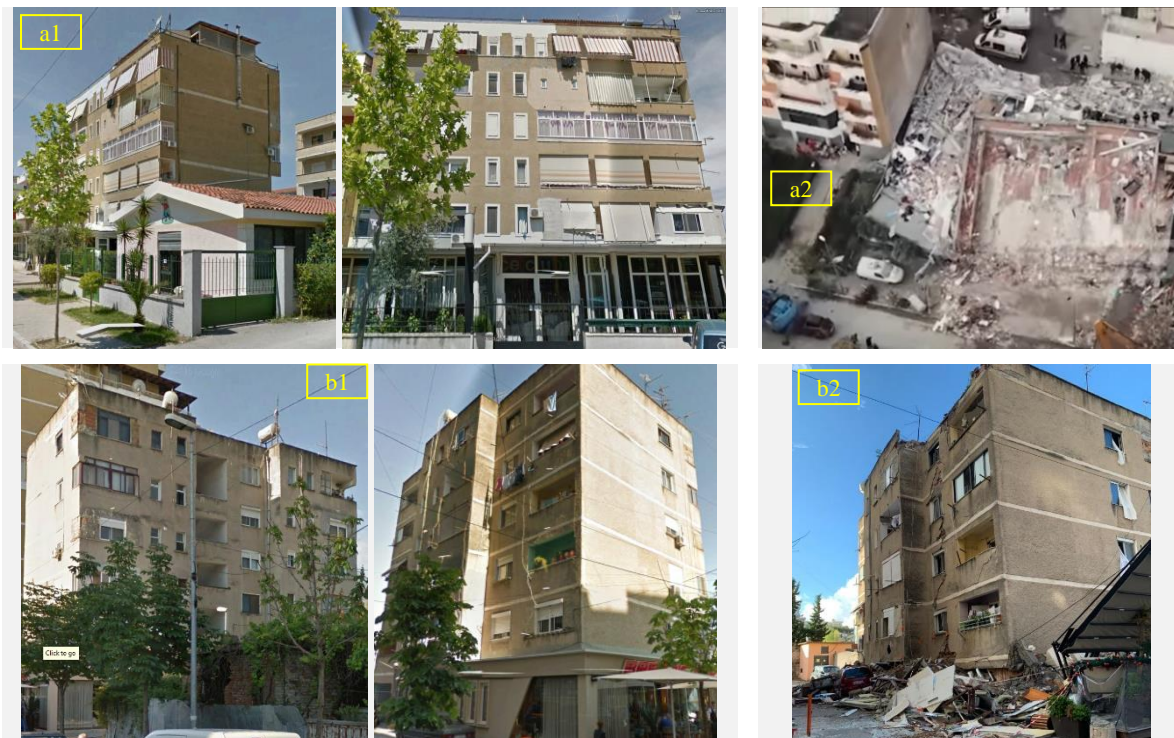
In Durrës, two buildings with the M-RC 82/2 Model collapsed, both with “soft story” mechanism. One of them subsequently develop also pancake collapse. Heavy damages suffer most of cast-in-place RC Models 82/2, original and modified ones in Durrës area.

Fig. 10. Two cast-in-place M-RC 82/2 Model collapsed buildings: a-) pancake mechanism; b-) “soft story” mechanism

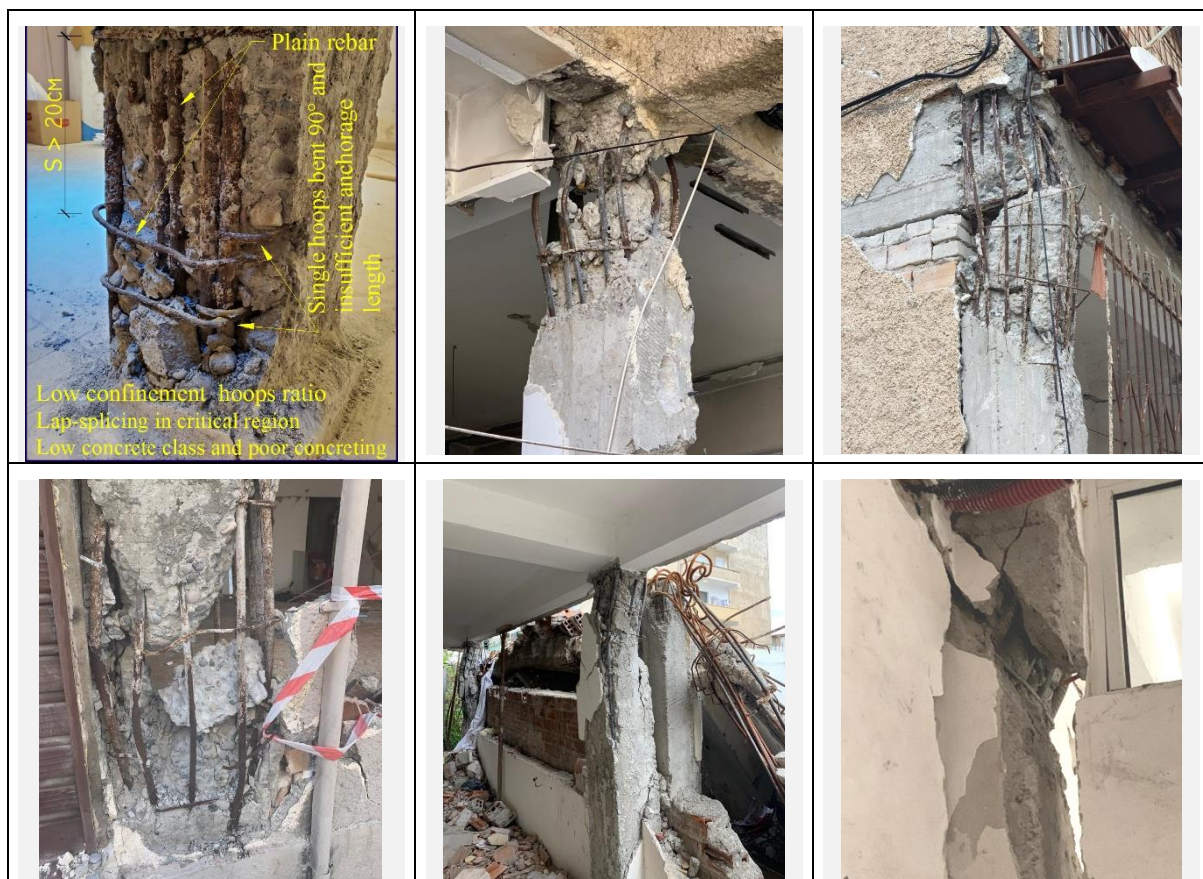
The damage patterns appears in cast-in-place 82/2 model are mainly concentrated on the ground floor: 1-) joint crush at the top of the ground floor; 2-) shear crack in columns and beams; 3-) columns buckling; 4-) failure due to high normal forces; 5-) diagonal cracks in the filling walls.

- Poor concrete quality and inappropriate detailing's: a-) low concrete strength; insufficient dimensions for primary structural element; b-) low percentage of the longitudinal reinforcement

and low volume ratio of the transversal reinforcement; c-) inappropriate reinforcement details: absence/deficiency of hoops in critical regions, deficiency in bar anchorage and lap-splicing, hoops bent not more than 90° and insufficient anchorage length into the concrete core; d-) inadequate stirrup/hoops amount and detailing in beam-column joints; e-) plain rebars;

- The severe reduction of the columns resistance above the ground floor – abrupt change in rebar percentage above ground floor;
- Insufficient stiffness and resistance in the longitudinal direction of the building;
- Prefabricated slab panels placed in one direction and without cast-in-place any top RC layer – no rigid diaphragm behaviour;
- Added floors and/or increased floor area without making appropriate structural verifications and design adaptations;
- Environmental factors deteriorating the qualities of the materials - is evident in the columns base. Lack of maintenance and possible interventions during the design working life.

Fig. 11. Columns damaged in six different cast in place RC and M-RC 82/2 Model

4-) For the assessment of the RC 82/2 models it is recommended to follow also these steps: a-) Verify the compatibility of the in-situ building with the typified model, since in many cases are present additional area, cantilever in each floor or added storey on the top of the building; b-) checking material strength and the condition of RC elements, especially the concrete deterioration and rebar corrosion; c-) assessing the existing capacity, paying special attention to: the longitudinal direction capacity, shear capacity, soft story mechanisms in ground and first floor, infill walls and one direction panel slabs.

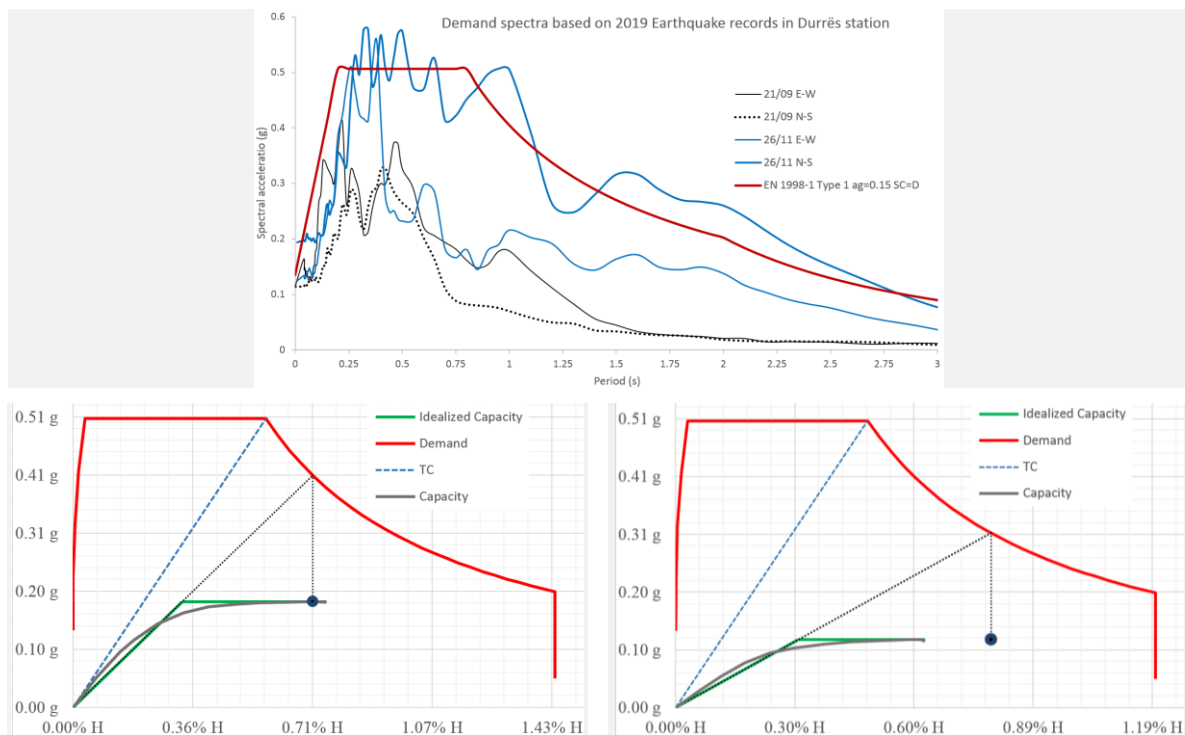
1-) Using as demand, the fitting demand spectrum comprising the 2019 earthquakes recorded at the Durrës station (Fig. 12-a), the RC 82/2 model suffer near-collapse (Fig. 12-b). The failure mechanism result soft story.

2-) The same demand is used also for the M-RC 82/2 model and the structure collapsed (Fig. 12-c). The failure mechanism is still soft story.

In both analysis the soft story mechanism is developed in longitudinal direction. Exist high possibility that the “soft story” mechanism to be developed in the first floor rather than ground floor, in those cases

were columns rebar amount is immediately reduced above ground floor. In fact, one of the two collapsed RC Model 82/2 has developed soft story in first floor.

Fig. 12. Target displacement in ADRS format: a-) demand spectra fitting all 2019 earthquakes records in Durrës station (Type1, SC D and $ag=0.15g$); b-) target displacement RC 82/2 Model; c-) target displacement M-RC 82/2 Model
