SEISMIC STRENGTHENING OF THE HISTORIC BUILDING OF “SOKOLANA” IN KUMANOVO

Elena Delova ⁽¹⁾, Aleksandar Zlateski ⁽²⁾, Veronika Shendova ⁽³⁾, Zivko Bozinovski ⁽⁴⁾

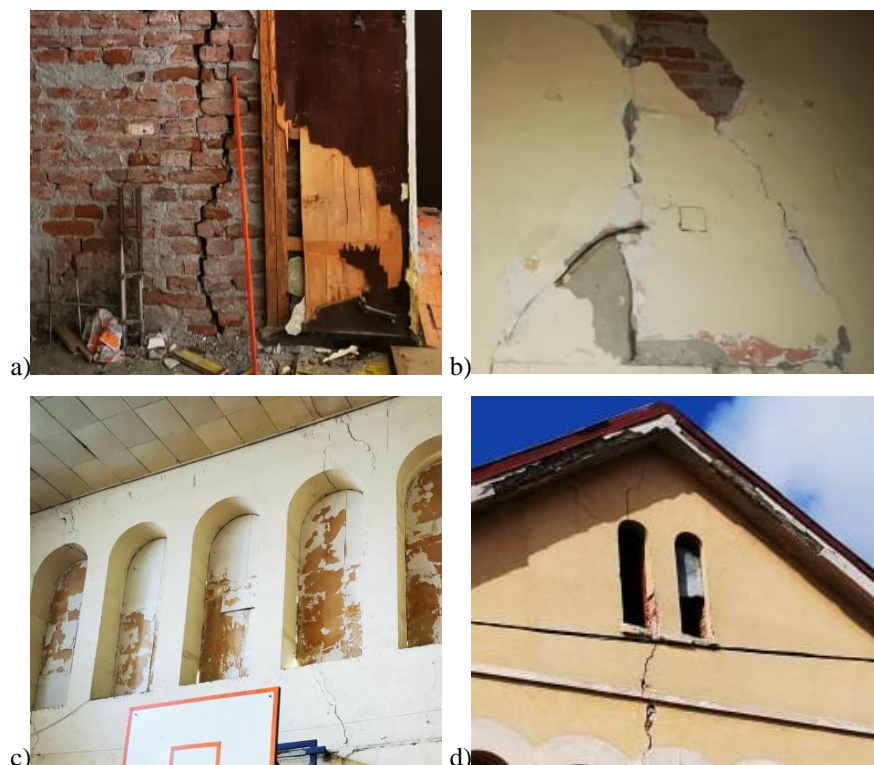
During the inspection, significant damage was observed on the load-bearing wall elements, manifested with large cracks on the walls. Heavy damage was observed also in the roof - wooden structure and ribbed reinforced slab, in the annex ground floor structures. (Fig. 4) After the visual inspection it was concluded that, in order to bring the building in functional condition, it is necessary to make a repair and strengthening.

Figure 4. a), b), c), d) Severe cracks on the load-bearing wall elements

The building of “Sokolana” in Kumanovo is a historic building built in the thirties of the last century. During the visual inspection, significant damage was observed on the load-bearing walls, due to the negligence of the building, manifested with large cracks on the walls. Heavy damage was observed also in the roof-wooden structures, and ribbed reinforced slab in the annex ground floor structures.

The solution for strengthening of the structural system includes the following, Bozinovski, Shendova et al. (2021): (i) strengthening of load-bearing walls with reinforced concrete jacketing in longitudinal and transverse direction along with the new foundations (shown with red color in figures 6, 7, 8); (ii) connecting the RC jacketings with horizontal reinforced concrete belt courses (shown with blue color in figures 7, 8) or rectangular steel profiles (shown with green color in Figures 7, 8), in transverse and longitudinal direction; (iii) strengthening of wooden joists from the roof truss with steel profiles (shown in figures 7,8 with green color) in order to form ties for connecting the elements in the transverse direction; (iv) local repair of the cracks manifested in the bearing walls; (v) local remove and replacement of the damaged wooden roof structure; (vi) local remove and replacement of the damaged ribbed reinforced slab above the ground floor. Figures 6, 7 and 8 show the formwork plans and characteristic cross-sections of the proposed technical solution for strengthening the “Sokolana” Structure.

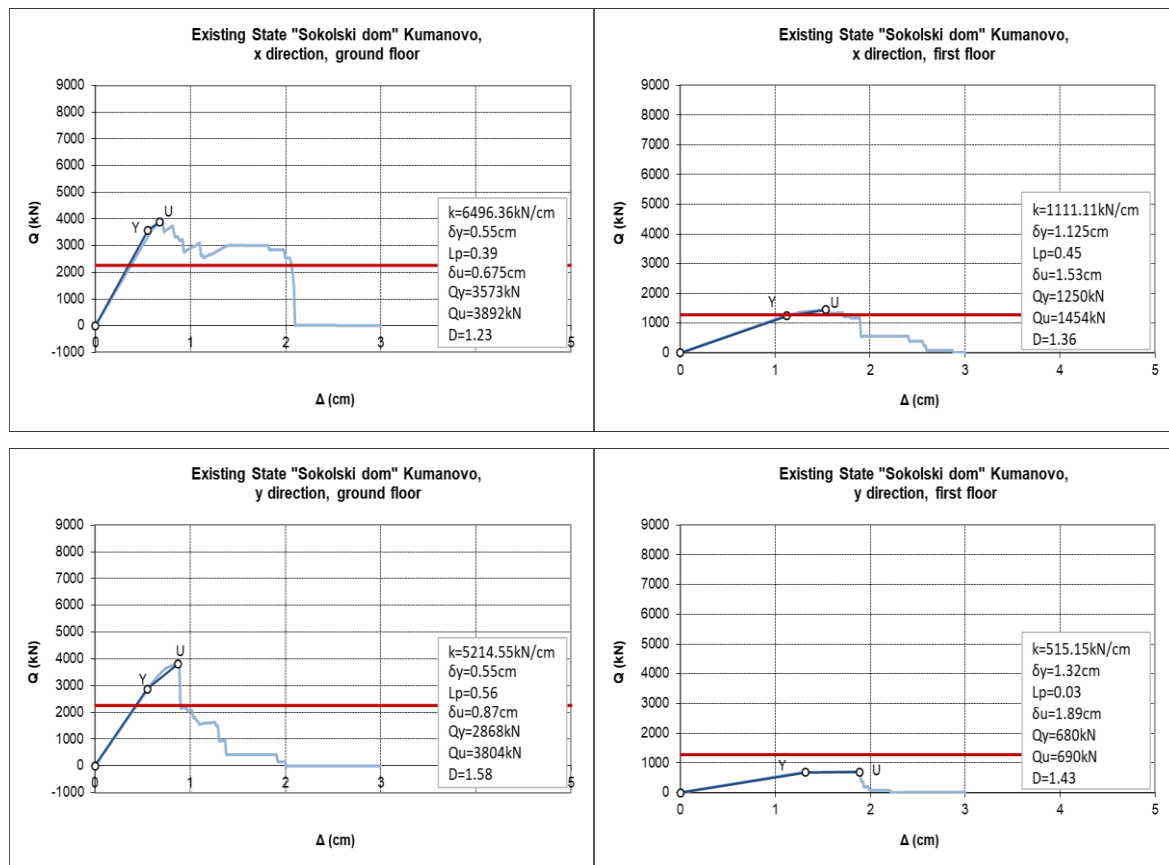
Figure 5. Storey $Q-\Delta$ relationship (existing state) for both orthogonal directions

The results of the analysis, in the form of summary storey $Q - \Delta$ diagrams for the two orthogonal directions respectively, are shown in Fig.5. The bilinear diagrams with the characteristic yield points "Y" and the ultimate point "U" are shown in blue, while the required load capacity of each floor is marked in red. Table 1 summarizes the obtained and required load-bearing capacities of the structure for each storey.

Based on the performed analysis of the existing structure and the obtained results, it was concluded that the strength capacity of the building for the ground floor for x-direction and y-direction is higher than the required according to the regulations, but for the first storey in both directions, it does not meet the requirements according to the regulations, PIOVS (1981). The ductility capacity for both directions in height is relatively small. The structure does not have sufficient strength for the ground floor for both directions, also the bearing capacity and deformability is relatively small for both directions, Bozinovski, Shendova et al. (2021). Given that structural interventions are going to be made, it is necessary to provide adequate strength and sufficient deformability, providing structural elements with greater ductility and increasing the integrity of the structure in both directions. From the above, the need for repair and strengthening is justified and necessary to improve the strength and deformation requirements and to achieve the desired dynamic response during future earthquakes.

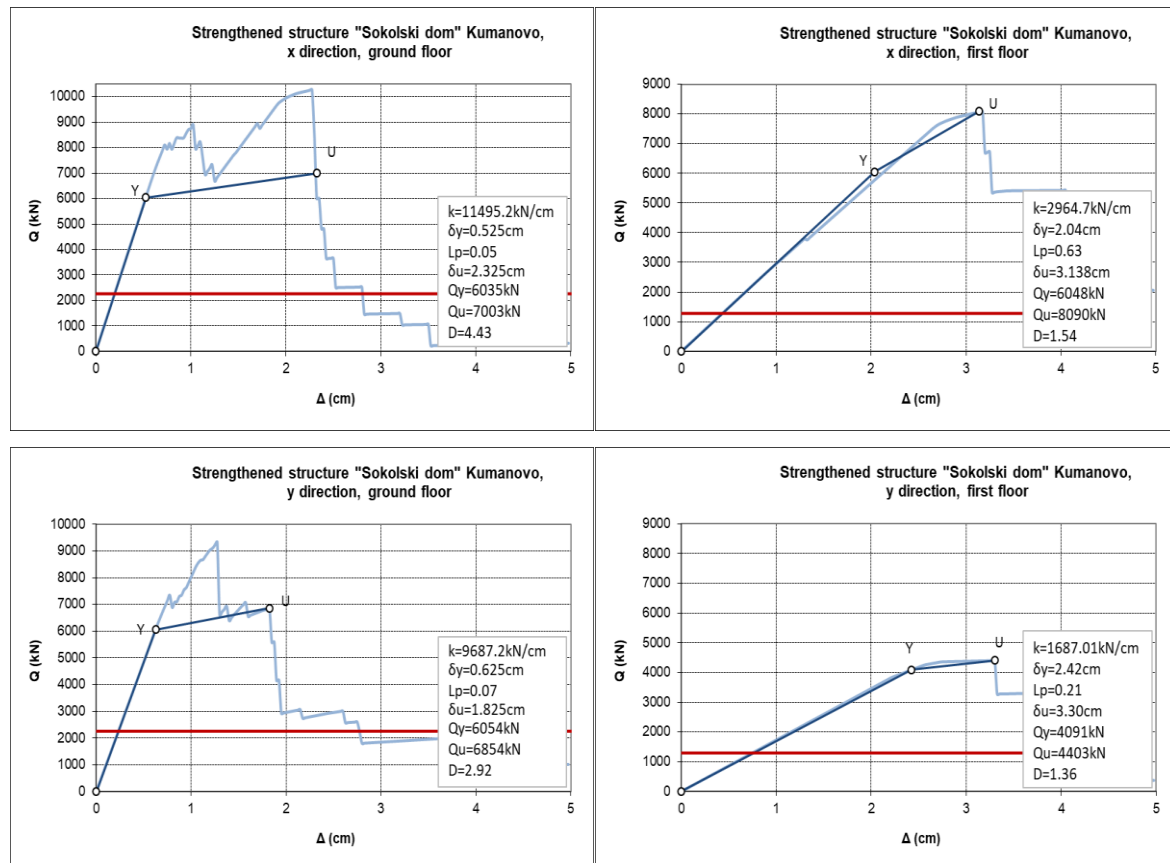
Fig. 9 - Storey $Q-\Delta$ relationship (strengthened structure) for both orthogonal directions

The bilinear diagrams with the characteristic yield points "Y" and the ultimate point "U" are shown in blue, while the required load capacity of each floor is marked in red (Fig. 9). Table 2 summarizes the obtained and required load-bearing capacities of the building by storey and directions, showing the new calculated safety factor.

From the results of the analysis of the repaired and strengthened structure, it is noted that the capacity of the strength in both orthogonal directions of the building is significantly greater than the required limit capacity according to the regulations, PIOVS (1981). The bilinear diagrams show an increase in the deformation capacity of each of the storeys in both directions respectively, with an increase in the ductility capacities. This leads to the conclusion that the strengthening will increase the ability of the system for greater dissipation of energy, Bozinovski, Shendova et al. (2021). This is especially important for this type of buildings in case of seismic excitations. By increasing the deformation capacity, the input energy in the system would be consumed, which would greatly increase the seismic safety and security of the building, Bozinovski et al (2021).
