REPAIR AND STRENGTHENING OF OLD FIRST CATEGORY BUILDING IN SKOPJE, N. MACEDONIA IN ACCORDANCE WITH IZIIS METHODOLOGY

Keywords: repair, strengthening, non-destructive tests, structural and non-structural damages, dynamic analysis

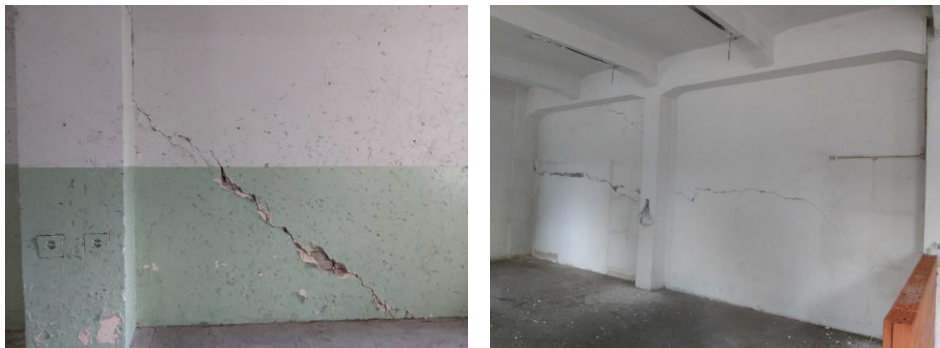
Structural and non-structural damages were observed due to the inappropriate foundation and maintenance of the building, which have increased during the exploitation period and seismic actions (Fig. 2, Fig. 3).

Figure 2. Horizontal and diagonal cracks

A greater percentage of the strengthening activities refers to strengthening due to inappropriate foundation resulting in diagonal cracks in bearing walls made of solid bricks in lime mortar, whereas strengthening against seismic effects is done to a relatively lesser extent.

- Local repair of cracks manifested in bearing walls and reinforced concrete elements;
- Local repair of the deformed floor structure at the ground floor.

bricks and is injected with repaired concrete or strong cement mortar. Local strengthening is done irrespective of strengthening because global strengthening of the structure prevents further opening of cracks.

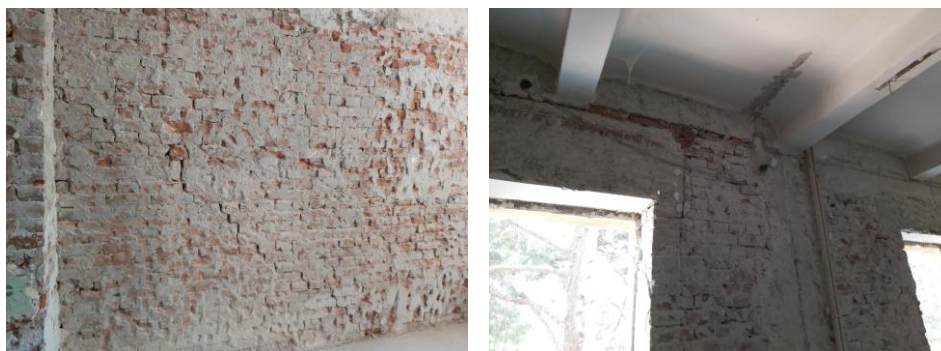
Figure 3. Cracks in masonry walls

For the existing condition, when we have clean masonry with vertical horizontal and diagonal cracks, as in the case, the analysis used $\sigma_t = 100$ kPa and $\sigma_c = 1000$ kPa, which according to the condition of the masonry and the degree of damage, are real.

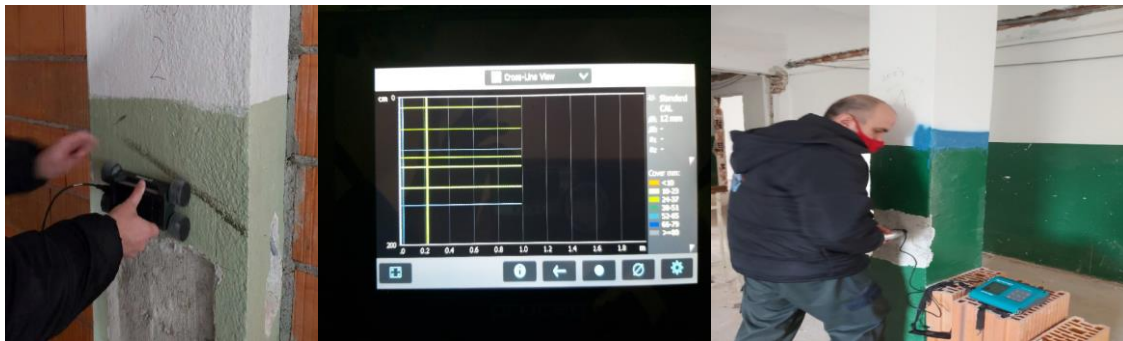
Figure 4. Non-destructive tests

The quality of the concrete and the embedded reinforcement is defined through non-destructive tests (Fig. 4). From the results, it was determined that the strength of the embedded concrete in the columns ranges from 22-25MPa, while in the beams from 19-22MPa. Reinforcement bars in the columns with a diameter of 16 Φ , 18 Φ , 20 Φ , longitudinal, as well as 10 Φ , 12 Φ , 14 Φ transverse, were found, and it was determined that smooth reinforcement GA240/360 was used.

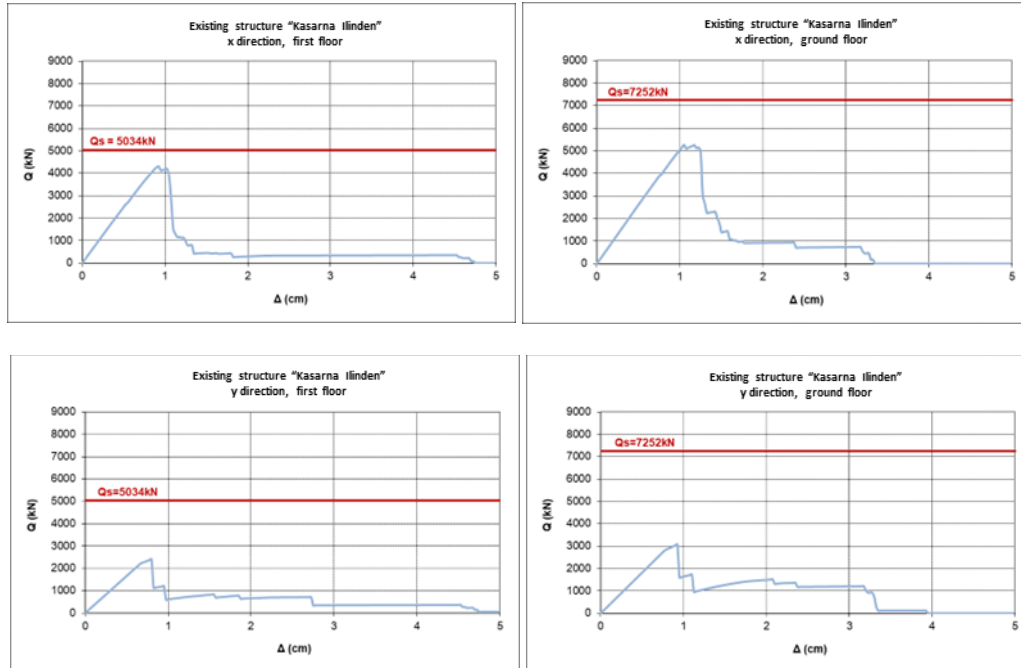
Figure 5. Floor $Q-\Delta$ diagrams for x and y direction

The structure's strength capacity for both directions is lower than required by the regulations, PIOVS 81, which is 16.5% for the X-X direction and 8.27% for the Y-Y direction of the total weight of the building. The required capacity according to regulations is 30%. Consequently, the structure does not have sufficient strength for the longitudinal direction and significantly insufficient strength for the transverse direction. The deformability capacity is relatively small for both directions. In addition to the requirements for seismic stability of the building, which have not been met, the building also has severe structural damage due to settlements of the foundation structure. The above mentioned demonstrates the necessity of improving the strength and deformation characteristics, in order to satisfy the basic requirements according to the existing technical regulation.

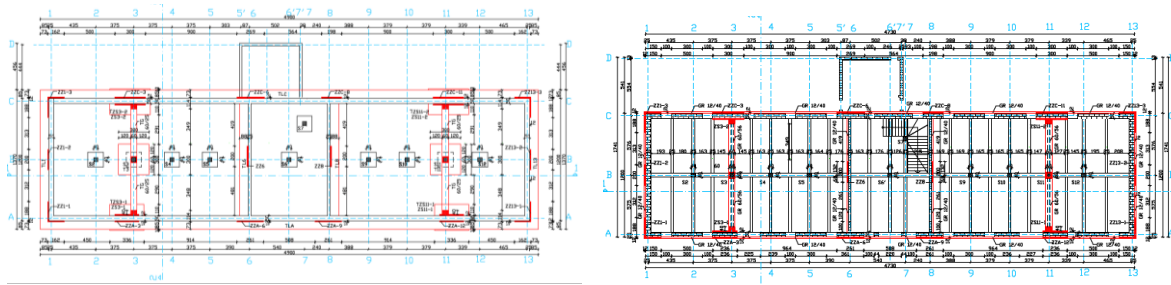
Figure 6. Strengthened and existing state at plan of foundations (left), ground floor and storey (right)

- Strengthening of the foundation structure and recommendations for drainage of atmospheric waters from the structure;
- Strengthening of the bearing walls by reinforced concrete jackets in longitudinal and transverse direction;

- Strengthening of reinforced concrete columns mainly along strengthening lines of external walls;
- Strengthening of transverse beams along the strengthening line of walls and columns;

- Foundation of reinforced concrete jackets into own footings. The same also holds for the strengthened reinforced concrete columns;
- Inter-connection of jackets by horizontal reinforced concrete belt courses mainly along the perimeter of the structure and at the level of the floor structure over the ground floor and over the storey;

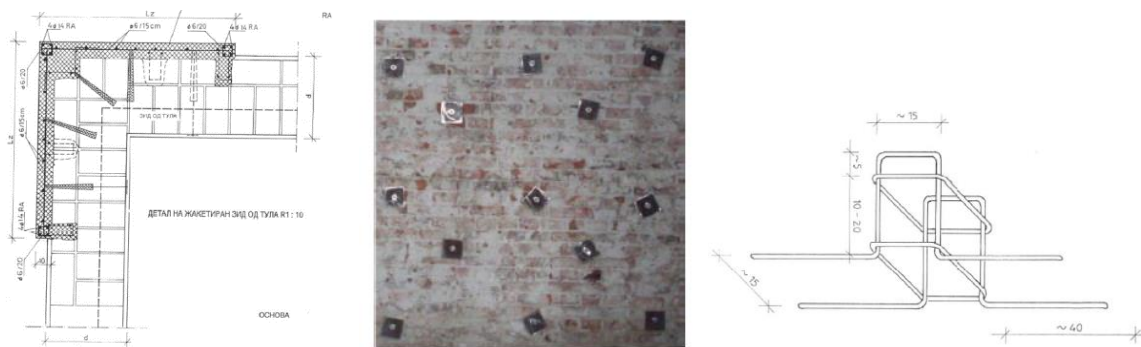
Figure 10. Details of the technology of performance of repair.

Preparation works consist of: chase cutting of mortar on the walls made of solid bricks in lime mortar at places of their strengthening with reinforced concrete jackets. Then, half bricks are taken from the wall at distance of 40 cm along horizontal and vertical line, in a chess shape, in order to provide a better connection between the masonry and the concrete part.

As an example, the figure below shows a detail of a jacket with minimal reinforcement and way of efficient connection with a solid brick wall. In addition to dowels, the wall is additionally connected to the jacket by a reinforcing wire and a metal plate on the opposite side. The next step is excavation for the foundation of the jacket. The excavation is done beside the wall, at depth down to the lower edge of the existing foundation plus 30 cm for the tooth, 8 cm for the lean concrete and 30 cm for the gravel layer. Details of the technology of performance of repair are shown on Fig. 10.

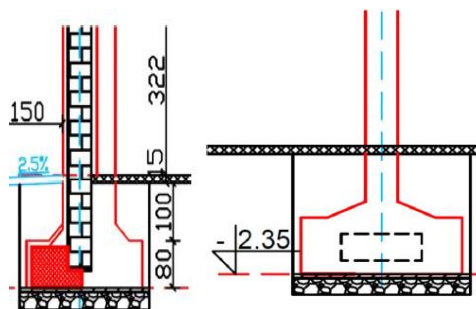
Figure 11. Details of repair of end column and central column

Following the excavation, compaction of the base is done by means of a light rammer (the so called frog rammer). Consolidation is done by light compaction. Upon the base, a layer of lean concrete is poured. With this, conditions are created for the construction of the jacket. The wall and the foundation are prepared for the placement of the anticipated reinforcement. Following placement, connection and checking of the reinforcement, shuttering of the jacket and the foundation into the planned shape is done. Concreting is done per phases, the first phase - upper edge of the foundation, i.e., down to the lower edge of the connecting foundation beam, second phase – connecting foundation beam, third phase – down to the lower edge of the transverse beam and longitudinal belt course. In the fourth phase, concreting of belt courses and transverse beams is done. The fifth phase involves the jackets over the storey and the last one includes the end belt courses over the storey. After concreting of the foundation, the earth is returned over the foundation and conditions are created for the construction of the footways. Simultaneously with these activities, preparations for the connection of the transverse beam and the external jackets are made, leaving sufficient space for embedment of reinforcement and the jacket–transverse beam concrete connection. Details of repair of end column and central column are shown on Fig.11.

A similar procedure is applied in strengthening of a central column. Chase cutting of the mortar from the column and roughening of the external surface are done in order to create a better connection between the old column and the jacket. Excavation for the foundation follows. The base is compacted, the gravel layer and the lean concrete are placed. Further on, reinforcement, shuttering and concreting are done in a number of phases. The transverse beam is constructed as entirely continuous. The same holds also for the external horizontal belt courses.
