## PRELIMINARY EARTHQUAKE SURVEY OF BUILDINGS – CASE STUDY OF SENJ

Josipa Mihaljević <sup>(1)</sup>, Davor Grandić <sup>(2)</sup>, Paulo Šćulac <sup>(3)</sup>

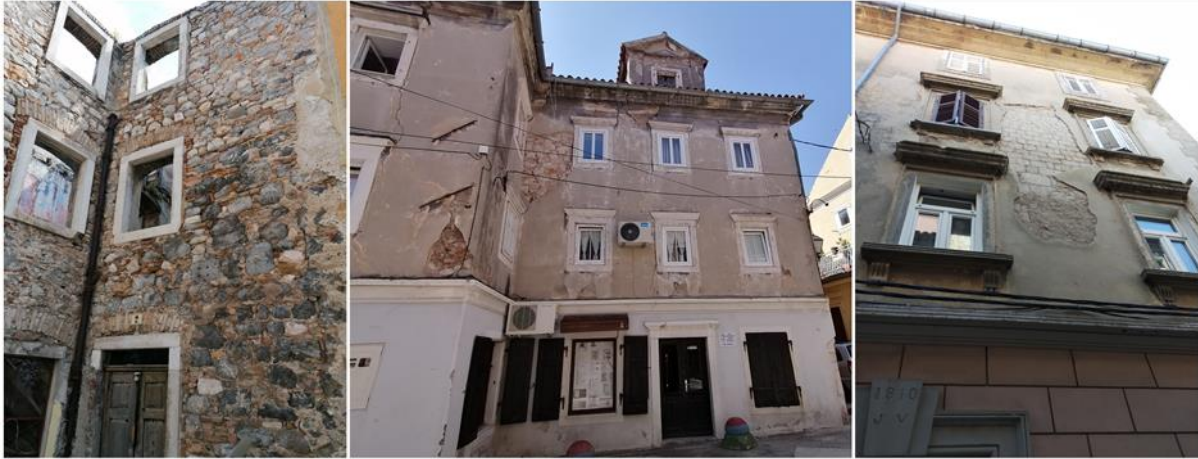
Figure 3. The facades of buildings within the historic city center of Senj

buildings. Also, numerous buildings of profane architecture have been repurposed over time and, for this purpose, often extended and rebuilt either for residential or business purposes [1]. Vaulted streets (passages) are one of the architectural features characteristic for the historical city center of Senj. Observing individual buildings, cracks formed around the window openings at the level of the first and second floors which can be seen in the Figure 3 (middle photo).

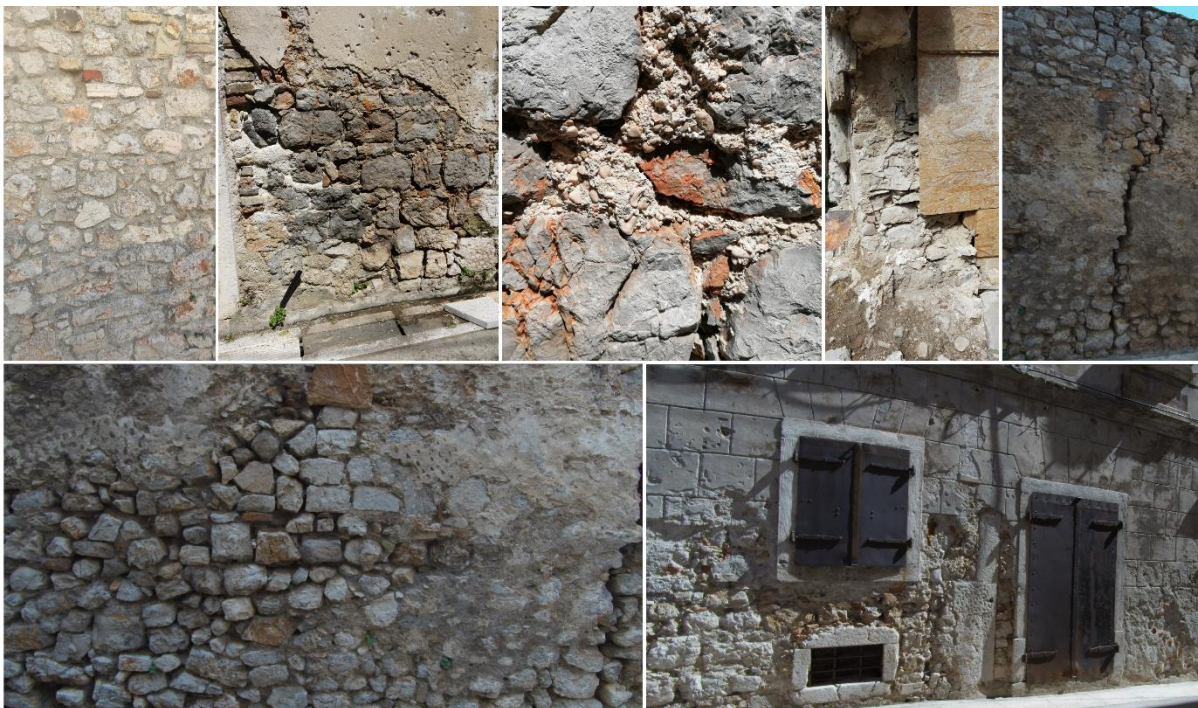
Figure 4. Masonry typology

For example, in the case of mortar, one can see what kind of sand was used (fine or coarse), which affects the strength of the mortar itself. It is difficult to discuss about the type of masonry when "open" access to the wall does not exist. Since there are several ruins within the historic city center, it was possible to see that the buildings were built as single leaf masonry, up to 50 cm thick (Figure 4). It is assumed that the other buildings were built according to the same or a similar principle. There are few buildings built with finely processed stone elements, while in most buildings mixed materials are used (Figure 4). Mixed material means the use of stone elements, brick parts, and mortar. Here, the regularity of the alternation of tone and brick layers cannot be precisely identified. Brick fragments were added to a thick layer of mortar. Apart from brick fragments, pebbles can be seen in the mortar. Some written sources [3] emphasize the use of stone elements made of white-gray limestone, tufa (quarried in the Gacka bed), and gray hard limestone. Figure 4 (below, left) shows part of the wall of one observed building where empty joints are clearly visible, which is the result of a weak bond between the mortar and the stone elements. Precisely in such places, it was observed that mortar with fine aggregate (sand) was used and that it crumbles under the fingers, which indicates low mortar strength.

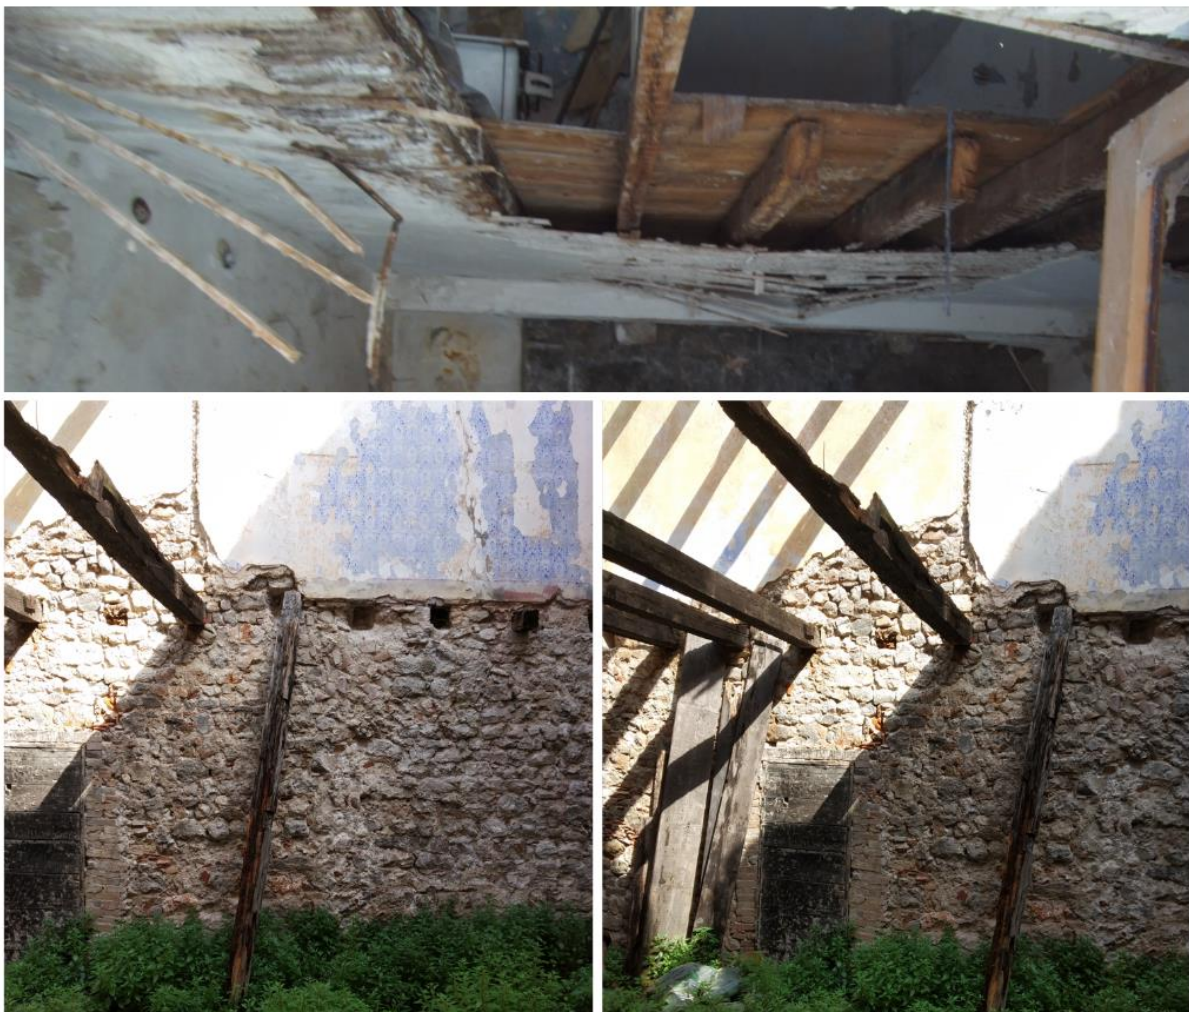
Figure 5. Timber floor construction

According to photo documentation [8] and by observing the badly damaged buildings in some parts of the historic city center, it can be concluded that the floor structures were formed by single timber beams placed at equal spans and supported on load-bearing facade walls (Figure 5). The floor consists of planks laid on joists, on which additional floor layers are placed. The underlay of the floor structure is formed by the formwork (slats) on which the reeds are placed and the final layer of plaster. However, to be able to say with certainty which is the predominant type of timber floor construction, it

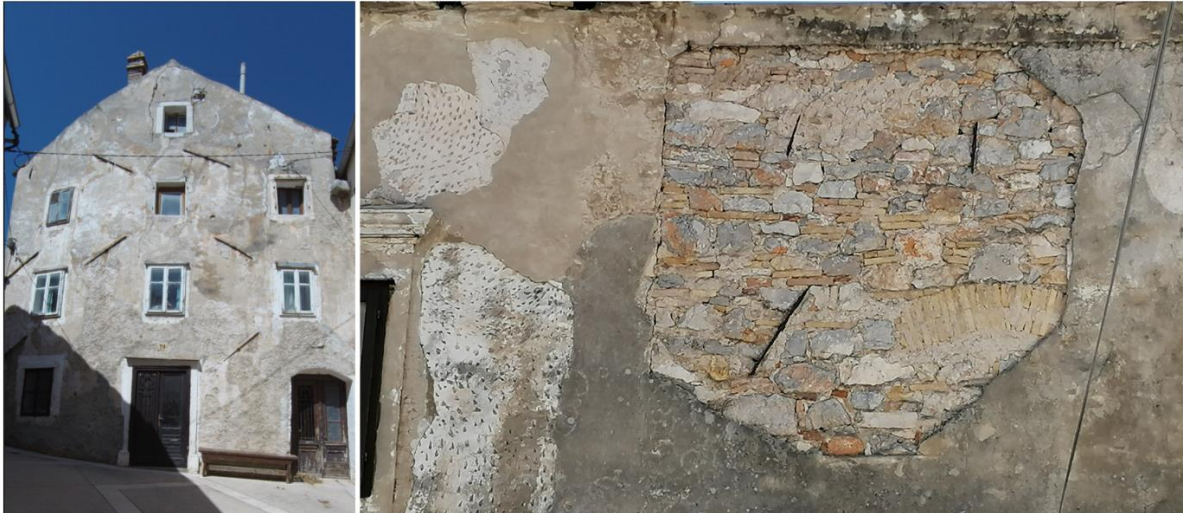
Figure 6. Tie rods visible on the facade of the building (left) and inside the section of the Wall (right)

is necessary to further research this area. The connection between the timber floor structure and the stone masonry wall is of great importance considering the behavior of the structure during earthquakes. One of the structural details that are characteristic of almost every old stone masonry building are the tie rods, which are shown in Figure 6. The ties were made of wrought iron.
