BEHAVIOUR OF SEISMIC ISOLATED BUILDING DURING CENTRAL ITALY 2016 – 2017 EARTHQUAKES

Antonello Salvatori ⁽¹⁾

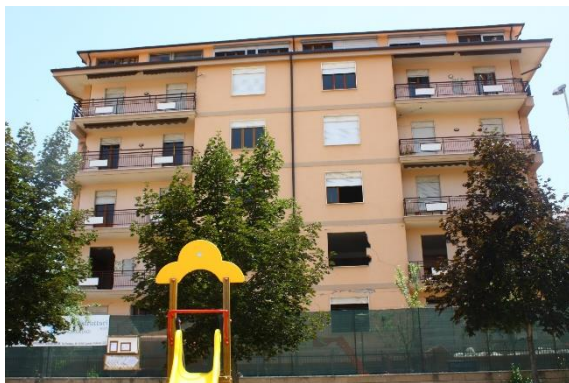
The first building under examination is located in the west area of the city, where no secondary amplification effect are detected. The building was heavily damaged during L'Aquila earthquake and was retrofitted by an isolation system. The damage concerned mainly brittle fracture in some pillars at low levels, and significant damage to the external infill panels, internal brick masonry panels and secondary non-structural elements. The type of non-structural elements damage is strongly variable but it is mainly related to wrong construction techniques, and, in second order, to wrong design.

The high deformability of reinforced concrete structures has carried out to high levels of the compression and shear forces. Storey drifts have reached high values, not compatible with the stiffness and relevant flexibility of masonry infills. After 2009 earthquake, which caused the noticeable damage in structural and non-structural elements, the only way to prevent further damage and increased collapse risk probability has been the seismic behaviour enhancement by applying anti seismic devices (isolators) with a retrofitting technique. Furthermore, the high planimetric non regularity of the building (T-shaped) can be regularized only by the application of an isolation system.

Figure 4. a) Building # 1 (seven storeys)

The retrofitted structure has reached a level of vulnerability, by applying anti-seismic isolation, equal to the 80% of the corresponding new structure, according Italian seismic code. The same level of seismic vulnerability, before the application of the isolation system, was equal to only the 15%, value which is confirmed by the damage in the 2009 earthquake. This building was hit again by nine strong earthquakes almost in the same area (Central Italy, epicentral distance from 30 to 50 km), in 2016 and 2017, (Mw 6.0 on August 24th, 2016), Valnerina 3 earthquakes (Mw 5.9 and 5.4 on October 26th, 2016), Norcia earthquake (Mw 6.5 on October 30th 2016), and Montereale – Capitignano 4 earthquakes (Mw 5.0, 5.5 on January 18th 2017) with no damage at all.

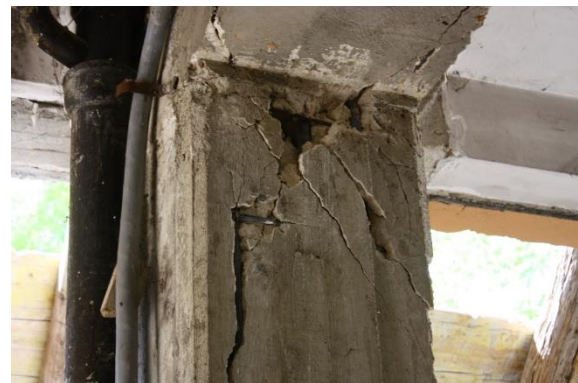
b) Brittle fracture in a pillar

By cutting pillar top edge, after reinforcing foundation and pillar lower part, 32 elastomeric isolators and sliders have been positioned. The HDRBs are 9 FIP SI-S 700/200 and 10 SI-S 800/200, and the sliding devices area 13 FIP VM 250/700/100. In fig. 5 the insertion of an isolator in the top of the pillar is shown.

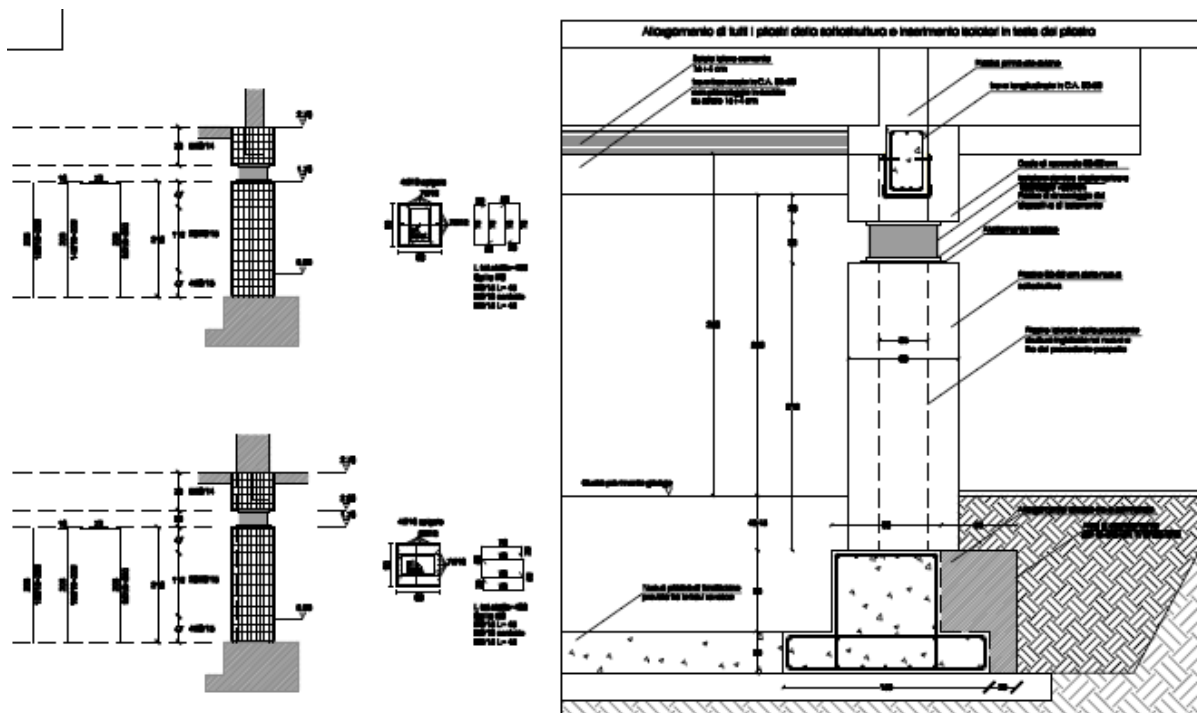
Figure 5. a) Enhancement of the lower part of pillars

b) Insertion of a HDRB isolators at the top of the pillar

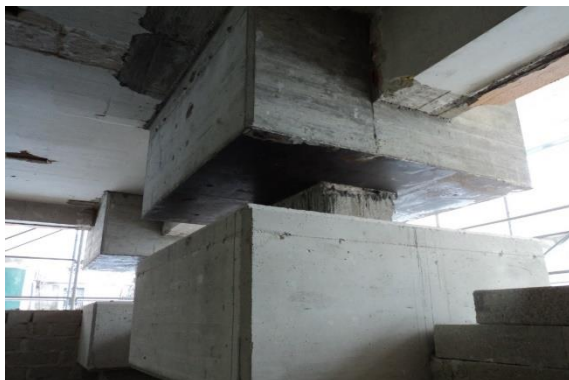
Figure 5. a) Strengthening of a pillar

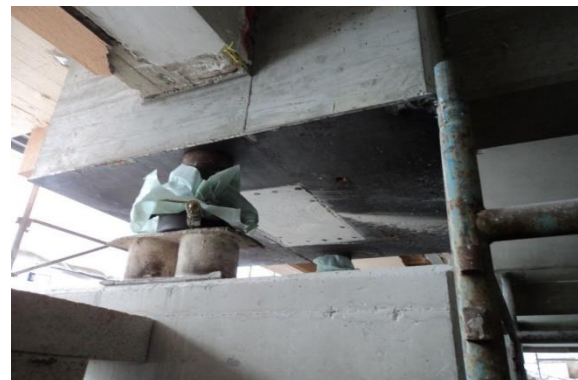
b) Cutting a pillar for isolator insertion

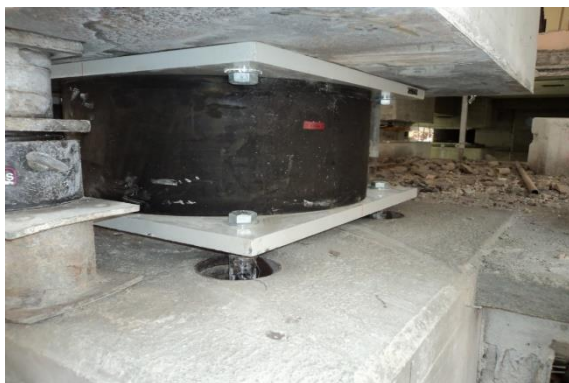
Figure 6. a) Insertion of an elastomeric HDRB SI-S 800

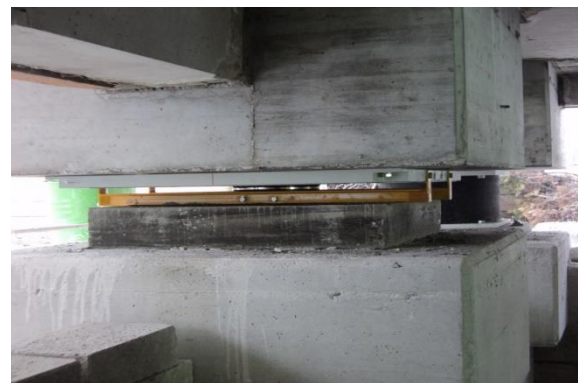
b) Insertion of a slider Vm 250/700/700

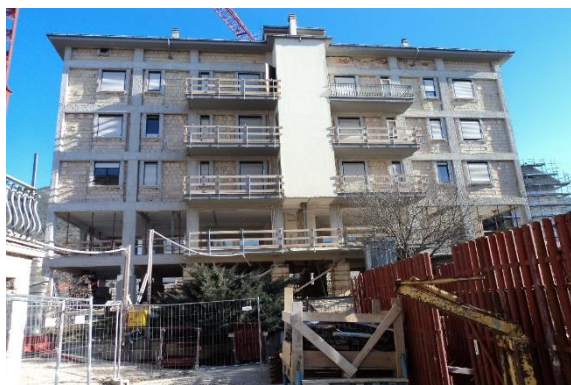
The second building under examination is located in the west area of the city too, where no secondary amplification soil effect are detected. Also this building was heavily damaged during L'Aquila earthquake, and was retrofitted by an isolation system. The damage concerned mainly brittle fracture in almost all pillars at ground level, and heavy damage to the external infill panels, internal brick masonry

Figure 8. a) Building # 2 (six storeys)

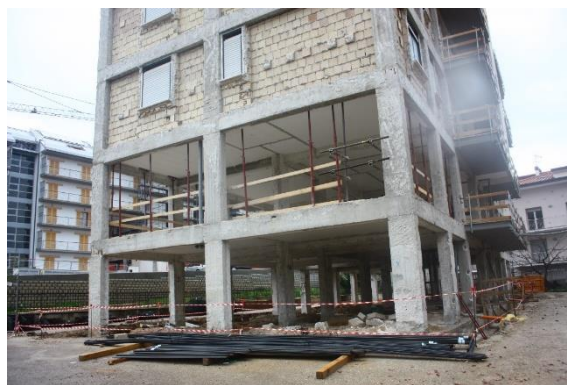
panels and secondary non-structural elements. The type of non-structural elements damage has been caused by the low stiffness of the vertical structure, with expulsion of the infills at the first and second storey.

b) damage and demolition of the infills

The damage caused by the 2009 earthquake in the building infills determined the need to completely demolish all the infills at the first two levels, and partially at superior levels (Fig. 8).

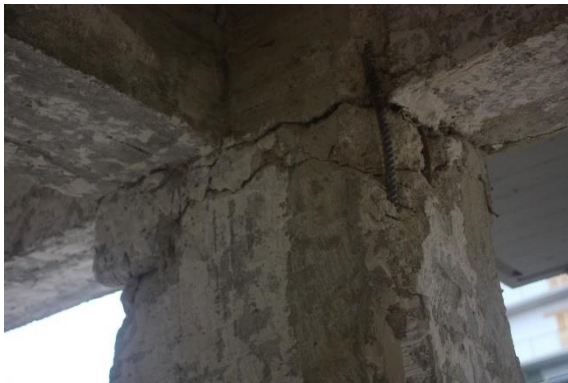
Figure 9. a) Brittle fracture in the top of a pillar

In order to strengthen the structure, an enlarged concrete section with new reinforcement bars were set up in all the pillars (Fig. 9 b).

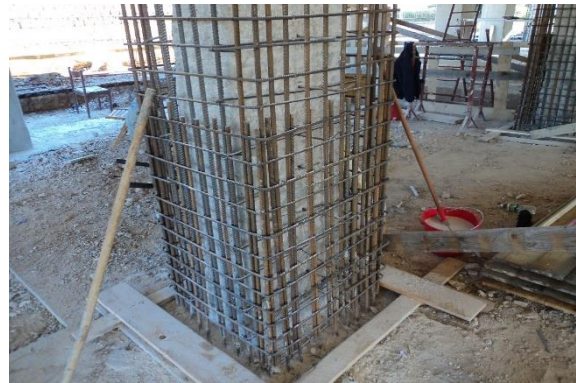
b) Increase of section and reinforcement bar in a pillar

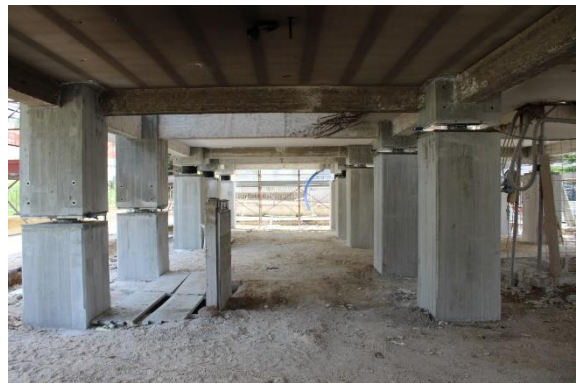
b) Sliding device in correspondence of the staircase

The building has been retrofitted with sixteen SI-N 450/126 high damping rubber isolators and eight sliding devices VM 250/250. It's worth noticing the position of sliding devices in correspondence of the staircase, (Fig. 11b) where they have been placed at a different height with respect the isolation level. The area of this retrofitted building is quite different from the preceding one, and is located near an active fault which caused several strong earthquakes in the past. The area has some resonances caused by the fault proximity. Also, this structure has been completely designed according to Italian code for new structures.
