ANALYSIS OF SGM DATA CHARACTERISTICS FOR BETTER EXPLANATION OF BUILDING DAMAGE DURING THE FEB.6TH, 2023 KAHRAMANMARAS, TURKEY EARTHQUAKES

Oguz Koz ⁽¹⁾, Sinem Guntepe ⁽²⁾, Oguz C. Celik ⁽³⁾

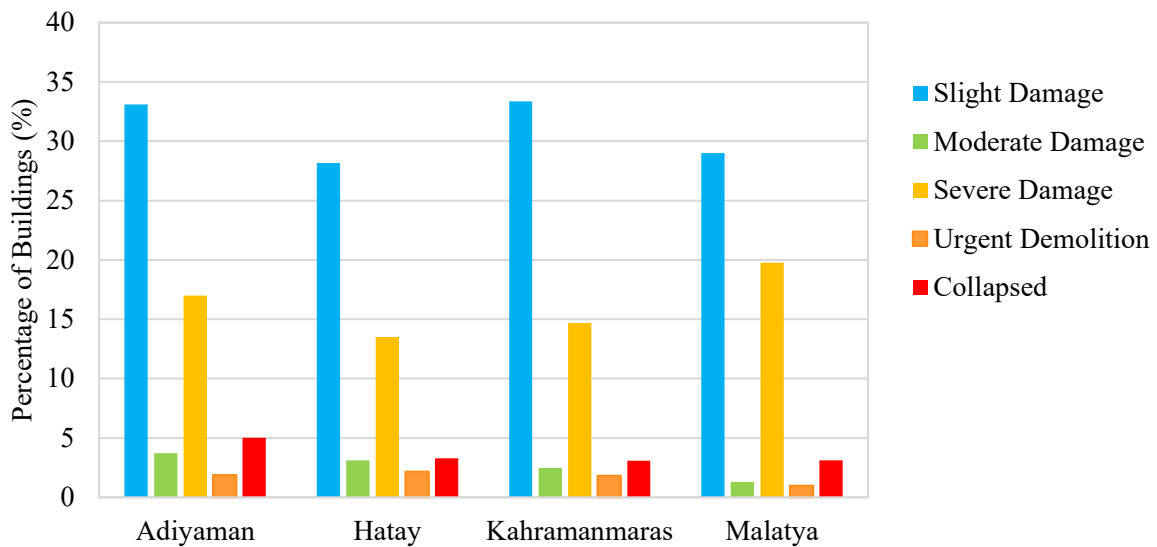
Figure 1. Building Damage Distribution (%) in the Most Affected Cities

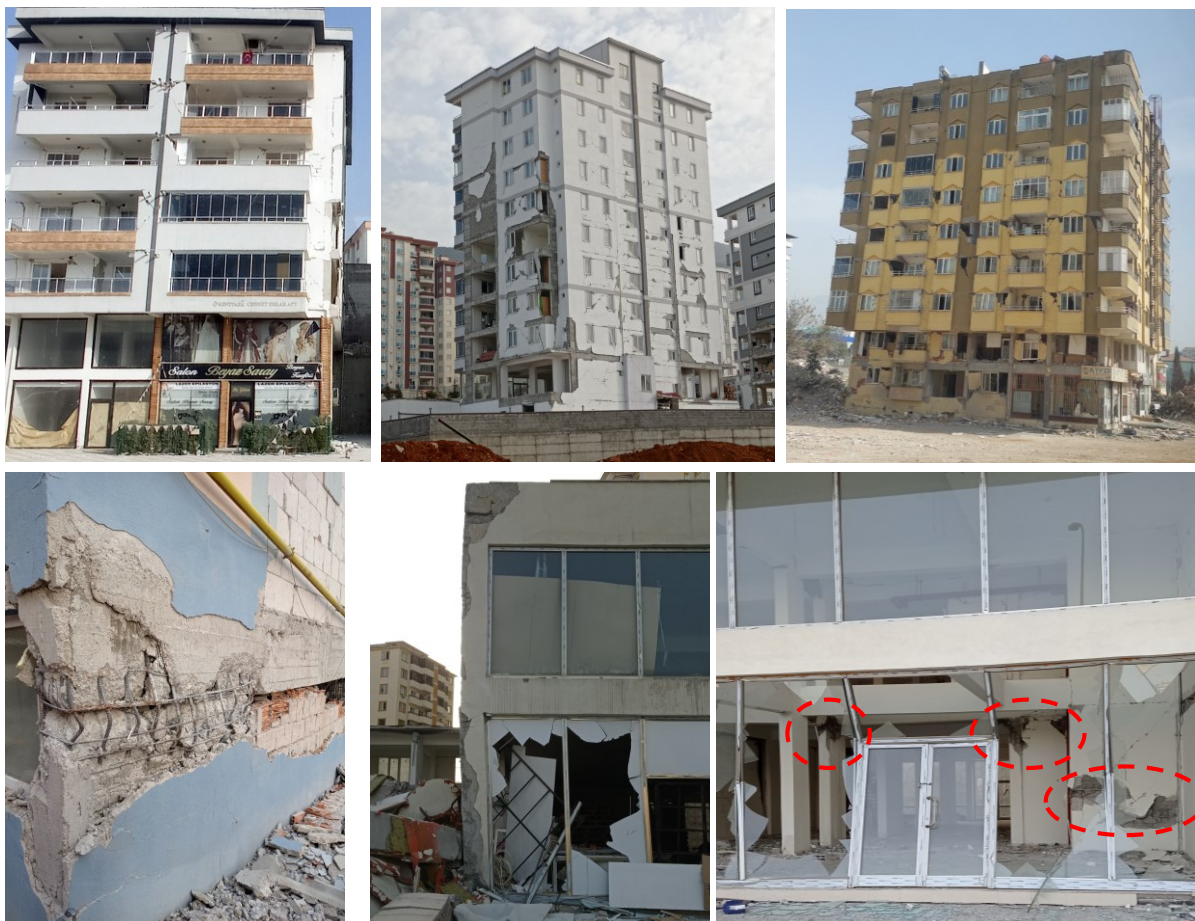
In the earthquake-stricken area, 86.7% of buildings are made with reinforced concrete while 2.4% of the buildings are steel, 3.5% are masonry, and 3.6% are prefabricated [18]. The other category includes timber, mixed or unidentified structural systems and the percentages of other structural systems is quite low. Structural damage classification categorizes buildings based on the severity of earthquake-induced damage, ranging from slight damage to totally collapsed buildings. Slightly damaged buildings exhibit minor cracks on paint, plaster, or walls, with some localized plaster detachment due to the earthquake. Moderately damaged buildings show wall fractures (nonstructural) and minor cracks in structural members, making them uninhabitable without prior repair or structural strengthening. Heavily damaged buildings experience extensive and widespread flexural or shear failures or separation of structural elements, resulting in an irreparable loss of structural integrity, both in terms of strength and economic efficiency. Urgent demolition is required for buildings where substantial permanent deformations have occurred in load-bearing components, leading to partial or total structural collapses. In terms of the building's assessment by Ministry of Environment, Urbanization, and Climate Change of Turkey on 2,457,942 buildings, there were 38,440 collapsed buildings and 20,537 were in need of urgent demolition, 204,745 of them got severe damage, 41,732 experienced moderate damage, and 636,840 were scored as slightly damaged [19]. The number of total and damaged buildings for the most affected 4 cities from these earthquakes is given in Table 4. The distribution of damage to buildings in these four cities is also displayed in Figure 1. Various levels of structural damage observed in buildings in the province of Kahramanmaras are presented in Figure 2.

Figure 2. Damaged building images from the province of Kahramanmaras

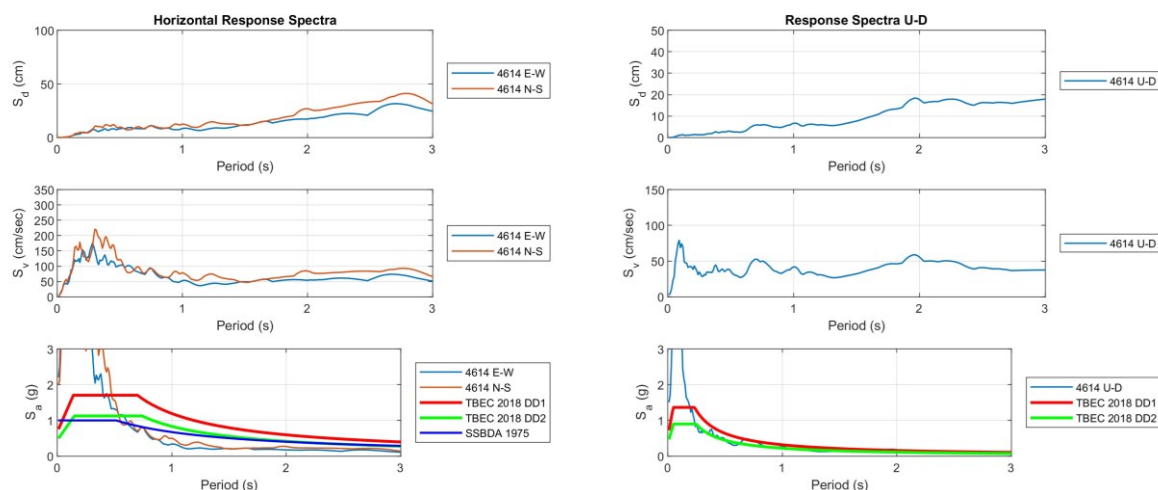
In the elastic response spectrum, within the period range $T=0\sim0.5$ s, the spectral acceleration of the 4614 N-S component peaked at 7.4g, while the 3129 N-S component reached its highest value at 5.32g. This highlights the significant impact of high-frequency ground motions on short-period structures (such as single-story or low-rise buildings), which were more vulnerable to these effects.

The spectral values obtained from the acceleration records measured at the Kahramanmaras 4614 and Hatay 3129 stations were found to significantly exceed the design acceleration spectrum, particularly in the short-period range. In Malatya, while the accelerations caused by the Pazarcik earthquake remained below the design spectrum, the accelerations generated during the Elbistan/Ekinozu earthquake exceeded the design spectrum values. High PGA values are indicative of intense shaking and immediate structural demands but are insufficient to comprehensively explain structural damage. Other factors contributing to structural damage include the earthquake's duration, directionality, and frequency content; the characteristics of the building stock; local soil conditions; architectural and structural design flaws in the load-bearing systems; and issues arising from non-compliance with the construction design or errors during the construction phase.

Figure 3. Response spectra for Kahramanmaras stations during the Pazarcik Earthquake:
(a) Horizontal components, (b) Vertical component

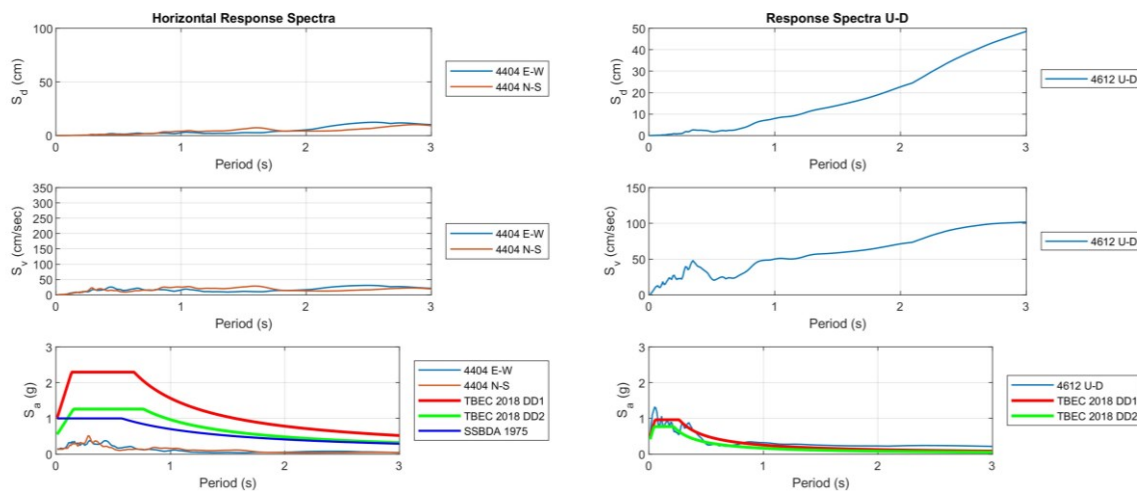
Figure 5. Response spectra for Malatya stations during the Elbistan/Ekinozu Earthquake:
(a) Horizontal components, (b) Vertical component

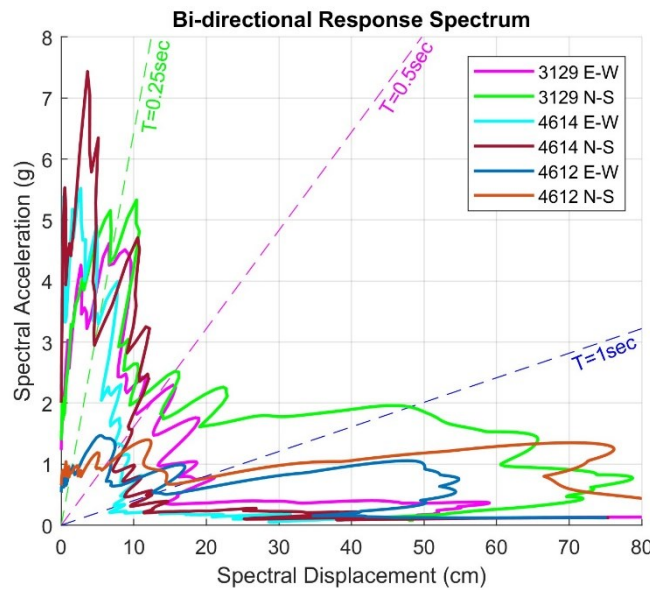
Elastic acceleration-displacement response spectra (bi-spectra) were generated for the Kahramanmaraş 4614 and Hatay 3129 stations during the Pazarcik earthquake, as well as the Malatya 4612 station during the Elbistan/Ekinozu earthquake, and are presented in Figure 6.

Figure 6. Acceleration-displacement response spectra (bi-spectra)

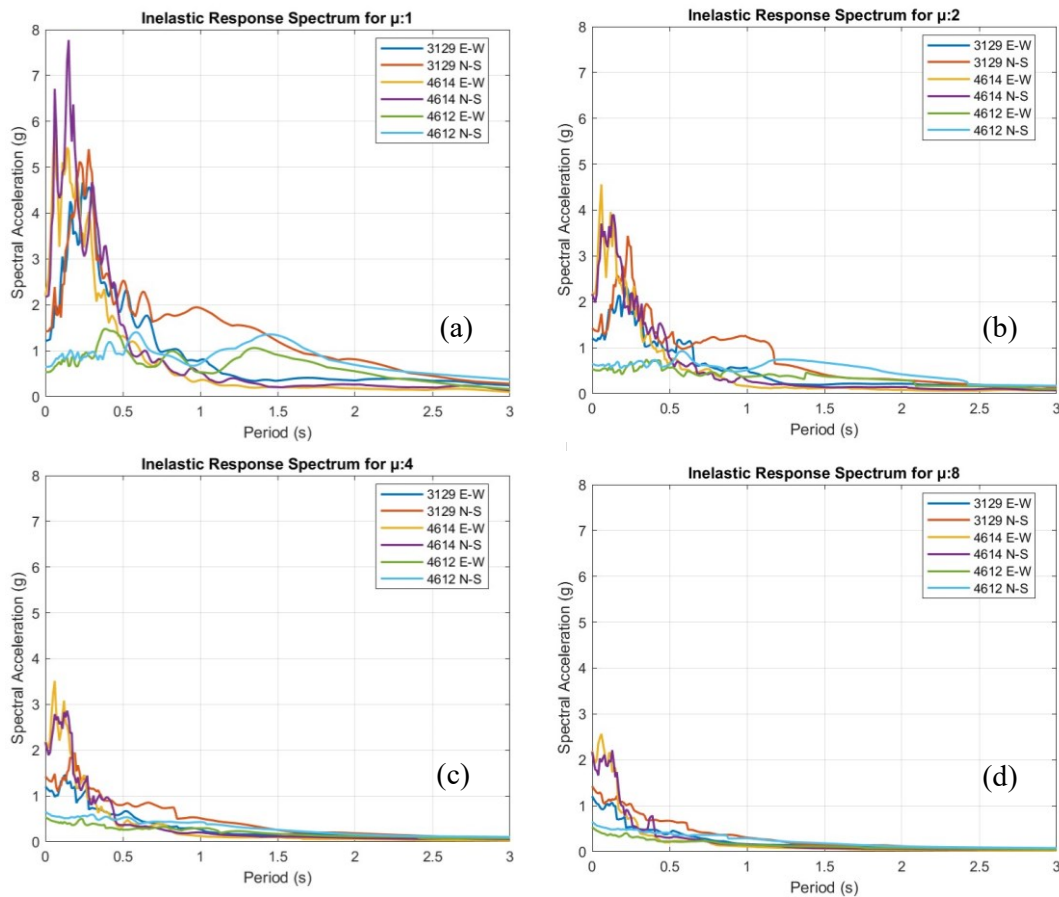
Figure 7. a) Elastic response spectra ($\mu = 1$), b) Inelastic response spectra for $\mu = 2$, c) Inelastic response spectra for $\mu = 4$, and d) Inelastic response spectra for $\mu = 8$
