ASSESSMENT, EVALUATIONS AND RETROFITTING APPLICATIONS METHODS FOR MASONRY OLD STONE STRUCTURE

The establishment of survey concept in case Study: Kulla e Ymer Poges, is result of:

2.2. Functionality of Cultural Heritage Buildings –Case Study Kulla-Ymer Poga

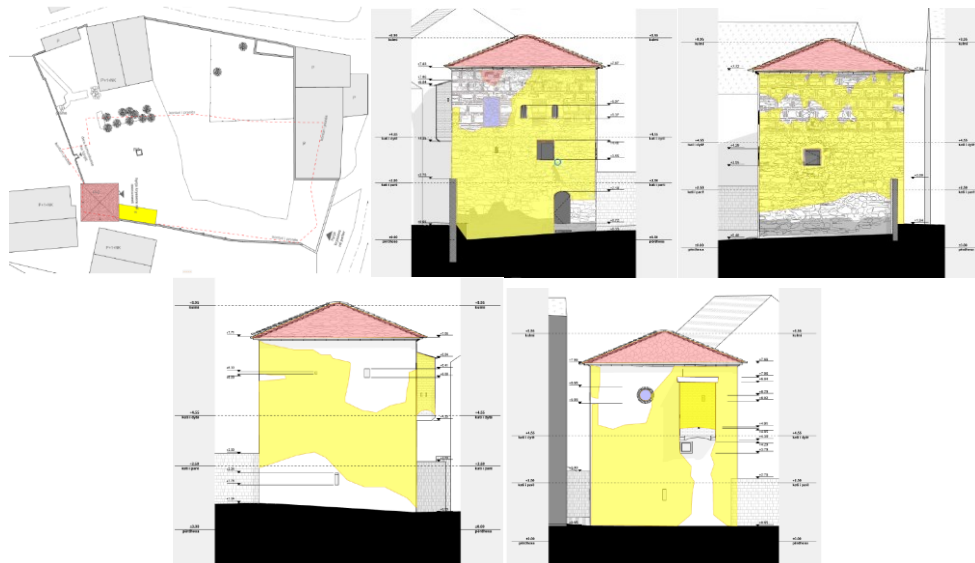
Comparing surveys over the years, we can determine the changes that the structure and its surrounding context have undergone. The changes from the original state, identified through the survey between 1990-2001, are marked in blue. Notably, the rosette on the southeast wall was walled up, as well as the door leading to the guest room on the northeast side. Changes following the 2013 survey are marked in red and yellow, where yellow indicates demolition interventions, and red marks new elements. Demolition interventions primarily involve clearing the surfaces of the building from plaster and demolishing a one-story structure built adjacent to the northeast side of the tower. A new element is the roof, which was restored in 2013 by adding a waterproofing membrane and a wooden floor under the flag stone elements, presented in fig 2.

Figure 2. Interventions over the years in building-Kulla Ymer Poga

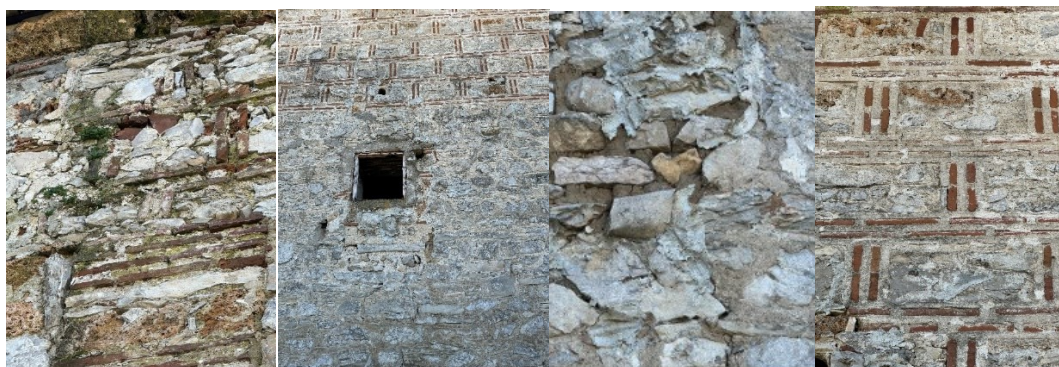
Based on the actually state of buildings are presented through the photos in fig.3.

Figure 3. Proposed interventions in stone walls

- Clean the surface of the stone walls
- Replacement the damages horizontal wood beams
- Replacement the lime mortar and eventually reinforced the structures with injection filling method
- Replacement the stone elements in perimeter of windows
- Replacement the stone elements in perimeter of wall foundation in needed positions

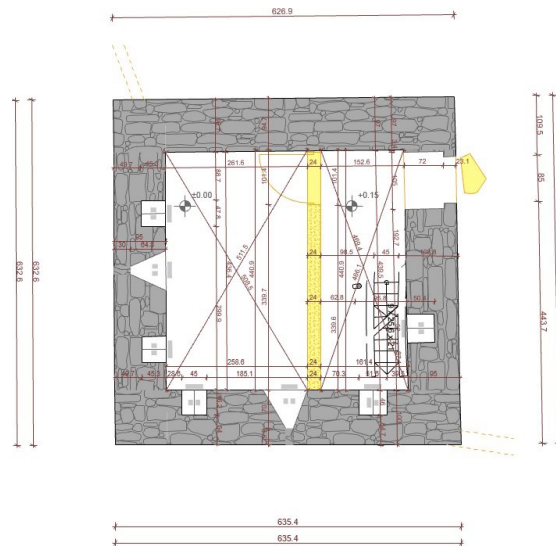
The monument maintains its planar layout on the 1st and 2nd floors, while on the ground floor the plan is restored to its original state. The first scenario on remove the interior wall , realized in over the years is presented in fig.4.

Figure 4. Demolition and remove the interior wall

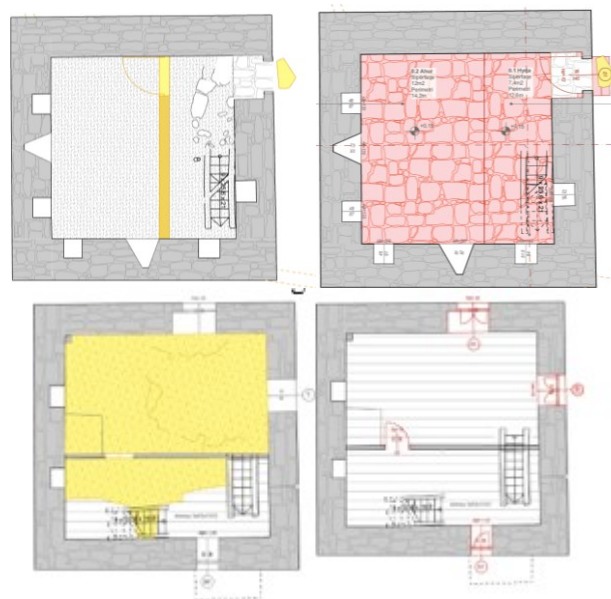
Interventions in ground floor are oriented in stone floor with flag stone elements, based on the entrance door model to create the stiff ground floor system using the heavyweight of the stone elements, presented in fig.5.

Figure 5. Restorations the ground floor with stone elements and floor restoration (right photos)

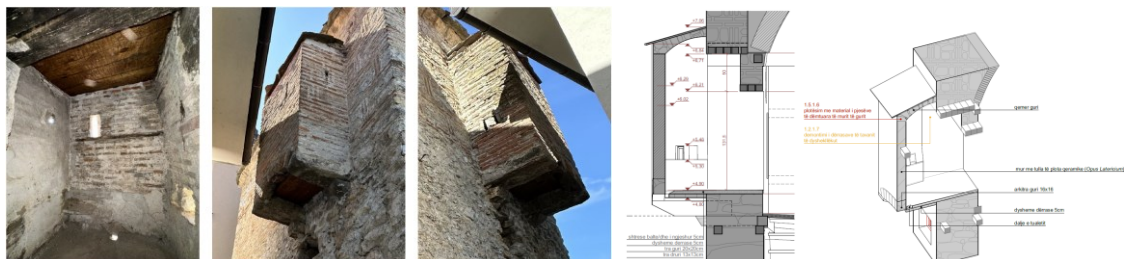
Figure 6. Analyze and proposal for restorations the protruding gallery

One of the main features of the monument's plan is the perimeter outside space (protruding gallery-dyshekllak) located at the 2nd floor level, which was an element not commonly used in these tower-kulla typologies, presented in figure 6.

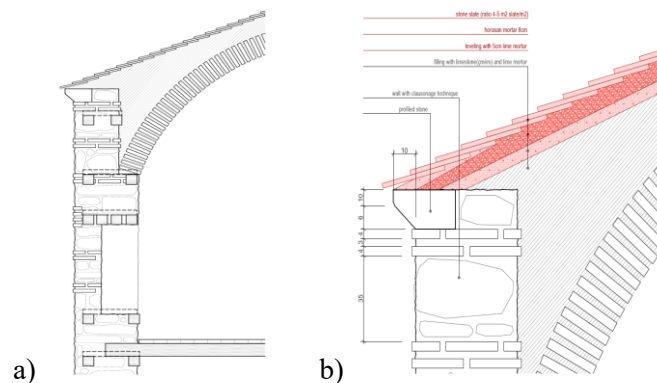
Specifically the roof restorations is one of the important Cultural Heritage element, because it's dome surface, characteristics in this typology of building, including the elements and materials, presented in Fig 7.a & b

Figure 7. Roof – dome existing section(a) and Roof – dome proposed layers(b)

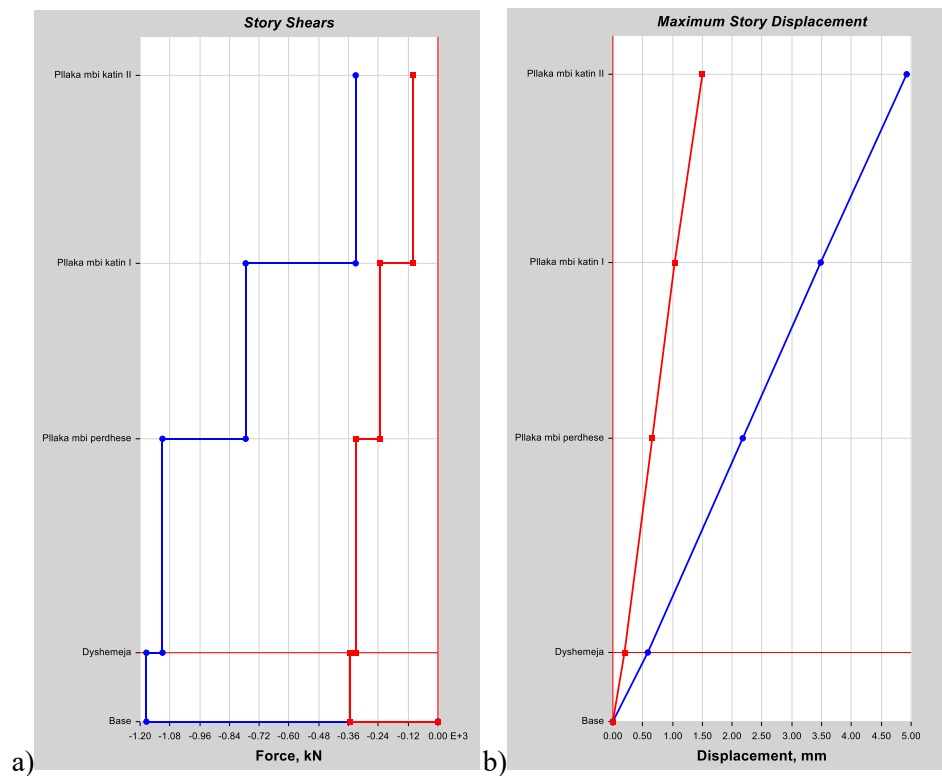
Under the given earthquake of peak ground acceleration (PGA) of 0.24 ag/g, the response of the masonry structure was analyzed to assess its performance. Since the structure is composed of stones and lacks structural elements that can absorb the energy and it does not possess designated zones for plastic deformation, leading to the adoption of a behavior factor $q=1.5$. From the analysis, it was determined that the structure can withstand base shear forces up to 1200 kN. The maximum deflections observed were 4 mm, and the presence of cracks was confined to the zones experiencing tension stresses, indicating the points of vulnerability under seismic loading. The following figure represents the building response before retrofitting.

Figure 10.a) illustrates the distribution of shear forces across the stories of the structure under seismic loading. Higher forces are typically observed at the lower stories due to the cumulative effect of inertia from the upper levels, while the forces decrease progressively towards the top of the structure. The second figure, 10.b), represents the displacement profile of the structure, showcasing the lateral movement experienced by each story due to the earthquake. The maximum displacement observed is 4.6mm.

Figure 10. Story shears and maximum story displacements, before retrofitting.

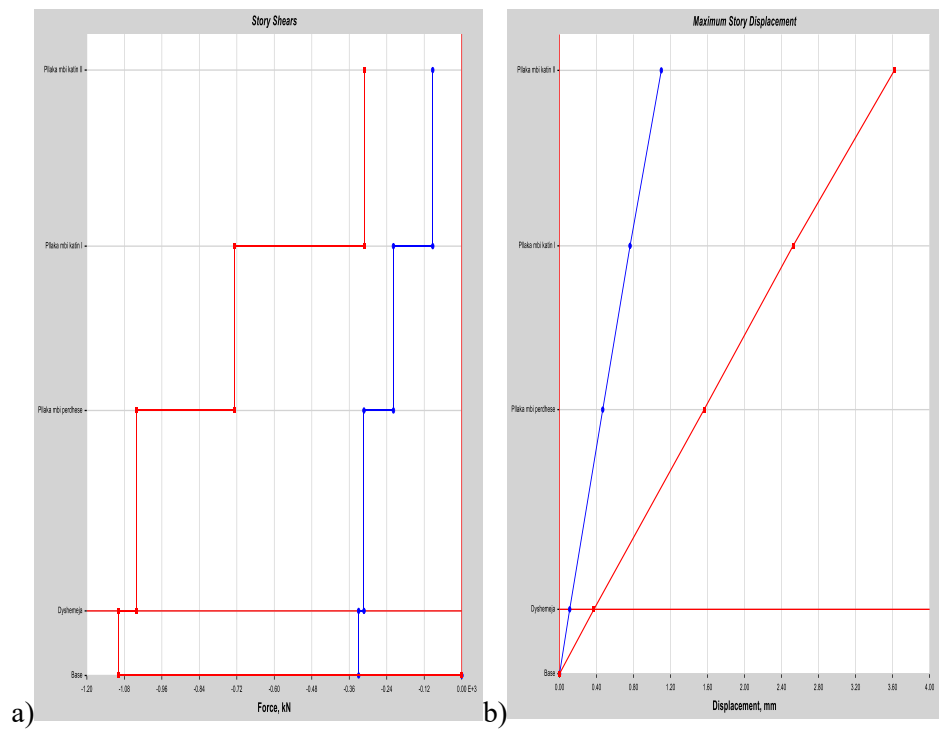
The following figure 11 presents the elastic response of the system after incorporating the effects of retrofitting into the model. This response reflects the improved performance of the structure, showcasing how the retrofitting measures enhanced its ability to withstand seismic forces. By increasing the stiffness of the masonry walls and providing confinement to the structural elements, the retrofitted model demonstrates a more favorable elastic behavior, effectively reducing deformations and mitigating potential damage under seismic loading conditions.

Figure 11. Story shears and maximum story displacements, after retrofitting.

Figure 11.a) illustrates the distribution of shear forces across the stories of the structure under seismic loading. The second figure, 11.b), represents the displacement profile of the structure. The maximum displacement observed is 3.6mm.

Retrofitting measures were implemented, primarily aimed at increasing the stiffness of the walls, which resulted in a noticeable reduction in the structure's fundamental period. This reduction in period correlates with a shift to a lower pseudo-acceleration range, thereby decreasing the seismic forces acting on the walls as per the analysis. Consequently, while cracks remain a factor under tension zones, the retrofitted structure demonstrates a more favorable response under the seismic conditions analyzed, showcasing the benefits of the strengthening measures applied. The retrofitting measures implemented not only enhanced the stiffness of the structure but also provided critical confinement to the masonry units. This confinement significantly improved the durability of the individual stone elements, ensuring they did not shatter or break apart like Lego pieces during the seismic event. The increased cohesion among the masonry units allowed the structure to maintain its integrity beyond the initial impact of the earthquake, providing resistance and stability throughout the seismic motion.

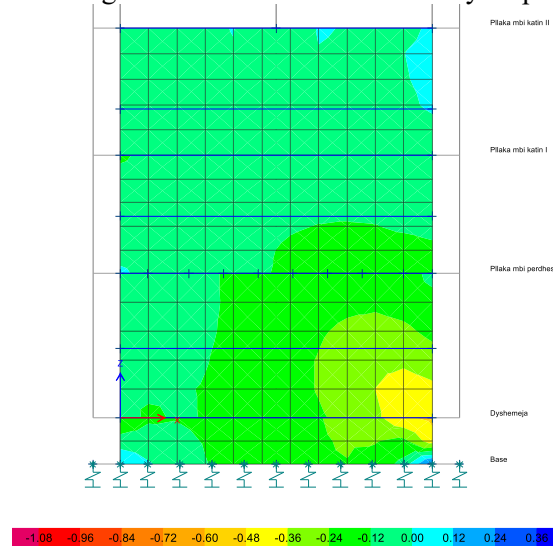
Figure 12 illustrates the distribution of stresses, measured in MPa, within the wall under a seismic load combination. This stress map provides critical insights into how the seismic forces are distributed across the structure, identifying areas of high stress concentration that may be prone to cracking or failure.

Figure 12. Normal stresses on the wall.

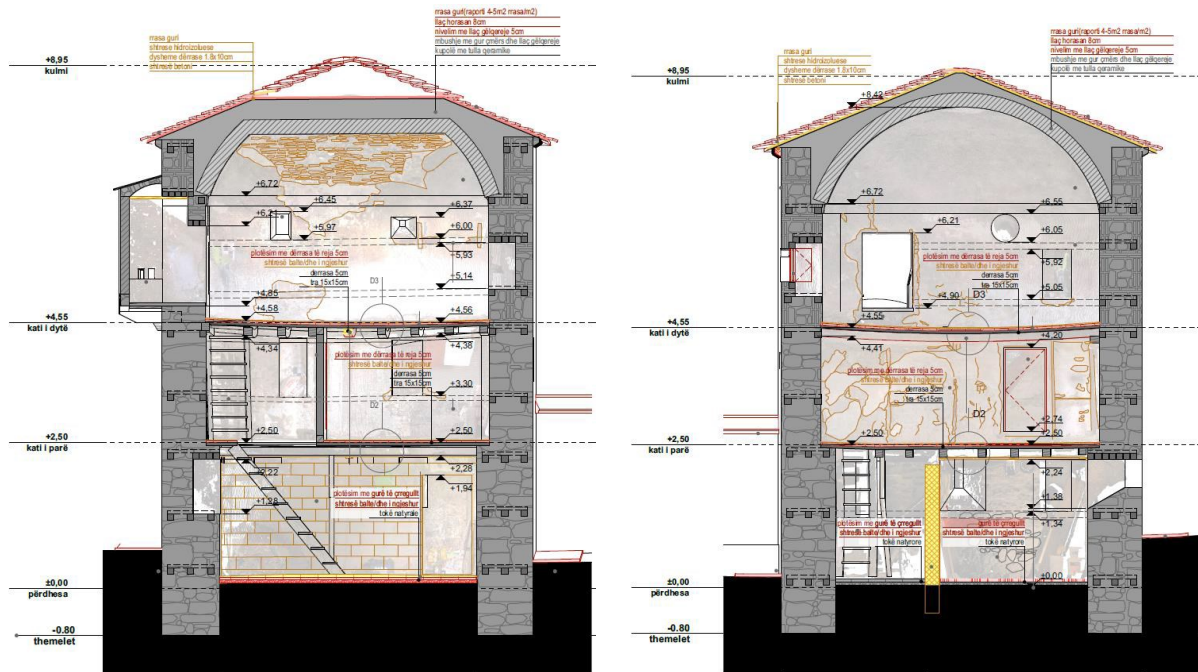
Figure 13. Proposal for Restoration the Kulla Ymer Poga

After the statically analyses and proposal for restoration is presented in figure 13.
