ASSESSING MECHANICAL PROPERTIES OF HISTORIC STONE MASONRY: CASE STUDY IN JURDANI (RIJEKA)

Paulo Šćulac ⁽¹⁾, Josipa Mihaljević ⁽²⁾, Ivana Štimac Grandić ⁽³⁾, Davor Grandić ⁽⁴⁾

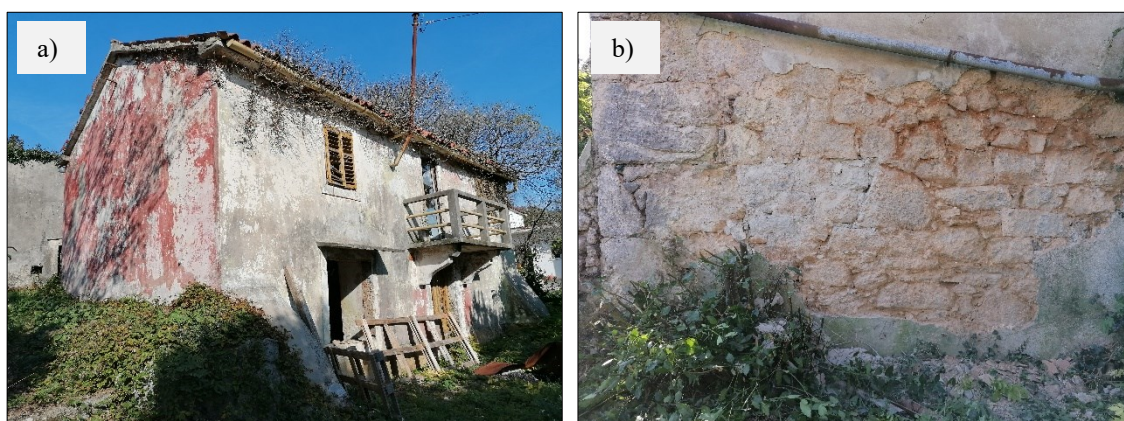
The building is located in Jurdani, in the vicinity of Rijeka. The year of construction is not known, but the house is displayed on the Second Habsburg cadastral survey from the 1819 [4]. The land lot contains a main building (the case study building) with a former livestock facility situated behind it. The case study building features a rectangular floor plan measuring $11,0 \times 6,0$ m and comprises of a partially buried ground floor and an upper floor (Fig. 1). The load-bearing walls measure 80 cm at the ground floor and 65 cm on the first floor (including the plaster layer). No iron ties have been detected within the building. The layout of the openings on the front façade is asymmetrical, and their dimensions differ between the ground and first floors, with the ground-floor openings being slightly larger. The building has a gable roof with a ridge height of 6,5 m. However, the roof structure, and consequently also the timber floor structure, have collapsed, so the interior of the building is exposed to weather conditions.

The masonry consists of irregular rubble stone blocks (limestone) of varying dimensions (Fig. 2a)), primarily composed of stone blocks with dimensions of $s/h/l = 25/35/40$ cm, where s represents the width, h the height, and l the length of the stone block. The largest stone blocks, exceeding 60 cm in length, are concentrated at the corners of the building (Fig. 1b)).

Figure 1. Case study building: a) front façade; b) side view.

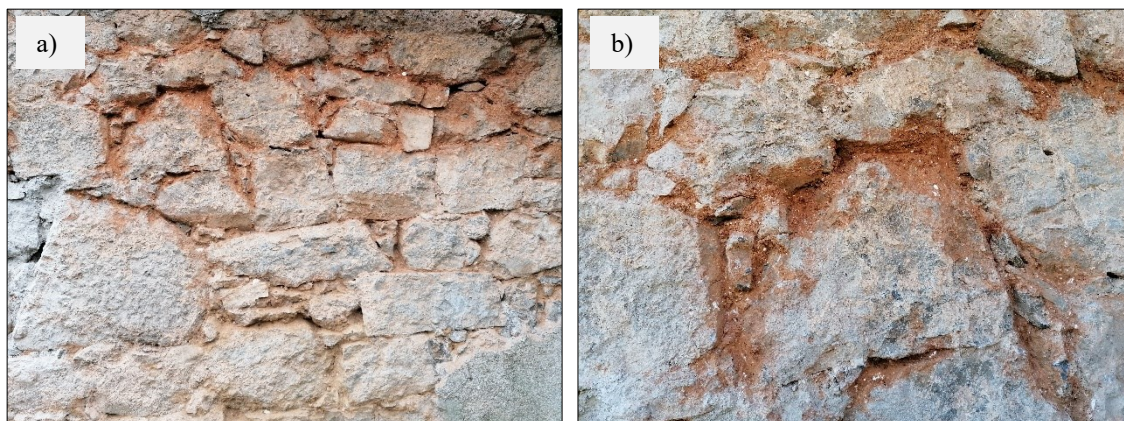
Figure 2. a) Masonry typology; b) detail of earth mortar with lime.

Non-degraded rubble stone blocks are bonded with a weak mortar. In this case study, instead of lime mortar, an earth mortar with a small addition of lime was observed, as indicated by the presence of white lumps visible in Fig. 2b). The surface layer of the mortar is crumbling. The vertical joints are mostly aligned, while the horizontal joints are discontinuous. Due to large dimensions of the stone blocks, the masonry contains a sufficient number of wedges to ensure the monolithicity of the wall.

The original plan was to assess the mechanical properties of the mortar using non-destructive methods, such as the mortar penetrometer or the mortar rebound hammer, but we encountered a mortar that was not lime-based and which was severely degraded in the bed joints near wall surface due to exposure to moisture (Fig. 2).

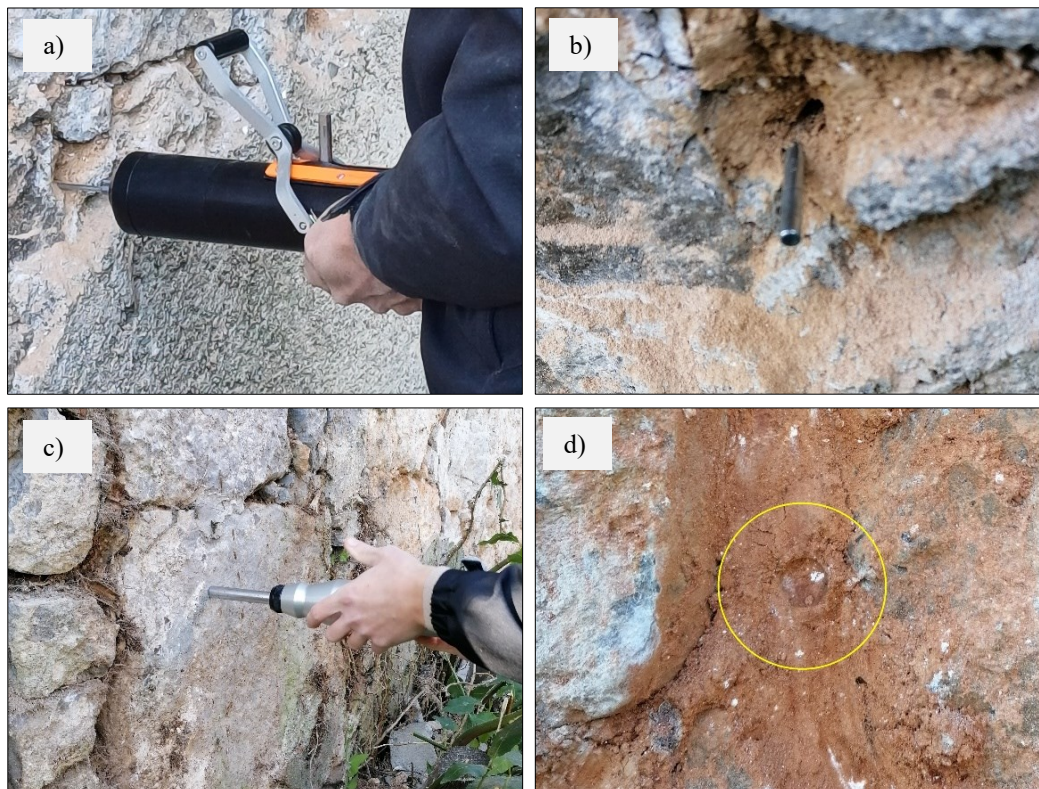
The mortar penetrometer (Fig. 3a)) measures the response of mortar to needle penetration and correlates it to the mechanical performance of the material, providing information regarding the quality and homogeneity of the mortar [6]. However, the needle penetration depth was so high (Fig. 3b)) that no correlation was possible (i.e. the mortar strength was so small that it was outside the calibration curve).

The mortar rebound hammer (Fig. 3c)) works on the same principle as the concrete rebound hammers: by measuring of the rebound of a spring-controlled mass that strikes a plunger that is in contact with the investigated material [7], except it has a different spring stiffness – the hammer we used may be applied for mortars with strength higher than 1,5 MPa [8]. However, due to low mortar strength the impact plunger just pressed into the mortar (Fig. 3d)), so correlation was not possible.

Figure 3. Application of NDT methods on mortar: a) and b) penetrometer; c) and d) rebound hammer.

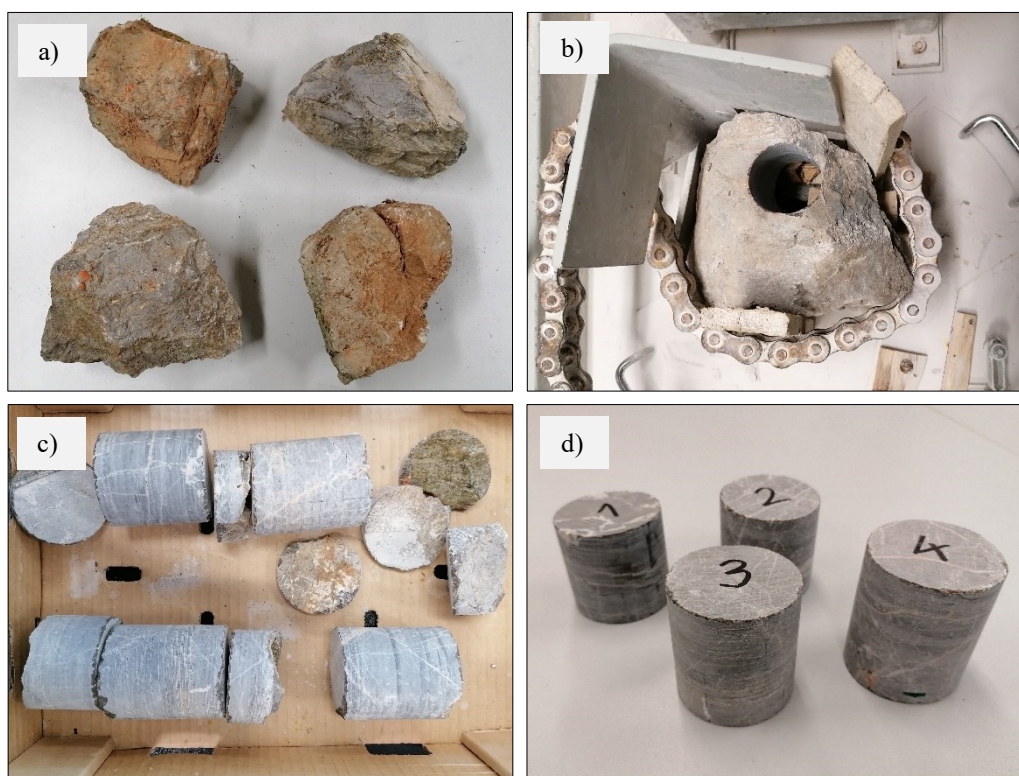
Four stone blocks have been extracted from the neighbouring livestock facility, which is nowadays connected to the case study building (assumed to have been built at the same time since as it is also listed on the cadastral survey [4]). From each block one cylindrical specimen was prepared (Fig. 4), in such a way that the diameter and height match the dimensions prescribed by the Standard [9] equal to 50 ± 5 mm.

Figure 4. Preparation of stone specimens: a) stone blocks; b) drilling of cylinders; c) extracted stone cylinders; d) specimens ready for testing.

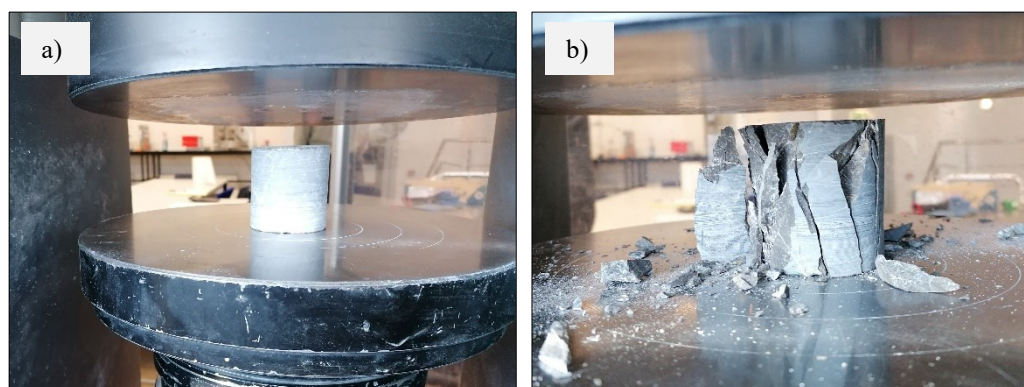
The specimens were loaded continuously at a constant stress rate of 1 MPa/s until failure (Fig. 5) according to [9]; the results of uniaxial compressive strength are given in Table 1. Result determined for specimen No. 4 was rejected from statistical analysis due to the large difference in compressive strength (58,6 MPa) and its failure mode during the testing which both indicates probability of the defect in the specimen. The compressive strength values determined in the range of 131,4 MPa to 145,0 MPa (for specimens 1 to 3) correspond to the limestone expected to be built with at the building location.

Figure 5. Uniaxial testing of stone cylinders: a) specimen No. 3 before; b) after test.

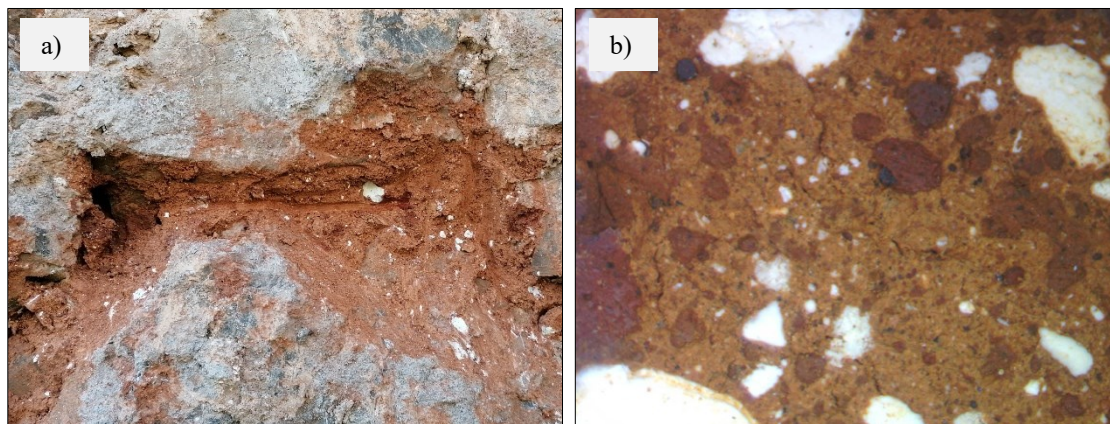
Fig. 6 b) presents an image of mortar specimen, which was extracted undisturbed from the bed joints of the case study building, obtained using light microscope with a 10x magnification: it consists of the brown matrix - earth (soil) with a small proportion of lime in the form of white lumps. The admixtures of organic origin (i.e. plant remains) are also visible as black areas in the figure [5].

Figure 6. a) Detail of the earth mortar with white lime lumps; b) microscope image of a mortar specimen (10x magnification) [5].

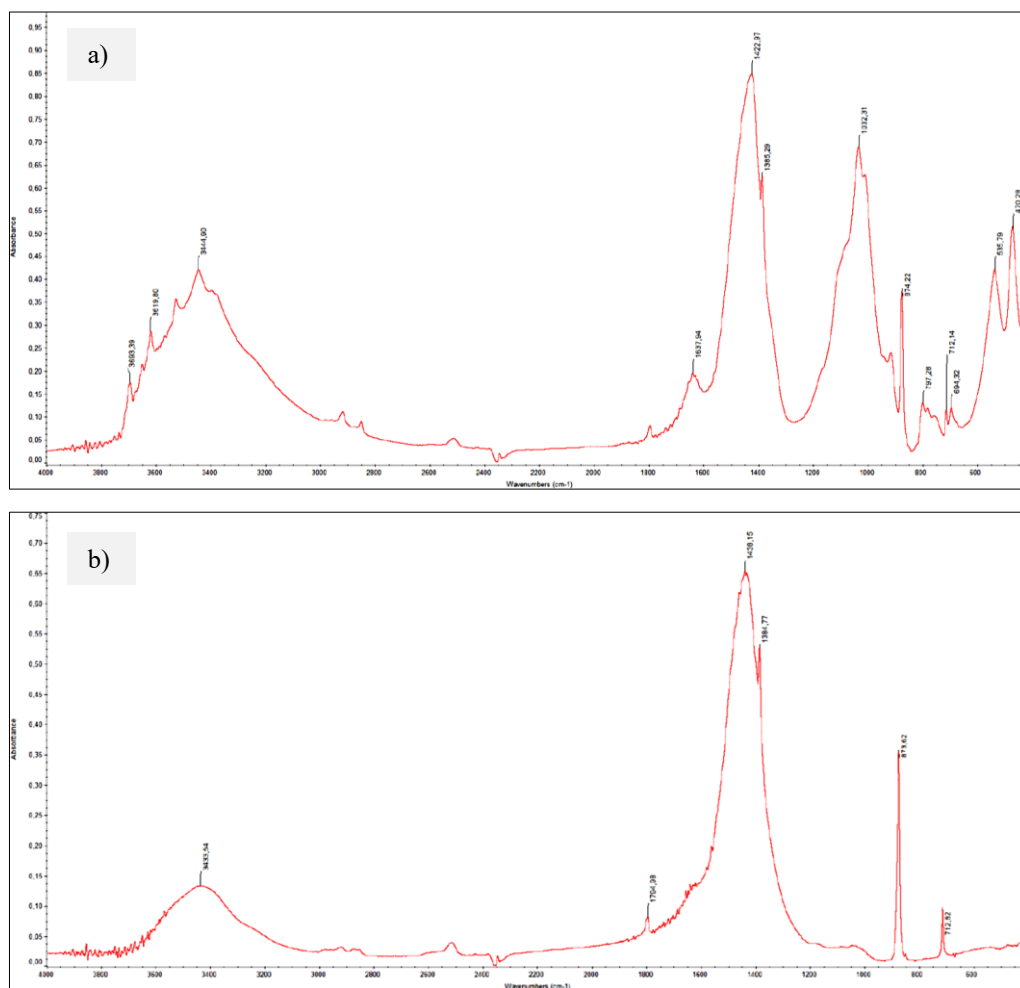
Figure 7. FTIR analysis of mortar: a) brown matrix (soil); b) white lumps (lime) [5].

The FTIR analysis (Fig. 7) showed that the brown-colored binding matrix consists of minerals typically found in soil (silicates and iron-aluminosilicates such as Illite, Montmorillonite...) and white lime lumps. Additionally, a band at 1385 cm^{-1} is visible in both spectra, indicating the presence of nitrates in the sample. Salts containing nitrates are typically found in buildings in rural areas or tombstones, i.e. in structures that are in direct contact with the soil. Considering that this sample contains a high proportion of the soil, it is possible that nitrates were present from the beginning as components of the soil from which the mortar was made [5].

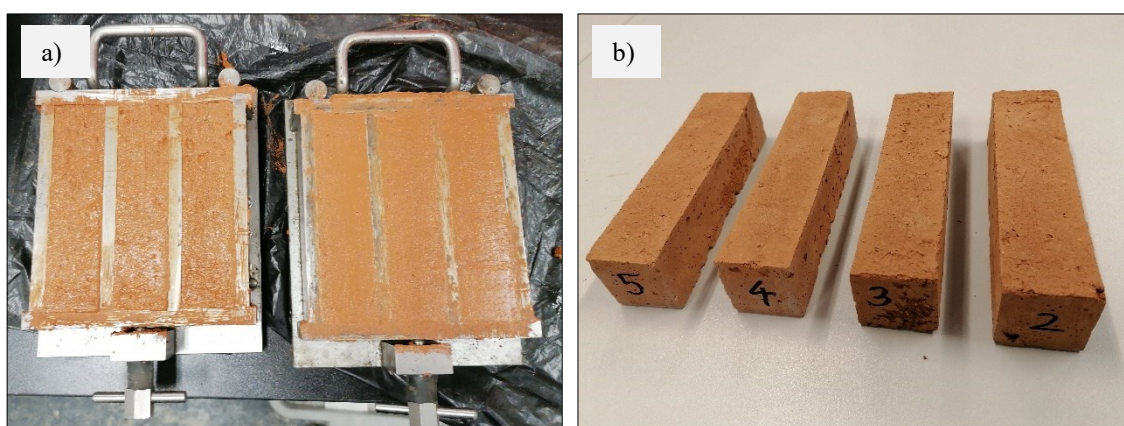
Since the mortar has degraded, it was possible to extract it from the bed joints in a powder form by simple scratching. The extracted powder was then used to prepare mortar prisms $160 \times 40 \times 40\text{ mm}$ for flexural and compressive strength testing – enough water was added to ensure good workability (although certain amounts of air pockets were noticed after drying). The metal moulds were filled with mortar in two approximately equal layers, each layer being compacted by 25 strokes of the tamper. The specimens were then stored in polyethylene bags for 7 days and afterwards for another 21 days in laboratory conditions. A total of 6 specimens were prepared (Fig. 8).

Figure 8. Mortar specimens: a) preparation in metal moulds; b) prisms before testing.

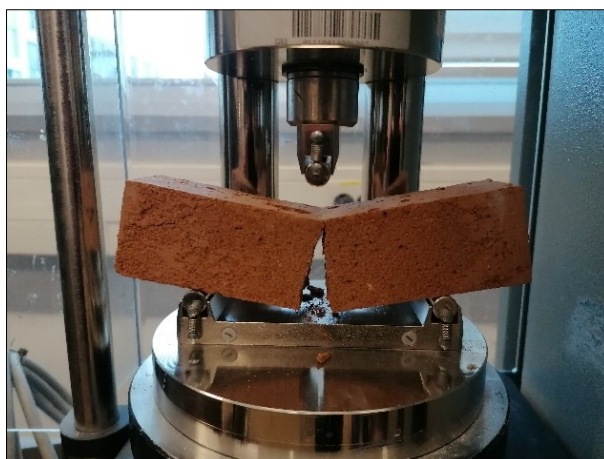
The specimens were tested at an age of 28 days after casting. The flexural strength of mortar was determined by three point loading to failure (Fig. 9) according to [19], and the results are presented in Table 2. The values of flexural strength between 0,18 and 0,3 MPa, with the mean value of 0,26 MPa, are rather low, as expected.

Figure 9. Flexural strength test – three point loading scheme.

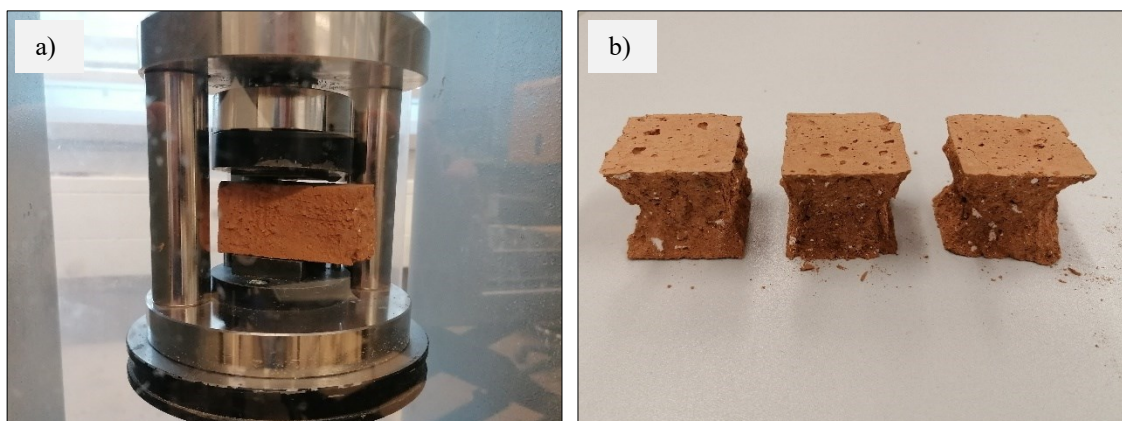
The compressive strength of the mortar given in Table 3 is determined according to [19] on the two parts of the specimens resulting from the flexural strength test (Fig. 10). The average compressive strength of the mortar cubes is 2,36 MPa (standard deviation 0,12). The results are comparable with results reported in [1]: average compressive strength of the mortar cubes 50,8 x 50,8 mm according to ASTM C-109 was 1.73 MPa (CoV 29,2%).

Figure 10. a) Compression test setup; b) hour-glass mortar specimens after testing with visible lime lumps.
