# TIES IN UNREINFORCED MASONRY STRUCTURES: CASE STUDY IN KRK

This paper examines the use of ties in a 19<sup>th</sup> century stone masonry building in Krk, Croatia. To prevent the out-of-plane failure mechanisms buildings should have adequate structural integrity. The beneficial details in this case study include: i) timber ring beams inserted into the walls acting as horizontal ties; ii) connections between the timber floor beams and the masonry walls via anchoring iron ties; and iii) connections of the attic walls and the floor beams using diagonal iron ties. The mechanical properties of wrought iron ties have also been investigated.

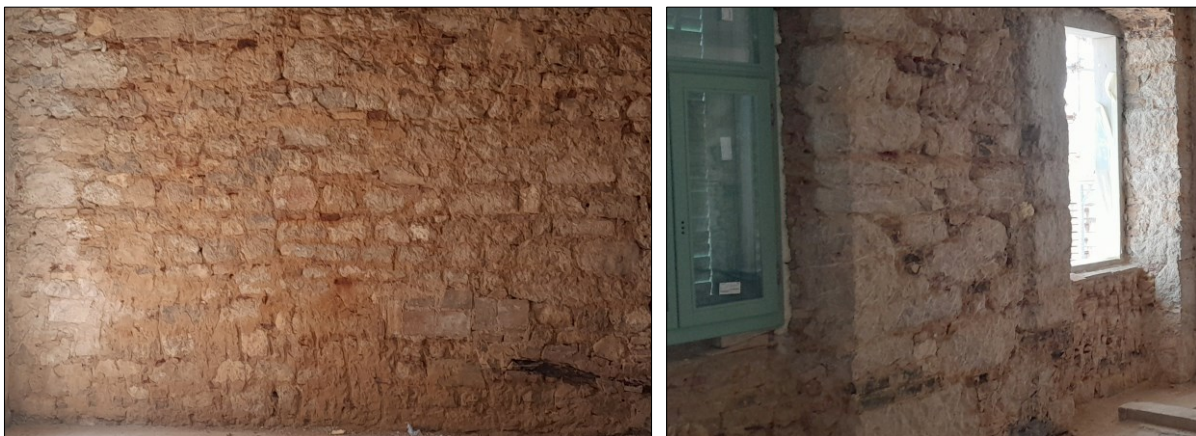
Figure 2. Masonry typology.

The floor structures are made of timber beams and boards, as common in this region, while the roof structure is a king-post, covered with tiles. The walls may be categorized into rubble stone masonry (wall thickness 65 cm), though some later added walls are built of brick. The stone blocks are mostly of the same size, with considerably larger dimensions at the corners or at the openings (Fig. 2)

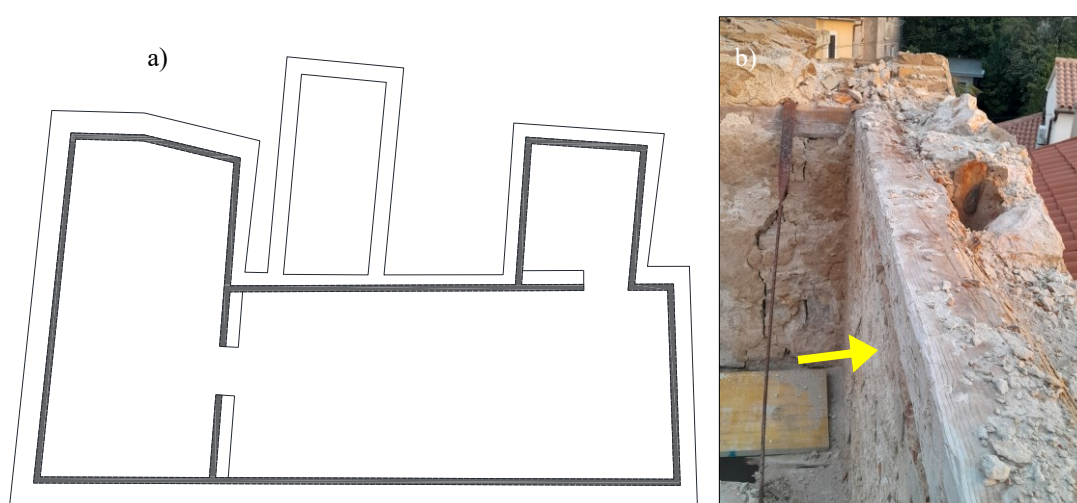
Figure 3. Timber ring beams at the roof level: a) Ground plan; b) Detail.

Authors of this paper have not so far detected timber ring beams embedded into masonry in the Kvarner Littoral, so the discovery of the timber beams in Krk was the motive for presenting this unique case study. These beams have minimum dimensions 13 x 19 cm, and are made continuous like a ring around the perimeter walls (Fig. 3): at the joint of two beam ends wrought iron ties have been used. At the positions of the opening for chimney in the cross-section of the wall, timber beams have been omitted (since there isn't enough width, but also due to heating) and instead replaced with iron ties (denoted with a red arrow in Fig. 4). The ring beams have also been provided in the inner walls.

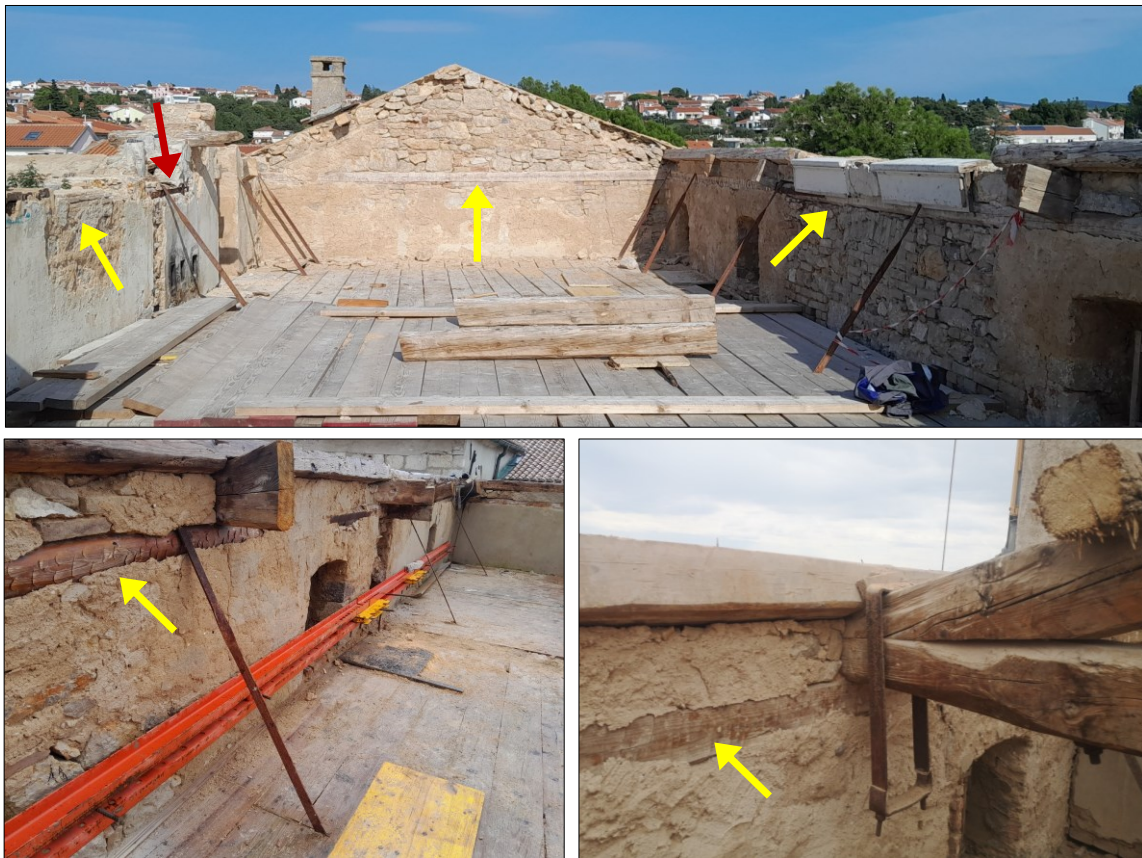
Figure 4. Timber ring beams at the roof level.

Diagonal iron ties are used to connect the attic walls and the floor beams, placed at every fourth or fifth floor beam (Fig. 4, Fig. 8). These ties have a “hockey stick” shape so that they can be attached to the floor beam by two nails, while the upper part of the tie is twisted by 90° and then bent into an L shape, so that it encompasses the timber ring beam (Fig. 8). The ties have a uniform rectangular cross-section measuring 45 mm in width, while the thickness varied from 8,5 to 12,5 mm, depending on the element.

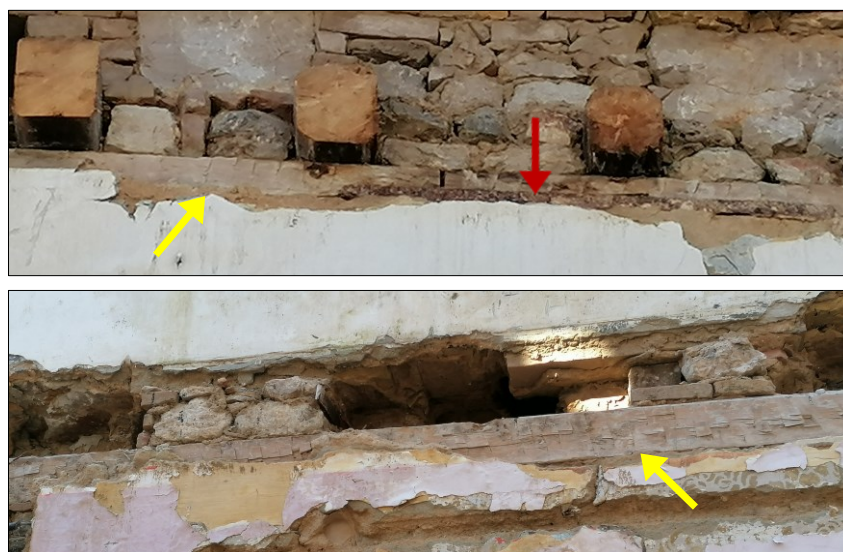
Figure 5. Timber ring beams at the floor levels.

The timber ring beams are provided at the floor levels and at the roof level (at the top of the attic walls). Note the connection of two beam ends using an iron tie (in order to ensure continuity), indicated with a red arrow in Fig. 5. No ring beams have been detected above the ground floor. This can be explained by the possibility that the ground floor had been probably built in an earlier period.

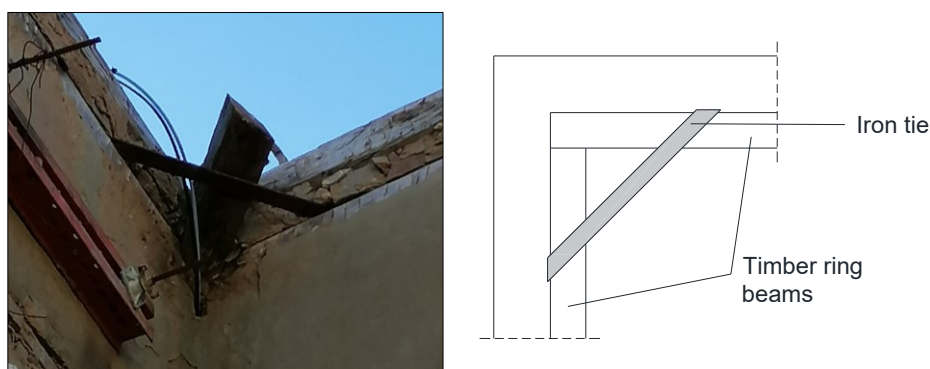
Figure 6. Connection of timber ring beams at a corner via iron ties.

The ring beams at one corner of the attic walls have been additionally connected by a cross iron tie at the top to prevent their separation (Fig. 6).

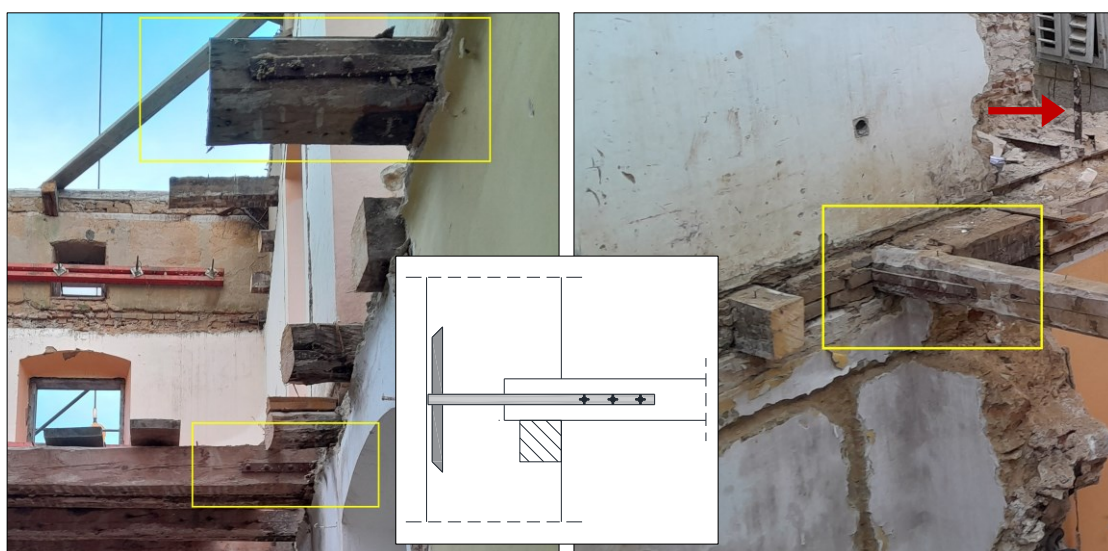
Figure 7. Horizontal wall-to-floor ties.

Wall-to-floor connections play a crucial role in the global stability of masonry buildings under seismic actions [13]. In this case study, connections between the timber floor beams and the masonry walls are placed at every fourth beam in the floor (Fig. 7). Wrought iron ties are anchored to the external walls by means of anchor iron bars (red arrow on Fig. 7). Three nails are used to connect the iron flat and the timber beam.

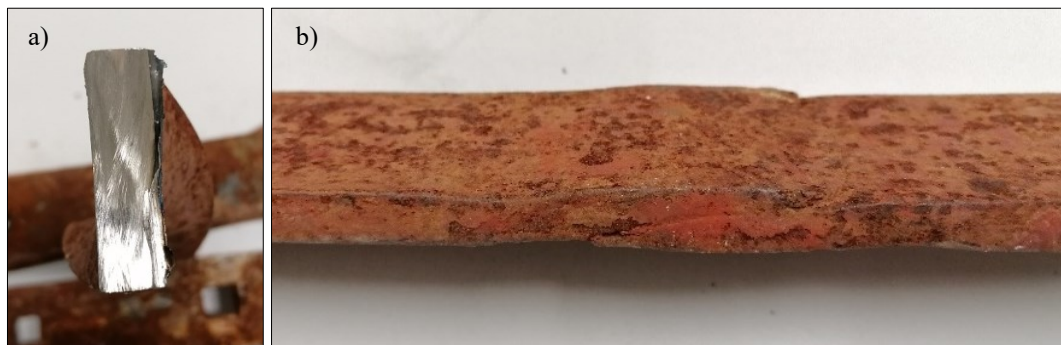
Table 1 shows the mean values of the measured weight percentage  $w$  of individual elements and their standard deviation  $SD$  obtained using glow-discharge spectrometer (GDS)[14]. The cross-section was prepared by polishing. According to the very low carbon content, a soft but very ductile material can be expected, what will be confirmed by tensile testing.

Figure 9. a) Cross section of a diagonal tie; b) Detail of forged connection confirming it is wrought iron.

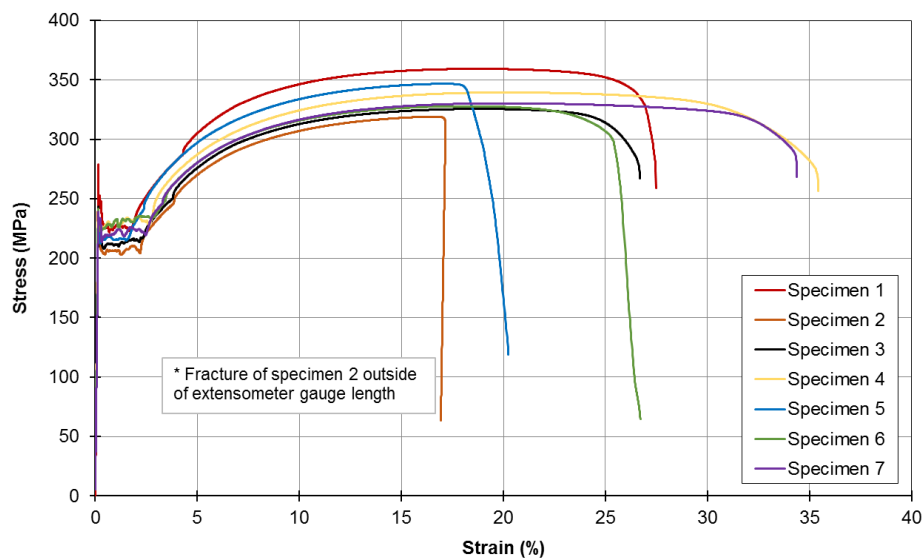
Figure 13. Stress-strain diagram of iron ties.

The following values were obtained: mean yield strength 244 MPa, mean tensile strength 335 MPa and mean elongation at fracture 26,8 %. When compared with the results of tensile test of ties from Czech Republic [16] or Italy [17], differences may be noticed, what can be attributed to the different composition of wrought iron and different periods of production, so special care should be taken when assuming mechanical properties from different periods and different countries.

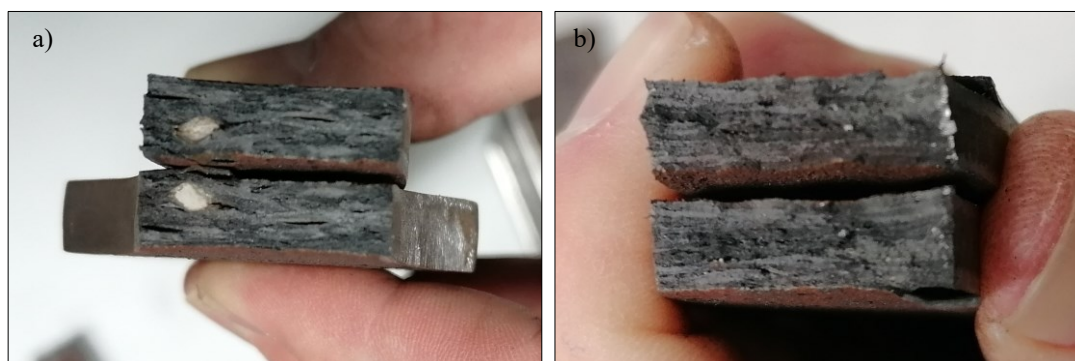
Fig. 14 presents the fracture surfaces of two specimens, where the foliar fractures may be noted. Specimen 2 had a smaller tensile strength and significantly smaller deformation  $A_t$ , what can be attributed to the defect in the cross section visible as a white spot in Fig. 14a.

Figure 14. Fracture surfaces: a) Specimen 2; b) Specimen 3.
