STRUCTURAL RECONSTRUCTION OF THE BELFRY, MONASTERY AND CHURCH OF ST. FRANCIS ON THE KAPTOL IN ZAGREB

Ante Mlinar ⁽¹⁾, Ante Kelava ⁽²⁾, Ante Borovina ⁽³⁾, Ante Buzov ⁽⁴⁾

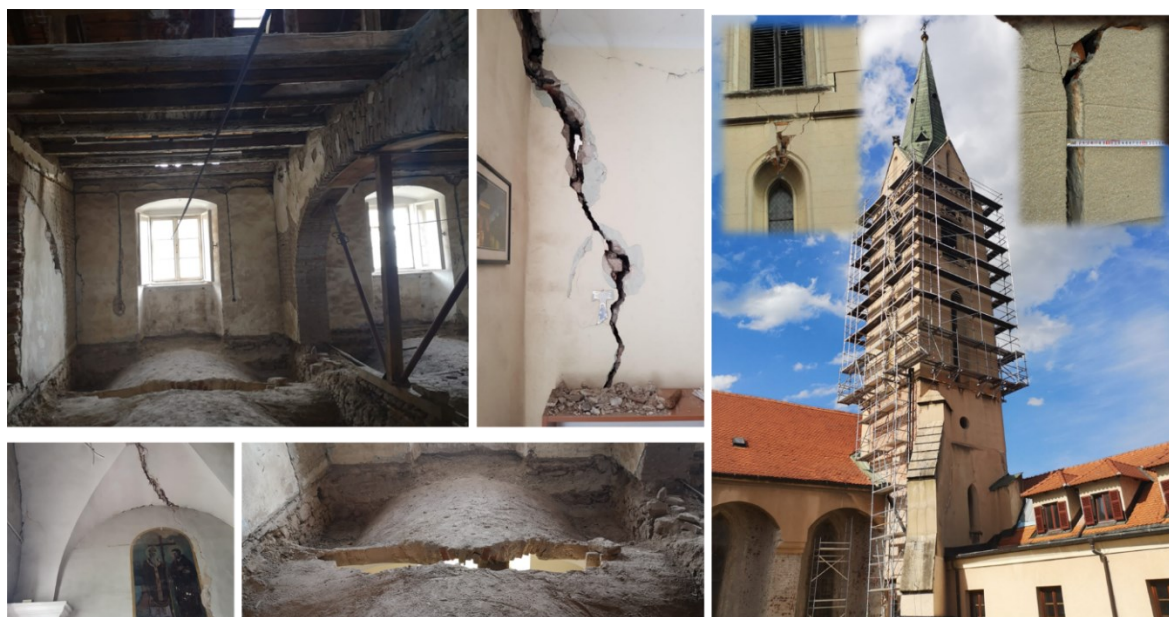
The second earthquake, measuring $M=6.4$ on the Richter scale, known as the "Petrinja Earthquake" or the "Banovina Earthquake," struck on December 29, 2020, at 12:19 PM, with its epicenter located 3 km southwest of Petrinja, heavily impacting Sisak-Moslavina County. These earthquakes caused extensive damage to the structural elements of the Franciscan complex, comprising the Church of St. Francis, the monastery building, and the bell tower. Due to the severity of the damage, the complex was taken out of use, as its structural instability posed a serious threat to human safety and a risk of further collapse. Some of the documented damage is shown in Fig. 5.

Figure 5. Photos of some damage to the structural parts of the Franciscan complex [1, 4]

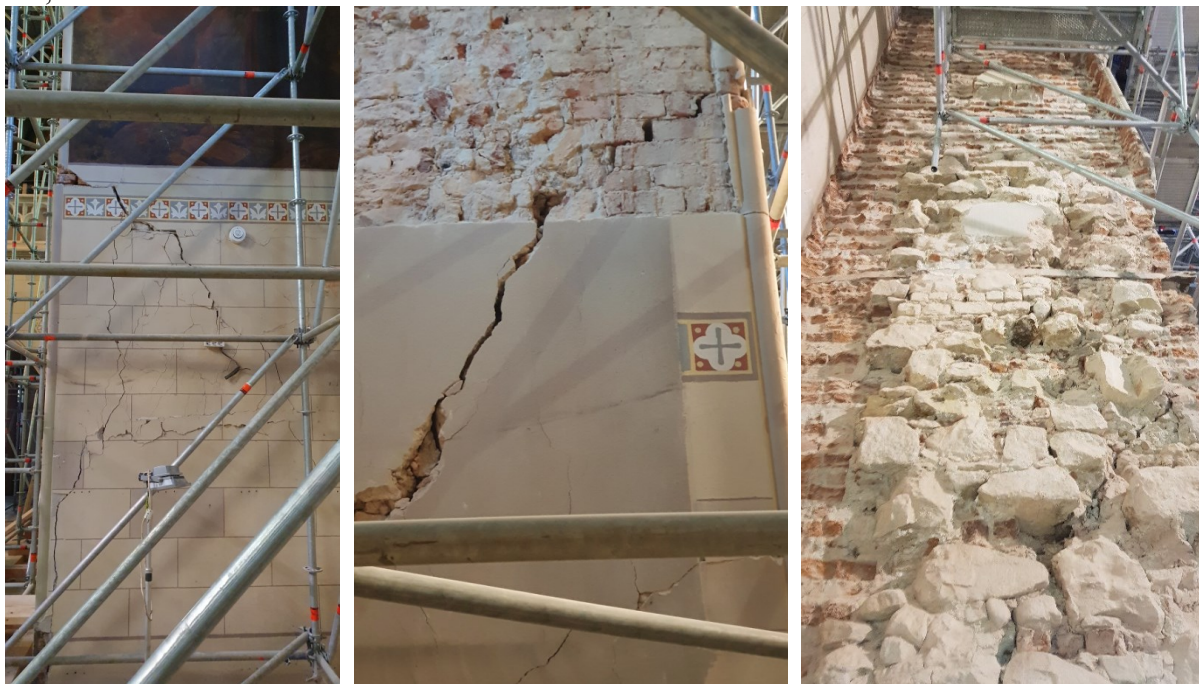
The load-bearing walls of the church are built from massive unreinforced masonry, consisting of solid brick bonded with lime mortar. The central part of the church is covered by a masonry vault, which rests upon these walls. Due to the height of the walls and the support reactions generated by the masonry vaults, buttresses were constructed to enhance the structural stability. Given their critical role and their position as the final structural element in the load-bearing system, the buttresses suffered significant damage. Figures 7–9 showcase various rehabilitation works conducted on the buttresses, as well as their final, restored state.

Figure 7. Damage to the church's buttresses [1, 5, 4]

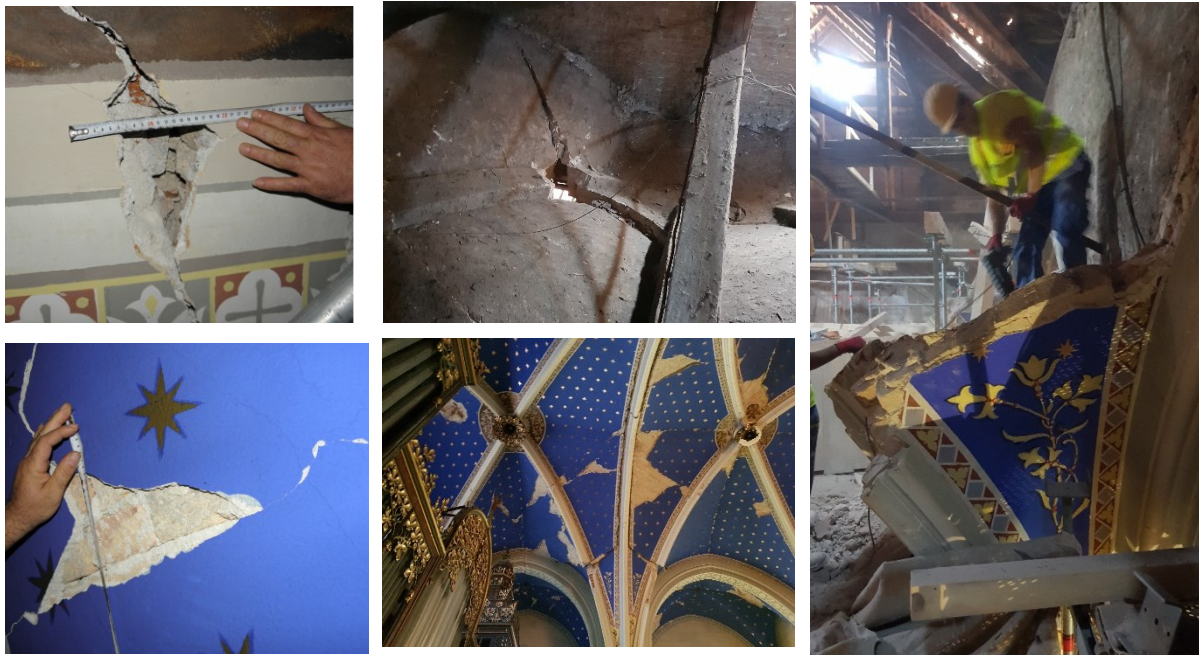
As previously noted, the vaults of the church are constructed as massive masonry structures. The first earthquake ("Zagreb Earthquake") caused significant structural damage to the vault, necessitating immediate shoring to prevent collapse. This temporary support system proved crucial in preventing further deterioration, not only of the vault itself but also of other structural elements of the church during the second earthquake ("Petrinja Earthquake"). Despite these stabilization efforts, the western section of the vaulted ceiling, having sustained severe initial damage, could not be effectively preserved or repaired. Consequently, it was replaced with a honeycomb-structured system made of glulam (laminated timber), over which prestressed hollow-core slabs were installed to enhance structural integrity. Figures 10–12 illustrate the extent of the vault damage, as well as its final restored condition following rehabilitation.

Figure 10. Damage to the church vaults [4, 5]

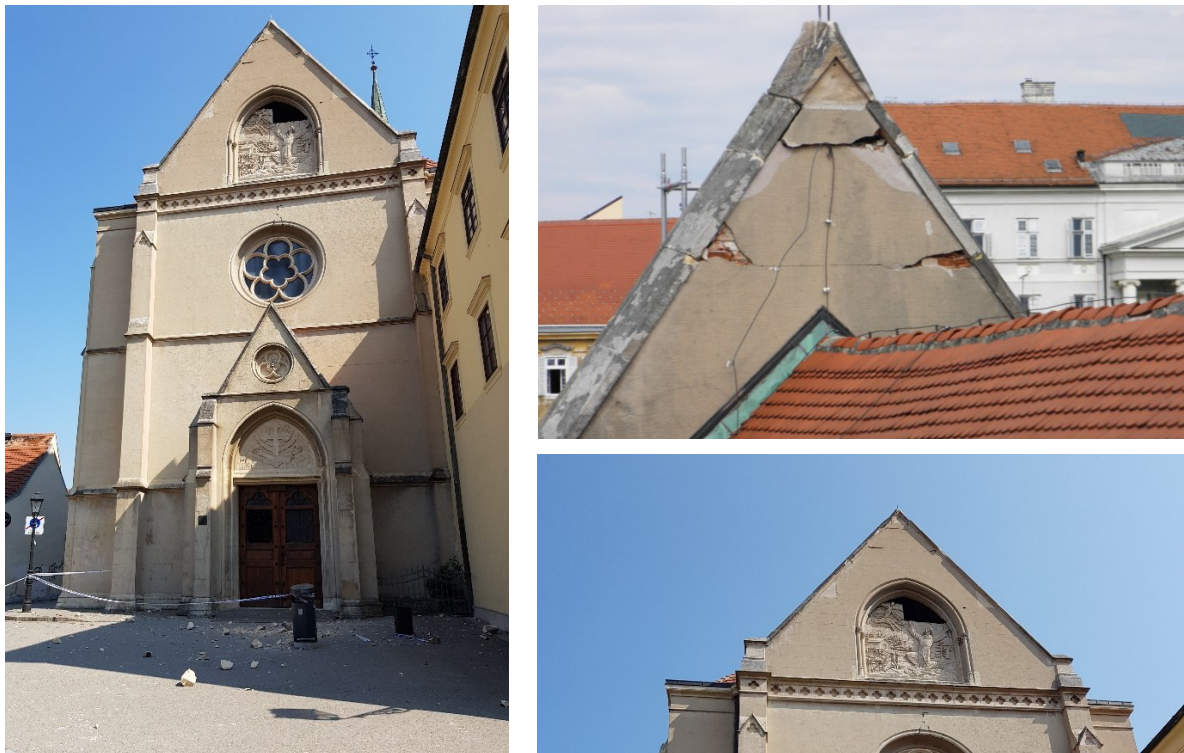
The damage sustained by the church walls, particularly the western gable wall, which suffered the most severe deterioration, along with the rehabilitation measures undertaken, is illustrated in Figures 13–15.

Figure 13. Damage to church walls [1, 5]

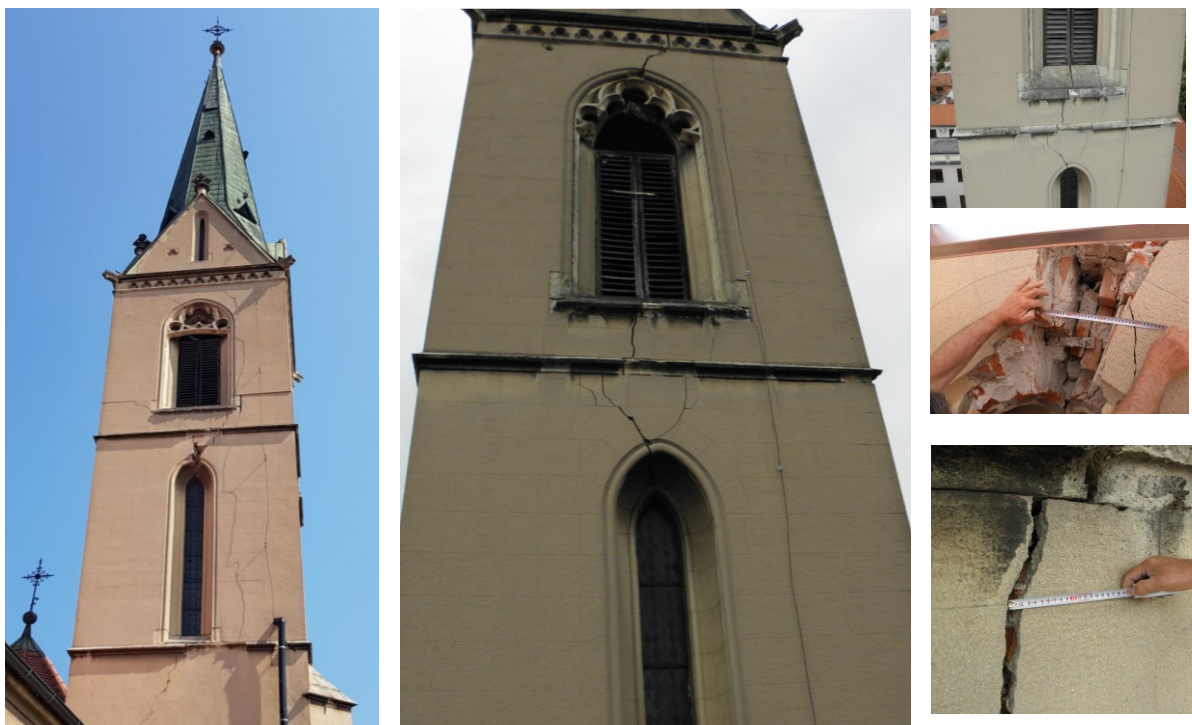
In plan view, the belfry transitions from a trapezoidal base to a square footprint, measuring 6.0×6.6 m, with a total height of 59.55 m. Over the centuries, it has undergone various structural modifications and sustained multiple instances of damage. By the time of the recent earthquakes, it stood as a masonry structure with large openings, featuring wooden staircases and galleries, while the bells were supported by a metal framework. The damage observed in the cantilevered section of the belfry is consistent with its structural frame system with rigid crossbeams, where cracks developed in the lintels due to seismic forces. Figures 16–18 illustrate key damage patterns, the rehabilitation process, and the final restored condition of the belfry.

Figure 16. Belfry damage [5, 1]

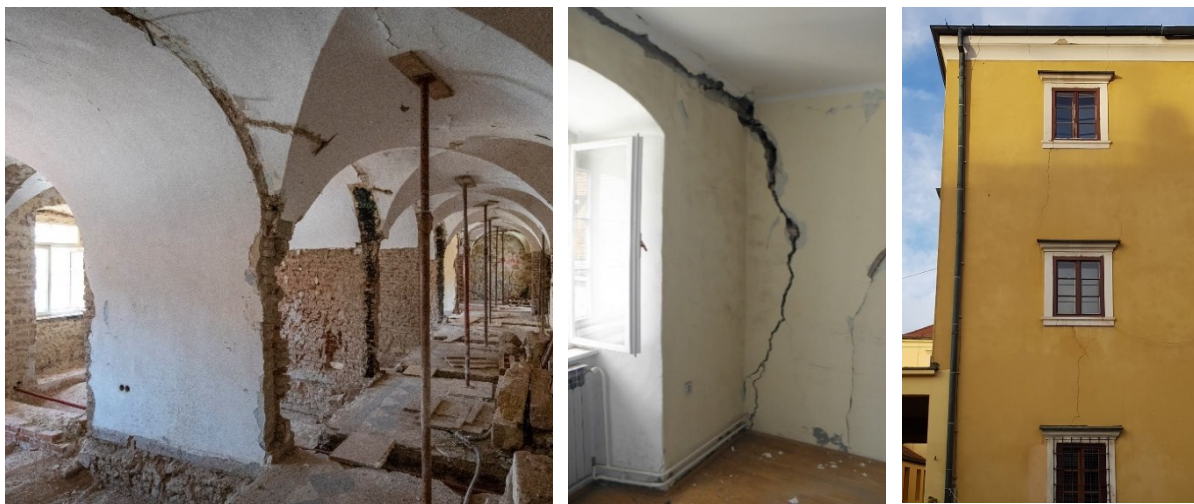
The monastery, much like the rest of the Franciscan complex, has endured multiple instances of structural damage and deterioration throughout its history. With a footprint of 55×38 m, it comprises a partially underground basement, a ground floor, two upper floors, and an attic. Built as a massive masonry structure, its irregular configuration in both plan and elevation contributed to significant structural distress during the Zagreb and Petrinja earthquakes. Figures 19–21 provide an overview of the damage sustained, the rehabilitation process, and the final restored state of the monastery.

Figure 19. Damage to the monastery [1, 4, 5]
