SEISMIC RETROFITTING OF SULTAN MURAT MOSQUE' CLOCK TOWER IN SKOPJE USING INNOVATIVE MATERIALS

Abstract

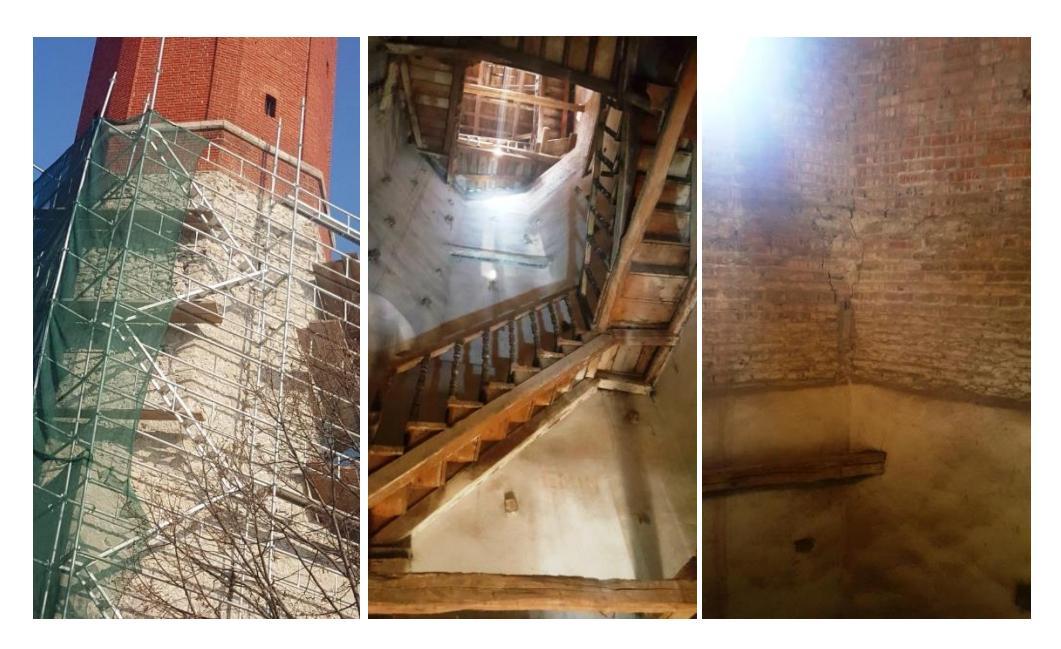
Figure 2. The condition of the structural masonry walls before rehabilitation

From the inspection of the building, it was generally concluded that the masonry was in good condition with some visible damages in the form of diagonal and vertical cracks on the facade stone

walls, on the inner side of the brick walls, damages from a deterioration of the wooden beams and the mortar due to aging, as well as damages due to an insufficiently regular maintenance.

This measure included repair of visible cracks, as well as all existing cracks that were noticed after the surface mortar layer had been removed.

The process of repairing structural cracks started with cleaning the facade mortar and injection of mixtures based on lime mortar with additives, (crushed brick, pozzolan), fluidity improvement additives, improvement strength and adhesion with the substrate.

For structural consolidation and overall increase of the masonry compactness and thereby improving the load-bearing capacity and integrity of the masonry, a systemic injection had been performed. The process included cleaning the inner surface of the elements and removing the damaged and labile parts. The injection was carried out with similar mixtures with increased fluidity, under a pressure of 1-1.2 atmospheres with specialized equipment, along previously systemically laid pipes and in the direction from bottom to top.

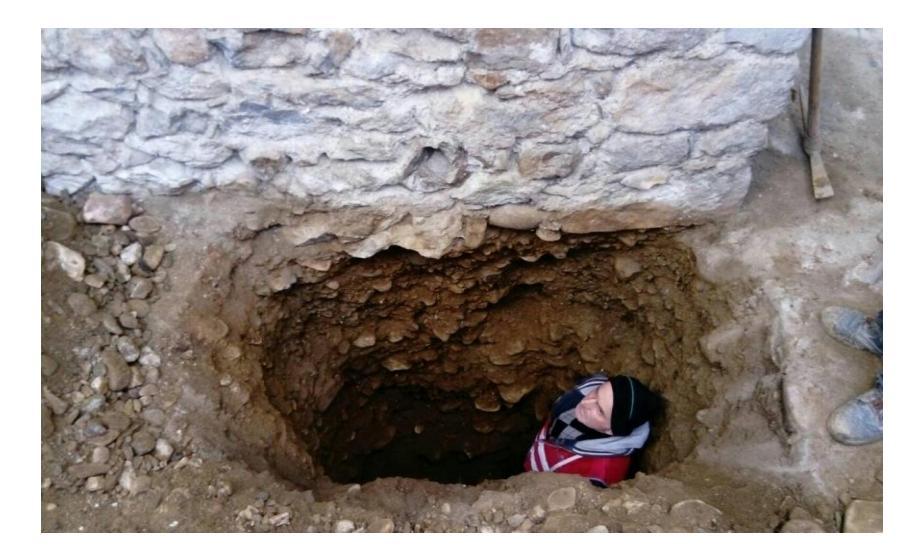
For the structural analysis purposes, additional research was carried out to determine the foundation depth. The tower is founded on a sloping terrain, so the southern side is at an elevation of +0.00 m, while the elevation of the northern part is at an elevation of -2.00 m. From the investigation probe along the northeast corner of the building, the identification of the foundation was carried out (Fig. 3). The foundation is constructed of a solid stone masonry in lime mortar without extension up to elevation -4.00 m and it is a continuation of the stone masonry above the ground level.

Figure 3. An exploratory borehole along the northeast corner of the tower

To consistently implement the strengthening below the ground level, based on the observation of the open probe, the knowledge obtained about the foundation and the calculations performed, a solution is provided for strengthening the foundation walls from elevation -4.00 m at least to elevation -2.00 m. It consists of a reinforced concrete wall, 25 cm thick with extra 80 cm of extension on the footing along the whole outer perimeter of the foundation walls after previous rehabilitation by injection and appropriate treatment of the surfaces. To achieve interaction with the existing foundation structure, chrome steel anchors with appropriate length were installed in previously drilled holes, filled with epoxy mortar. With such a solution, the reliability coefficient against overturning from maximum seismic forces have been significantly increased.

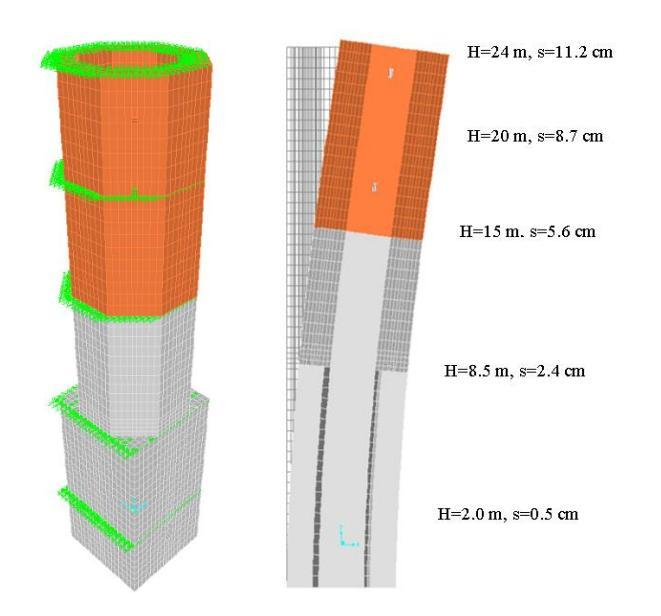
Since there is no direct connection of the masonry from elevation +24.30 above, further analyses were performed up to that level by considering the influence of the upper part of the building only as an additional weight. According to the numerical analysis the natural periods on both orthogonal directions have the same value ($T_{x-x} = T_{y-y} = 0.81$ s), while the natural period in torsion is lower ($T_{tor}=0.21$ s). These values are within the expected limits for natural period of clock towers, The total displacements from seismic force in the longitudinal and transverse directions are 11.2 cm in both directions (Fig. 5) and they are higher than the maximum allowed according to regulations ($\delta_{max}=H/600=2900/600=4.83$ cm).

Figure 5. Unretrofitted state - elevations of applied seismic forces (left), displacements due to the design seismic actions (right)

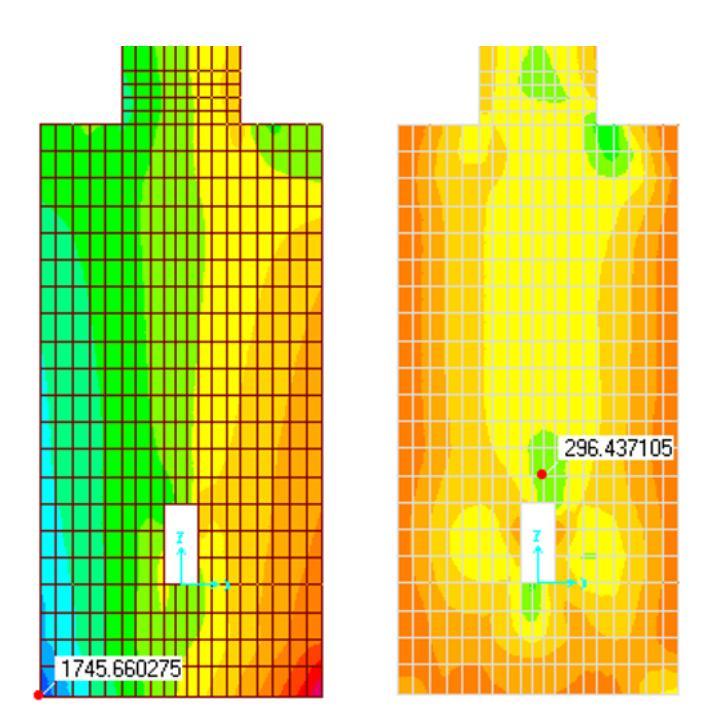
The resulting stress-deformation state indicates a sufficient capacity of stability and reliability for gravitational loads since the maximum compressive stresses are lower than the expected ultimate compressive strength of stone masonry. However, considering the maximum expected seismic impacts, tensile stresses higher than the expected tensile strength of the masonry occur in local zones, which would result in structural damage due to the expected seismic action (Fig. 6). Thus, the need for structural consolidation and strengthening was determined in order the seismic protection level to be achieved.

Figure 6. Unretrofitted state - stress in kPa under gravity loads and seismic actions in critical points – vertical tensile stress (left), shear stress (right)

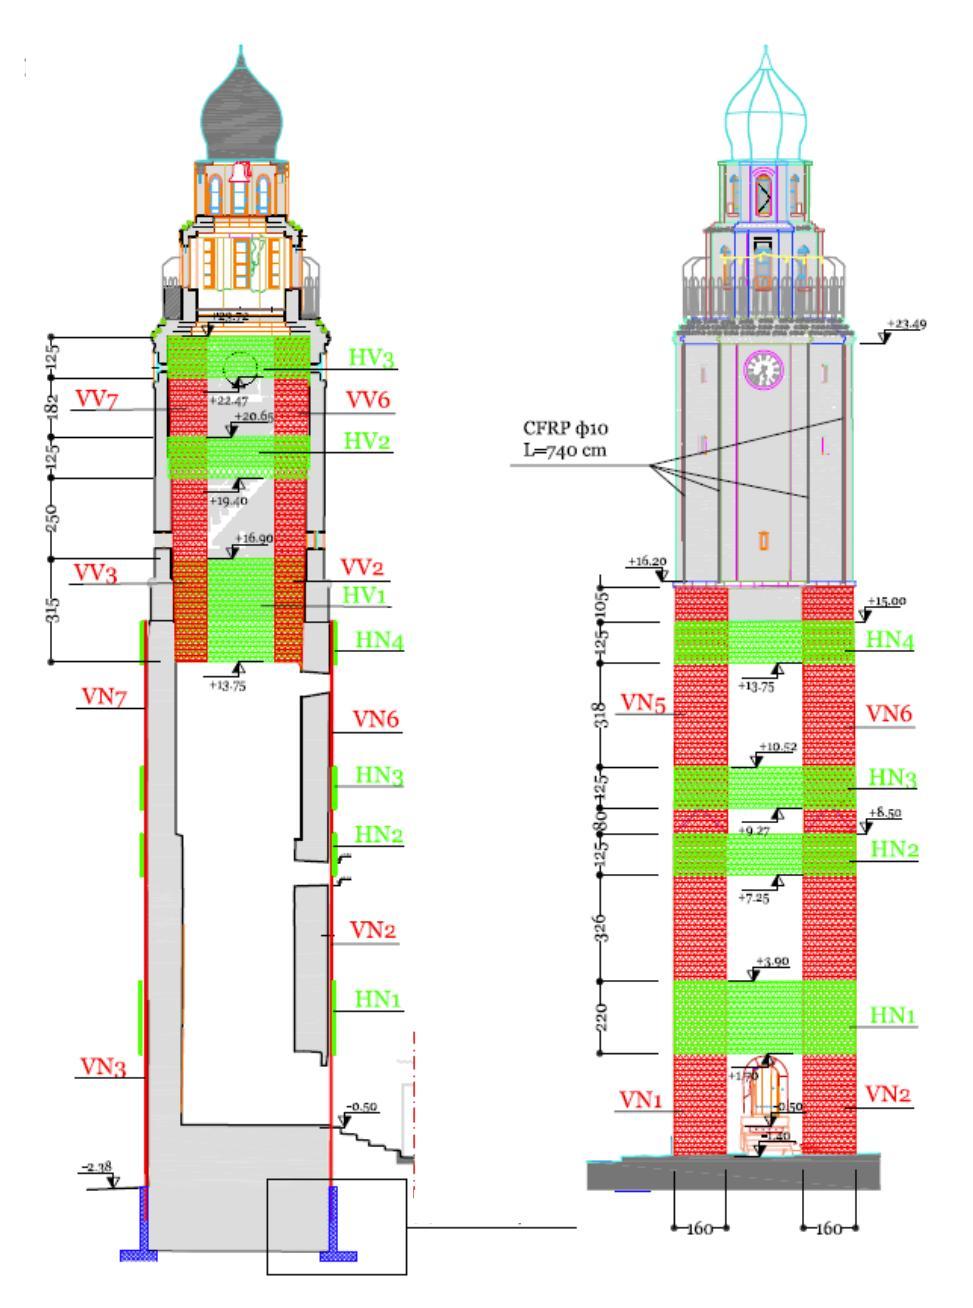
Figure 8. Strengthening elements – cross section (left), on the facade (right)

According to the conducted analyses and the possibilities for the application of the proposed system, the following strengthening elements were foreseen (Fig. 8):

- Vertical external elements VN1, VN2, VN3 and VN4 at the corners of the lower part of the stone masonry in the form of a square with a length of at least 320 cm and a height of at least 12.5 m (from elevation level -3.00 m to +8.50 m, plus overlapping length);

- Vertical external elements VN5, VN6, VN7 and VN8 on four of the eight sides of the octagonal part of stone masonry with a length of 220 cm and a height of 7.5 m (from elevation +8.50 m to +15.00, plus overlapping length);

- Vertical internal elements VV1, VV2, VV3 and VV4 on four of the eight sides of the brick masonry with a minimum length of 160 cm and a height of 10 m (from elevation +15.00 m to elevation +24.30 m, plus overlapping length). These elements were constructed on the inside of the walls due to the requirements for keeping the facade unchanged. In order to fully achieve the integrity effect, it is planned to connect these elements with composite bars (CFRP bars) placed next to the pilasters on the facade brick wall;

- Horizontal external elements HN1 and HN2 on the part of stone masonry in a square shape that go around the eternal facade on elevation +3.90 m and +8.00 m respectively, with a minimum width of 220 cm and 125 cm respectively and a length of 23 m;

- Horizontal external elements HN3 and HN4 on the section of stone masonry in an octagonal shape on elevation +10.50 m and +15.00 m respectively, with a width of at least 125 cm and a length of 18 m;

- Horizontal internal elements HV1, HV2 and HV3 on the section of brick masonry on elevation +16.90 m, +20.60 m and +23.70 m with widths of 3.20 m, 1.25 m and 1.25 m respectively, and a length of 13 m. The connection to the composite bars at the root of the pilasters described above applies to the connection to these elements as well. The connection should be achieved applying chromed steel stirrups inserted through the joints in the masonry on every 40 cm from elevation +16.40 m to elevation +23.40 m.

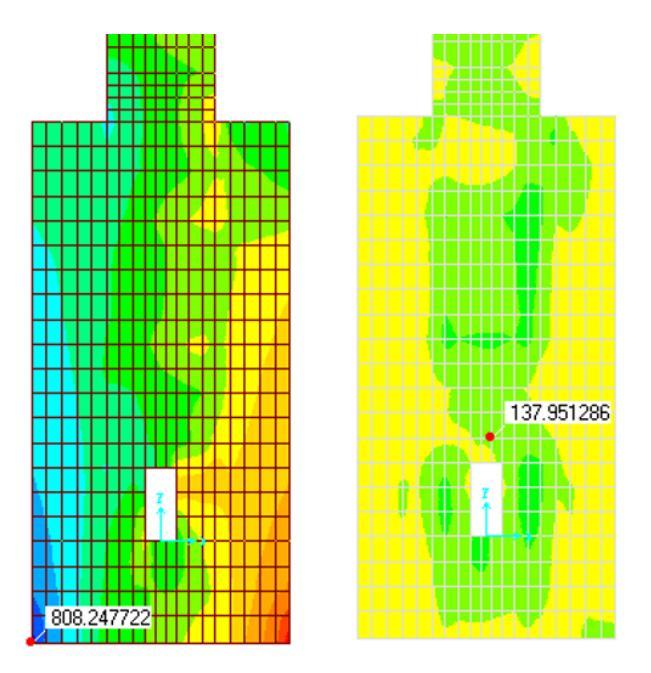
The resulting stress-deformation state of the retrofitted structure indicates that the maximum expected seismic impacts, tensile stresses is significantly reduced compared to the unretrofitted structure. Although remains higher than the expected tensile strength of the masonry in smaller local zones (Fig. 11), the global safety and stability of the structure to seismic events is significantly increased.

Figure 11. Retrofitted state - stress in kPa under gravity loads and seismic actions in critical points – vertical tensile stress (left), shear stress (right)
