## Seismic response of unreinforced masonry buildings from 1950's

### Abstract

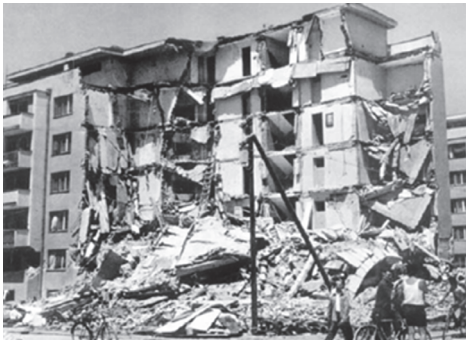
**Figure 3. Total collapse of URM building, Skopje 1963**

The most severe consequences after a strong earthquake are total or partial collapse of the URM building structures, which were observed during Skopje and Banja Luka earthquake (Fig. 3 and 4). Five-story masonry building without vertical reinforced concrete confining elements could not withstand earthquake of the seismic intensity 9 (estimation) and collapsed (Fig. 3). Similar observation can be confirmed by failure of the corner building (Fig. 4).

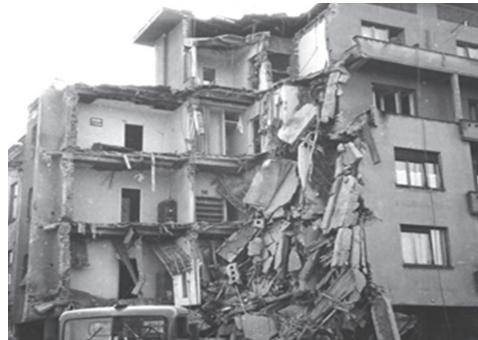
**Figure 4. Partial failure of the masonry building, Banja Luka 1969**

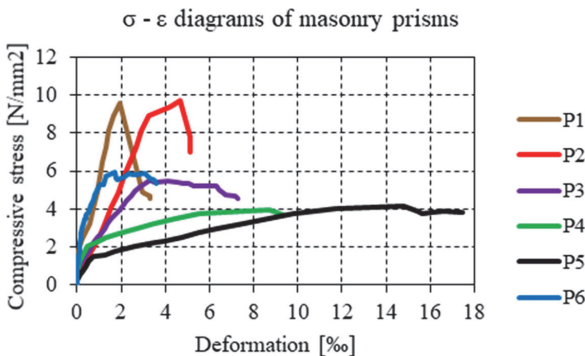
**Figure 6. Masonry prisms: stress-strain diagrams due to vertical compression**

Four measuring instruments – LDVTs were installed on the both sides. The average compressive strength is  $6.48 \text{ N/mm}^2$  and the coefficient of variation amounts to 36 %. Significant deviation of results can be attributed to numerous factors, not only to variation of pure mechanical properties of masonry constituents (geometric imperfections of specimens and testing machine, transport, varying execution of the mason etc.) The average value of the modulus of elasticity is  $4024 \text{ N/mm}^2$ , while the coefficient of variation equals to 46 %. Based on the measured values, it can be concluded that the modulus of elasticity is considerably smaller than the recommendation given in EC6 [10] according to which  $E_m = 1000 f_k$ . However, according to some authors [11] the modulus of elasticity may vary within the limits  $100 f_k \leq E_m \leq 1000 f_k$ .

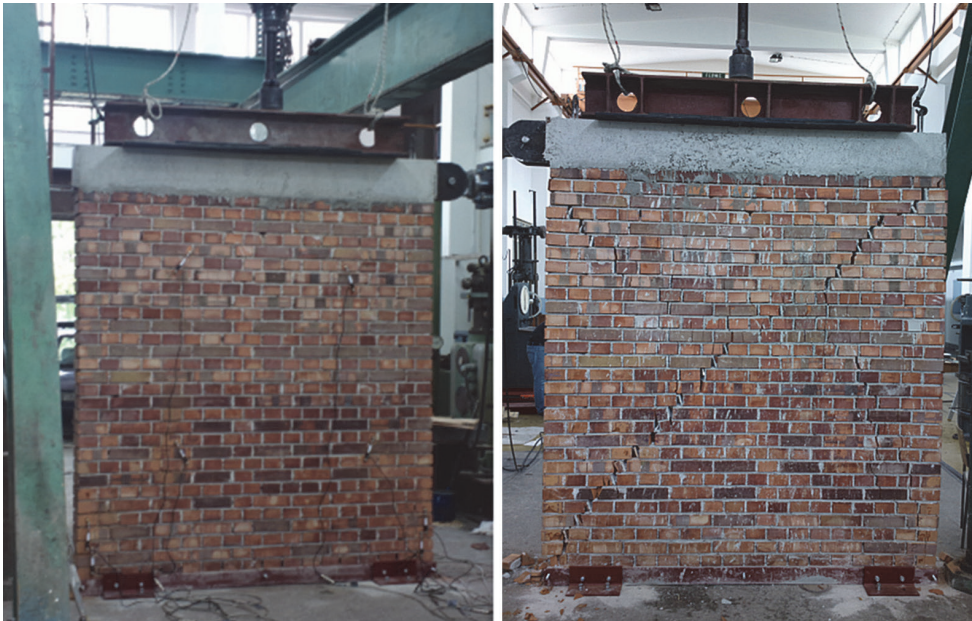
described and tested, taking into account the typical story height of 2.5 m and the wall thickness of 25 cm. Two full scale cyclic tests were performed on unreinforced masonry walls with dimensions length/height/thickness = 233/237/25 cm, see Fig. 7.

**Figure 7. Full scale model (specimen) of URM wall, before and after the test**

Diagonal cracks, typical damage on masonry walls caused by earthquake motion, were observed at the end of the test (see right photo on Fig. 7). Diagonal cracks generally follows the vertical and horizontal mortar joints. The crack width reaches several cm at some specific points. The diagonal cracks could be more clearly observed on the Fig. 10 for one side of the wall specimen.

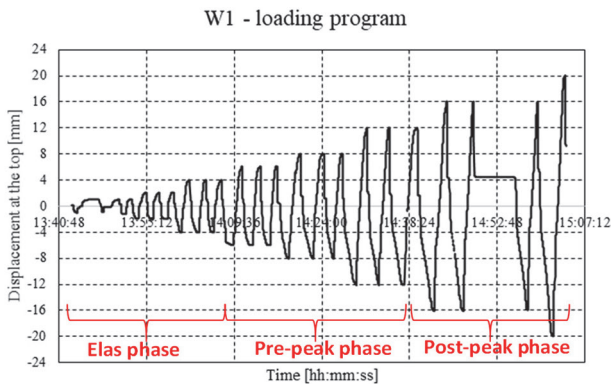
The wall specimen was exposed to constant vertical compression equal to  $0.4 \text{ N/mm}^2$ . Horizontal load was applied at the top of the wall in the wall plane direction as static cycle loading. Following Fig. 8 illustrates the testing protocol, displacement at the top of the wall vs. time, in the form of controlled displacement, gradually increased up to 2 cm, whereby the identical shift is repeated three times in both directions.

**Figure 8. Protocol for horizontal loading at the top of the wall**

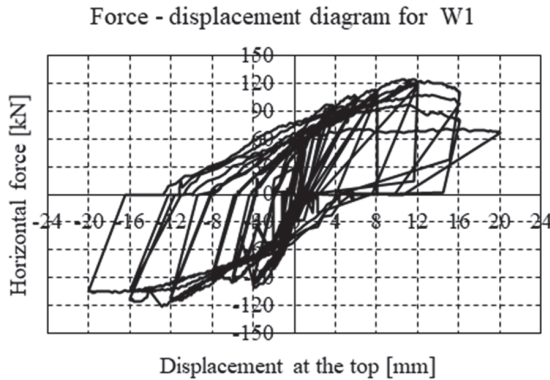
The obtained hysteretic loop is shown in Fig. 9. One can notice significant capacity of ductile behavior of the tested URM wall. This differs significantly from traditional recommendations on very limited ductile behaviour of the unreinforced masonry walls without confinement. It is to repeat here that seismic codes prescribe average behaviour factor for URM walls without confinement equal to 1.5, which seems to be rather conservative, when compared to the results of the test.

**Figure 9. Horizontal force vs. horizontal displacement at the top of the wall W1**

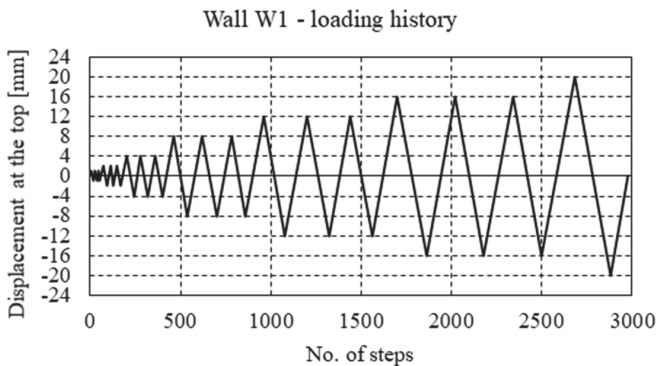
Masonry is a highly heterogeneous material, composed of bricks and mortar, two building materials with rather different mechanical properties. And already by moderate earthquake the structure moves to the nonlinear range of the behavior. This means that numerical modelling of the masonry wall is not an easy task. One of the solution is to implement macro-modeling or to approximate masonry as homogeneous building material. The mechanical properties should be estimated by appropriate tests on masonry wall models or wallets. Engineering masonry model from FEM software DIANA [12] was implemented in this research. It is calibrated with previously described test results. Detailed descriptions of the model could be found in the literature [6, 8, 9]. Horizontal loading scheme (Fig. 11) is similar or equivalent to the experimental loading protocol.

**Figure 11. Horizontal loading scheme for the numerical analysis**

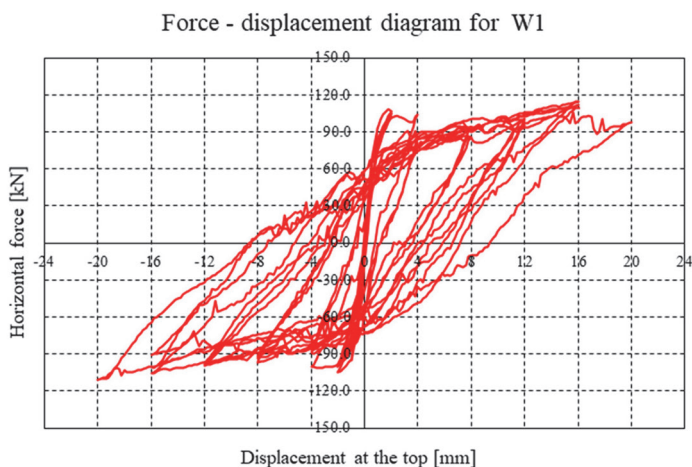
Engineering masonry model can simulate compression, tension and shear failure mechanism and present development of the cracks. Hysteretic curve showing relation between total horizontal force and displacement at the top of the wall is presented on the Fig. 12.

**Figure 12. Numerical analysis of the masonry wall, horizontal force vs. top displacement**

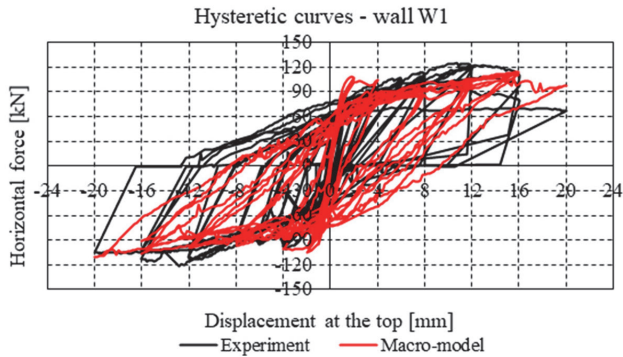
The hysteretic curves obtained by experimental and numerical analysis showing relations between total horizontal force and displacement at the top of the wall are overlapped and presented on the Fig. 13. Good matching between experiments and numerical analysis can be observed.

**Figure 13. Experimental vs. numerical results, hysteretic nonlinear behaviour of URM wall**
