The 4th century Siscia (Croatia) earthquake – archaeoseismological evidence

Miklós Kázmér¹, Rosana Škrgulja²

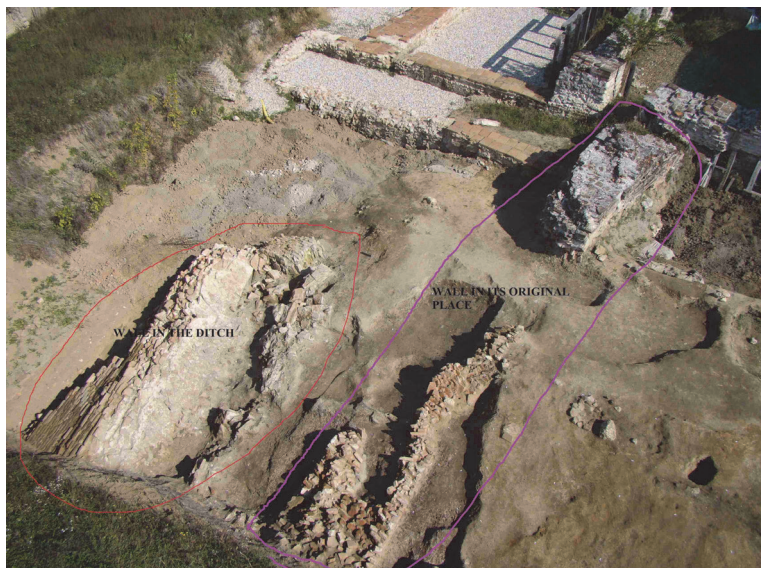
Figure 2. A collapsed segment of the city wall of Roman Siscia. There are still low parts of the wall in place on the right. Top of these walls displays clear sign of shearing to the left. Upper portion of the wall is in the city moat on the left: brick layers are bottom-up(!). North to the left

During the first season of the excavations, a part of a wall was found, some 10 m to the south of the confirmed position of the city wall. It is 10 m long, up to 2 m wide, and the building technique corresponds to the entrance. It continues, after a hiatus, into the western profile. When discovered, it was considered that it had fallen from the entrance wall. Later excavations revealed that a large segment of the corresponding wall collapsed into the defense ditch, along with segments of smaller walls.

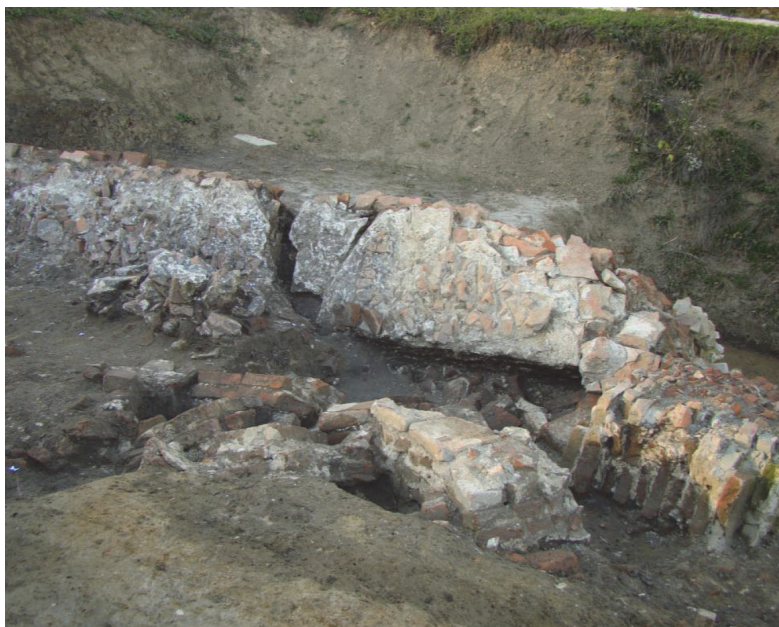
Figure 3. Overturned wall in the moat. The viewer is looking at a mortar layer between rows of bricks, a seen from below(!). Note that in-plane deformation caused a wide gap to appear, marking extension of the wall during shaking or during collapse [37]

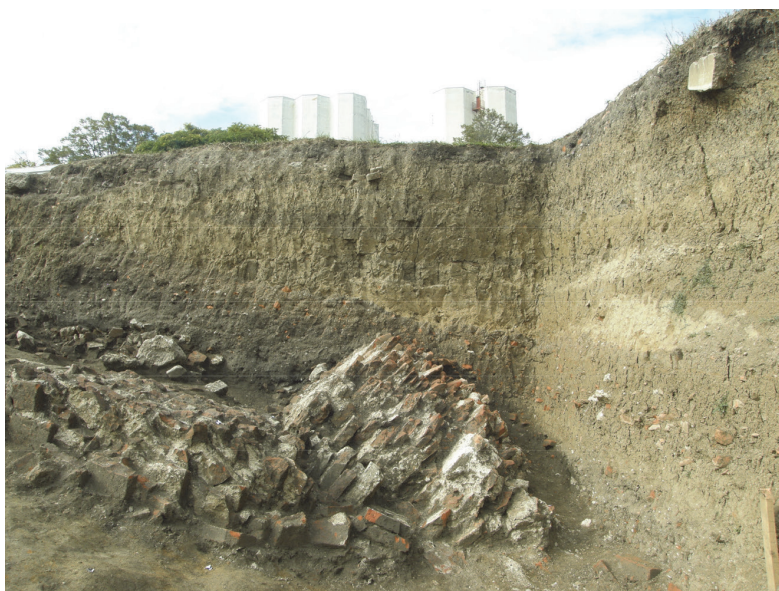
Figure 4. Two portions of a collapsed wall, arranged in different positions. Left block tilted towards the viewer, right block tilted towards west

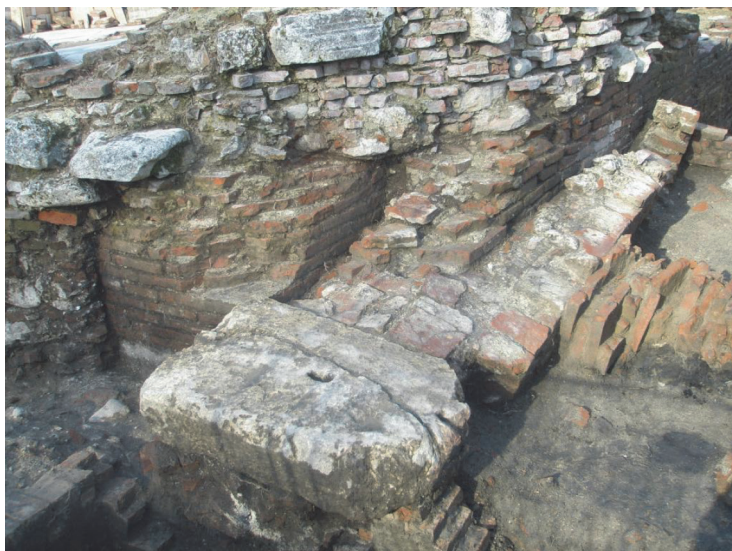
Figure 5. View of the church apse. A tilted wall, next to the early 3th century vertical walls of the Roman entrance complex, on top of which is the 18th century church [19]

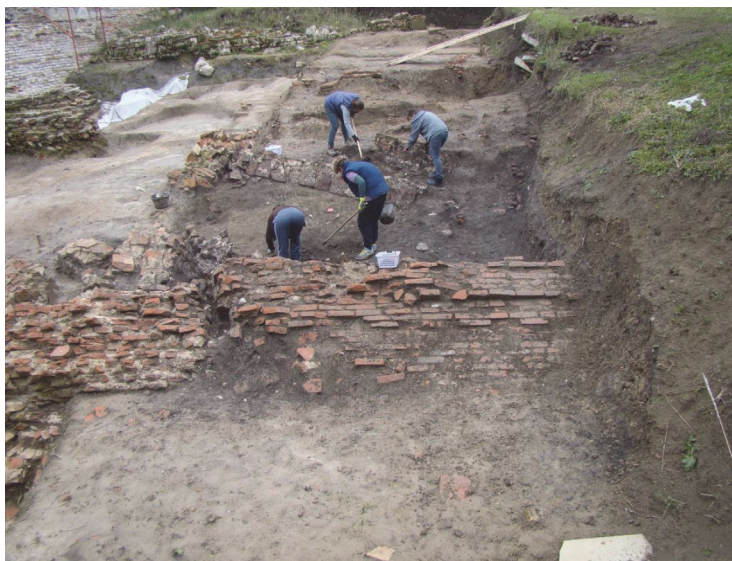
Figure 6. Brick masonry walls collapsed in various directions [37]
