Seismic vulnerability in guatemala city considering the urban planning

Luis Dávila Migoya¹, José Manuel Cabrero², Héctor García-Diego³

Abstract

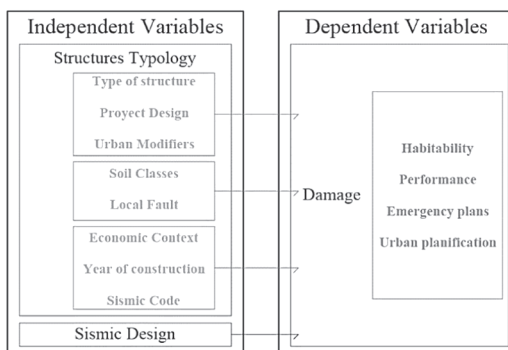
A proposal to classify damage to inform seismic design for high buildings in different places in Guatemala City is given. The objective is to consider the different independent variables, structural and non-structural damage (Fig. 1).

Figure 1. Variables in the present study

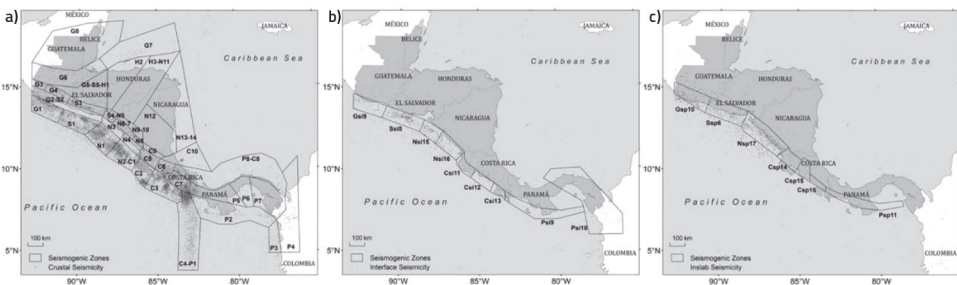
The last updated Central America catalogue of regional seismic events was proposed by Benito et al., 2010. CA has been struck since 1522 by numerous earthquakes that caused devastation, both in the subduction zone and in the local faults of the volcanic chain. The first type produced higher magnitudes earthquakes of subduction M_w 8, but these events were less frequent and caused less damage than those originated at the local fault because their epicentres are normally located seaward, and their depths are $h \geq 25$ km. In the Volcanic chain, the earthquakes present measured magnitude $M_w \leq 6.7$ but caused more damage because there are crustal events with $h < 25$ km and are frequently located close to the population centres. In Fig. 3 the, different seismogenic zones are shown.

Figure 3. Seismogenic zones adopted for the seismic-hazard assessment: a) Crustal zones superimposed to surface seismicity, b) Interplate zones superimposed to intermediate seismicity, c) In-slab zones superimposed to deep seismicity. [4]

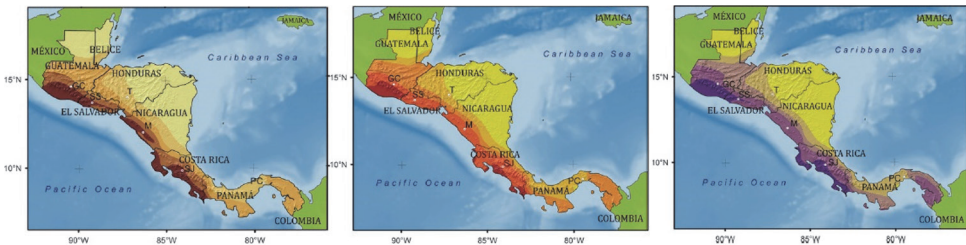
Analysis of these figures allows highlighting the following results from Guatemala: the greatest values of PGA are predicted in the south of Guatemala and in some areas of the volcanic chain. For a return period of 500 years, PGA reaches a maximum of 600 cm/s² in south Guatemala, and 500 cm/s² in some places located in the volcanic chain along Guatemala (Fig. 4). It is found an exception in southern Guatemala, where the isolines are not parallel to the coast as in the rest of CA, and PGA decreases more slowly showing the influence of the Motagua fault. Also, similarities in the PGA isolines for the return periods of 1000 and 2500 years can be observed, being the greatest values entirely located in southern Guatemala.

Figure 4. Seismic-hazard maps of Central America in terms of PGA for return periods of: a) 500 years, b) 1000 years, and c) 2500 years [4]

rently continues as KUK ÆPÁN: an integrated regional study of structure and evolution 4D of CA lithosphere, with implications in seismic hazard and risk calculation. The RESIS II project obtained maps of PGA and SA (1 s) for three return periods: 500, 1000, and 2500 years.

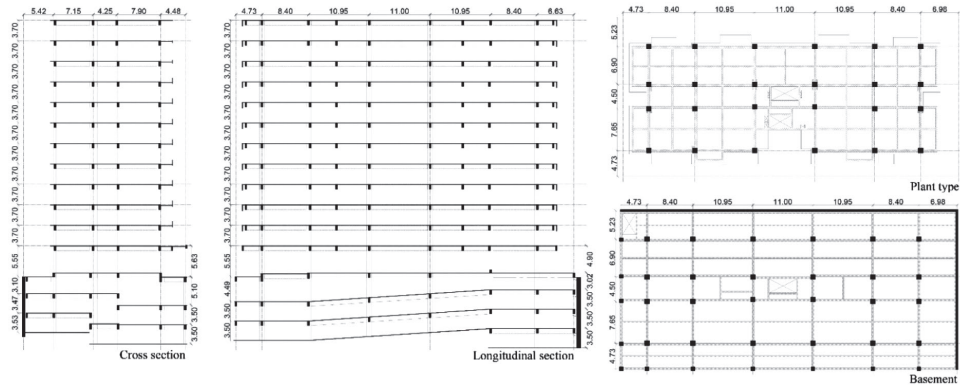
This building is in Avenida Las Americas, 11 calle, zona 13 in Guatemala City. It is randomly chosen. On the left side of Fig. 7, the ubication of the building is given, and urban planning of the area in the POT [9] shown on the right-hand side. Fig. 8 shows the principal plans of the building: urban typology to the right, and the vertical irregularity, the number of floors, and another independent variable to the left. The information is provided by a private company, this facilitates data collection. Other information that was obtained was the construction year, the main use, and the current seismic code.

Figure 8. Plans of the case
