## Sinkholes induced by the Petrinja M6.2 earthquake and guidelines for their remediation

This paper proposes a remediation solution for the sinkholes appeared as a consequence of a devastating earthquake of 6.2 magnitude which hit Croatia in December 2020. At the time of writing this paper, more than 90 sinkholes in villages Mečenčani and Borojevići opened, all triggered by the main impact as well by the series of aftershocks, leaving both authorities and public, as well the professional – scientific community, in surprise. The sinkholes are identified as the cover collapse sinkholes, a most dangerous type of a sinkhole which collapses without any prior ground surface deformation. Owing to the fact that the conditions for the formation of these phenomena are in geological setting of this sinkhole prone area, characterized by the proluvial deposits underlain by the soluble karstic rock mass, the necessity of appropriate investigation works and remediation techniques is highlighted. Since the sinkholes are presumably well-integrated into the karstic conduit system of the aquifer, part of which is a water supply source Pasha's spring, the remediation techniques should rely on the pe

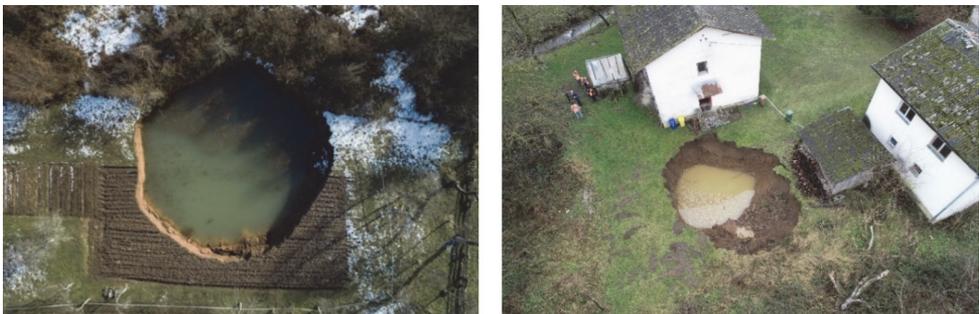
**Figure 1. Some of the sinkholes at the Mečenčani village: the largest sinkhole in field, from [1] (left) and one sinkhole in vicinity of houses (right)**

A strong earthquake of 6.2 magnitude hit Banovina region in Croatia on December 29<sup>th</sup> 2020, with the epicentre near the city of Petrinja. The main impact was preceded by two foreshocks of 4.7 and 5.2 magnitude, and followed by the series of aftershocks with the strongest one having the magnitude of 4.9. The main impact, along with the foreshocks and aftershocks, resulted in seven fatalities and devastating consequences for buildings and infrastructure. The earthquake-linked geotechnical issues at the site manifested as the ground dynamic instabilities, including the activation of many landslides, as well the liquefaction at large scale since several rivers cross the area and the overall geology is characterised by the saturated, poorly graded, sands and silty sands. In addition to these geo-hazards, another phenomena left the inhabitants, authorities, as well the engineering community, completely baffled. In the area south of the epicentre, mainly in villages Mečenčani and Borojevići, more than 90 openings, at the time of writing this paper, appeared on surface. Most of the openings appeared in the fields, such is the largest one having 25 m diameter and 12 m depth, Figure 1a, however some of them appeared in vicinity of buildings and infrastructure, Figure 1b.

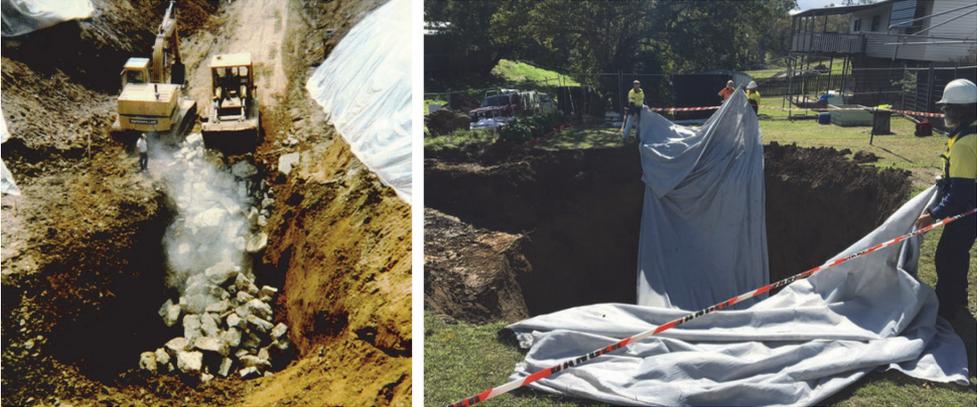
**Figure 6. Bulldozing chunk rock into the throat of a large subsidence sinkhole, from [17] (left); installation of the geotextile to line the base and walls of the sinkhole, from [18] (right)**

The technique comprises the backfilling of a sinkhole including blocking of the throat of the sinkhole with rockfill and/or boulders, Figure 6a, possibly in combination with sandy or gravel material with addition of 3 % to 5 % cement and water, followed by the installation of upper layers, each having finer particles than the one below him. If the filling material is compacted, as suggested by some authors, it would be necessary to provide a proper geometry and angle of the slopes. However, such slope re-profiliation and compaction require additional efforts, and if the sinkhole has loose sides, access by heavy machinery could also trigger a wider collapse. Some of the finer layers can be also stabilized with 3 % to 5 % cement. Even though a sinkhole provides a convenient place to deposit trash, this should be avoided since any contaminants disposed of in sinkholes may end up in caves, springs, and water wells in the area of the sinkhole.

Geosynthetics can be also used to improve the effectiveness of the remediation solutions, and it was successfully used in some previous works [14, 16]. Geotextiles or geogrids are sometimes used to line the base and walls of the sinkhole and to retain the material above the throat of the sinkhole, Figure 6b. They can also support layers within the lower and top selected fill layers [14], to improve to improve load distribution on softer overburden material left in place on shallow overburden strata.
