## Seismic analysis of the stone masonry building in the Korčula archipelago

Frančeska Brkić<sup>1</sup>, Mario Uroš<sup>2</sup>

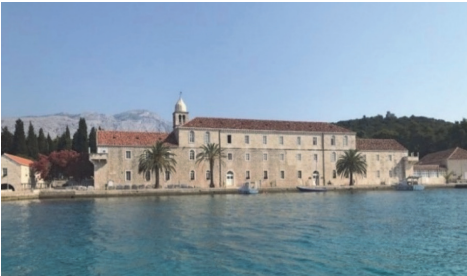
Figure 1. Photograph of the building

The analyzed building is the main part of the Franciscan monastery complex located on the island of Badija in Croatia (Figure 1 and 3). The monastery complex showed on Figure 2, is protected as a cultural monument by the Croatian Ministry of Culture. Originally it was built during the end of the 15<sup>th</sup> century. It was damaged and rebuilt several times, with the last major renovation in 2012. [1]
