Practical applications of fiber reinforced polymers in retrofitting of RC and masonry structures

Engin Cuneyt Seyhan

Regional Application Manager Europe, Master Builders Solutions, engin.seyhan@mbcc-group.com

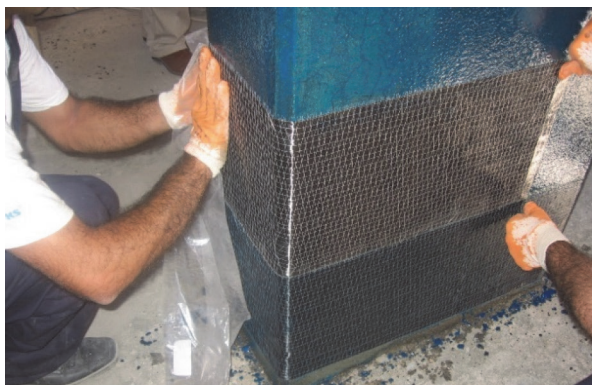
FRP fabrics are available in different type of fibers, e.g. carbon, glass, aramid and basalt. Carbon fiber reinforced polymers (CFRPs), which have relatively high modulus of elasticity when compared to glass, aramid and basalt fibers are more efficient in confinement due to creating much higher passive lateral pressure. FRP fabrics, due to easiness of shaping like an ordinary textile cloth, are suitable form of composite materials for confinement of columns. FRP fabrics must be wrapped around the columns tightly avoiding voids between fabric and concrete surface as seen in Fig. 1.

Figure 1. Wrapping a rectangular concrete column with uni-directional CFRP fabric

Since confinement is a contact critical application, the strength of the concrete substrate is not much critical as smoothness of the surface. Irregularities on the concrete surface cause stress concentrations at single points and this may lead premature fractures on the FRP wrap. It is recommended to limit the maximum size of irregularities down to $\pm 1\text{mm}$. Another key point in this application is using a high strength, low viscous, durable material as an adhesive for gluing FRP fabric on the concrete surface. Since FRP fabrics are weaved from perfectly dry fibers, the composite material can be created only on the job site. The selected adhesive not only bonds the fabric onto the concrete surface, it also creates a matrix around the dry fiber filaments and takes an important role on load transfer between the individual fibers. This is crucial for achieving successful composite effect. Otherwise, the loads applied to concrete element, cannot be carried successfully by FRP wrap.

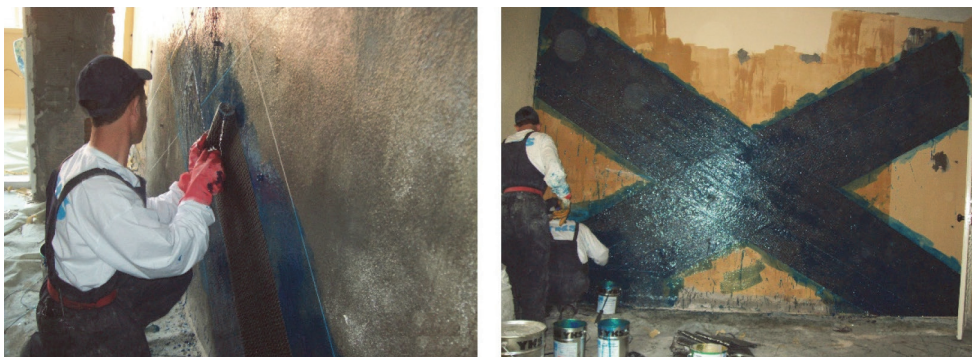
Although the interior walls of the RC structures are not designed as load bearing elements and thus not considered as a part of structural system, it has been experienced during the earthquakes that these walls can contribute to the lateral load bearing capacity and reduce damage by limiting interstory drift deformations when they are strengthened. The use of diagonal CFRP fabrics to integrate the existing infill walls with the surrounding reinforced concrete columns and beams as shown in the Fig. 4 has been proved to be a practical and effective solution for retrofitting seismically deficient RC frames.

Figure 4. Strengthening of infill walls by using diagonal CFRP fabrics
