Slope stabilisation in earthquake prone environment – the TECCO[®] System

Helene Hofmann¹, Armin Roduner², Vjekoslav Budimir³

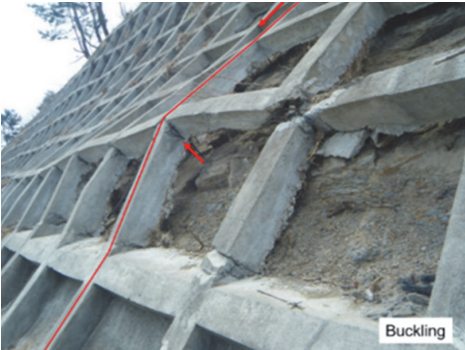
Figure 4. Collapse of shotcrete grating crib work in Kuji City after the earthquake. Buckling and shearing of the concrete ribs are observed

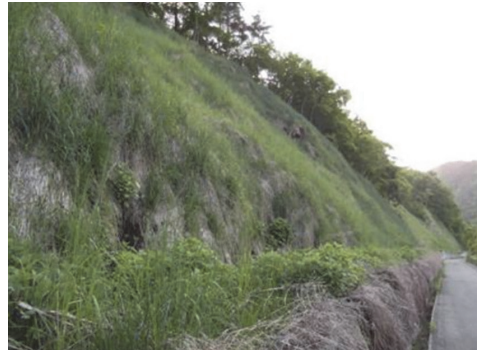
Figure 5. Not far away, a stretch of road where the slope stabilisation was done with high tensile steel flexible system and soil nailing and has long been revegetated, in Tono City. The whole stretch of slope along the road remained stable throughout the earthquake swarm

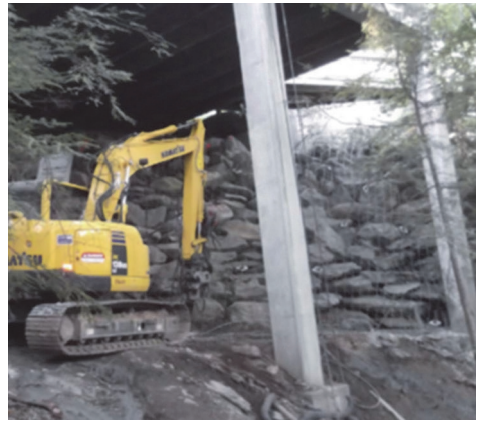
Figure 8. Slope stabilisation under a newly built residential car park. No damages were observed during and after the earthquake. The potential damage of slope failure would have resulted in the collapse of the residential compound and the car park

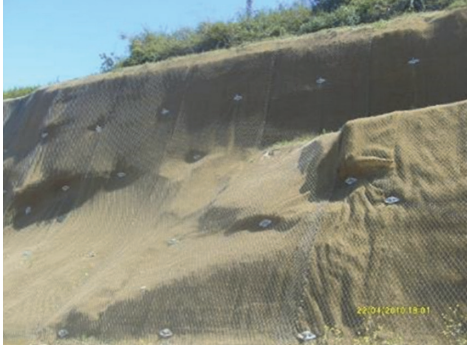
Figure 10. Previously installed Tecco system, which did not sustain any damage during and after the earthquake. The slope remained stable

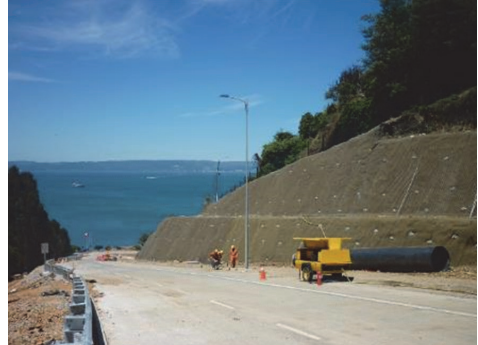
Figure 11. Overview of the stabilised road stretch. No deformation or failure after the earthquake
