## Mavrovo earthquake, experience and dynamic structural response

**Key words:** aseismic design, seismic design parameters, real accelerogram selection

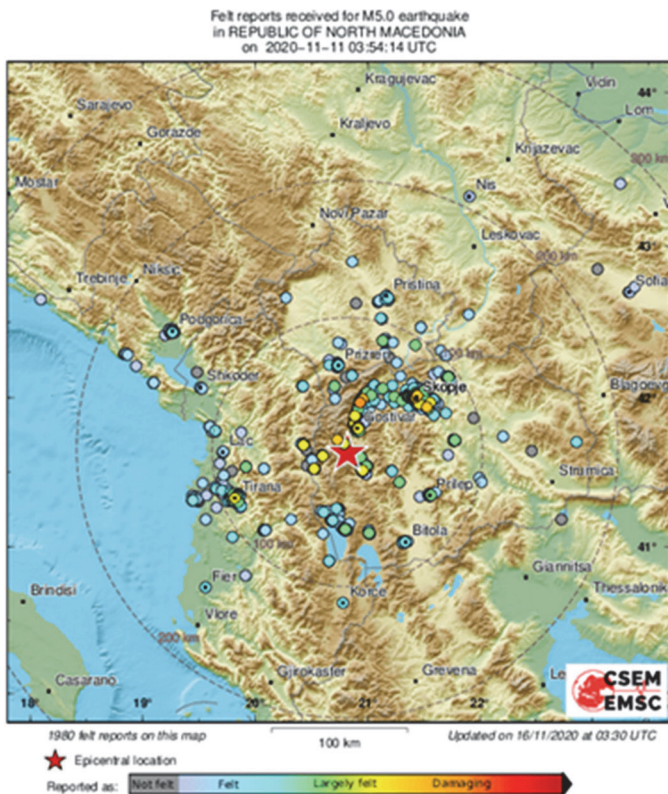
**Figure 1. Regional map of the earthquake from 11.11.2020 at 03:54:14 (UTC) marked with red star (EMSC-CSEM, 2020)**

Due to the above-mentioned earthquake that occurred on November 11, accelerometers type Episensor ES-T that are part of the strong motion network in the Republic of North Macedonia were activated. Strong motion data were recorded at ten different locations of instruments installed on bedrock. In figure 1 the stations' locations and the epicenter of the earthquake are presented.

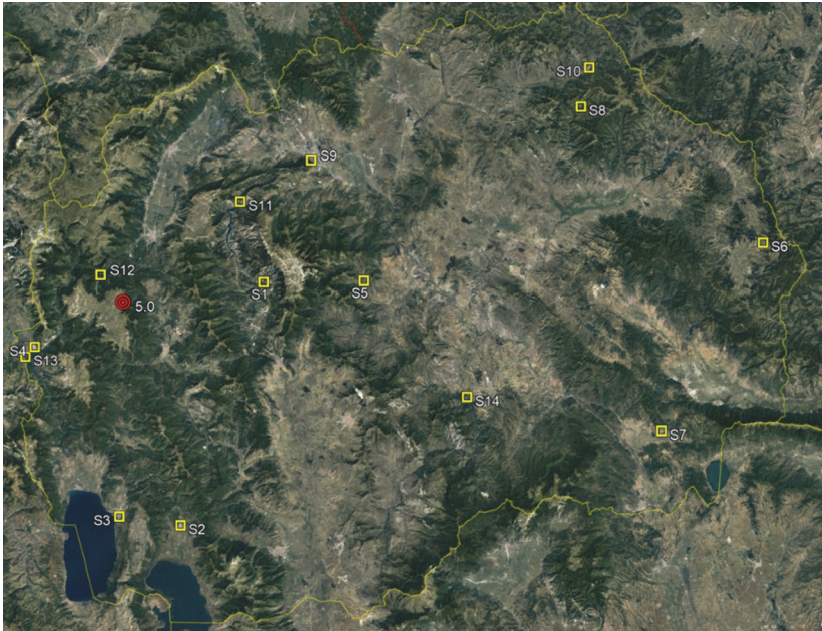
**Figure 2. Strong motion instruments location**

Station	Max. acc. [ $m/s^2$ ]	Distance [km]
S1 - Belica E-W	0.102104	38.2
S2 – Resen E-W	0.029380	62.1
S3 – Ohrid E-W	0.012049	57.9
S4 – Debar N-S	0.187309	27.2
S5 – Lisice N-S	0.137293	65.1
S6 – Pehcevo E-W	0.008479	173.6
S7 – Valandovo N-S	0.003522	149.3
S8 – Zletovica E-W	0.002758	136.9
S9 – Skopje IZiIS N-S	0.066572	63.5
S10 – Kriva Palanka N-S	0.008066	140.8
S11 – Kozjak N-S	0.068227	41.6
S12 – Mavrovo Z	1.057843	9.6
S13 – Spilje N-S	0.071858	30.7
S14 – Tikves Z	0.009048	96.2

The closest station was at 9.6 km from the occurred earthquake with a maximum recorded acceleration of  $1.05784 m/s^2$ . The farthest station was located 173.6 km from the epicentre with a maximum recorded acceleration of  $0.008479 m/s^2$ .
