## Harmonization of seismic vulnerability assessment of urban historic centers

### Abstract

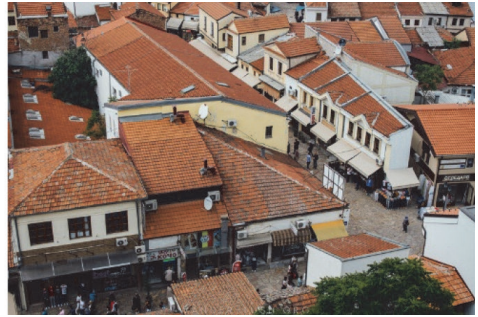
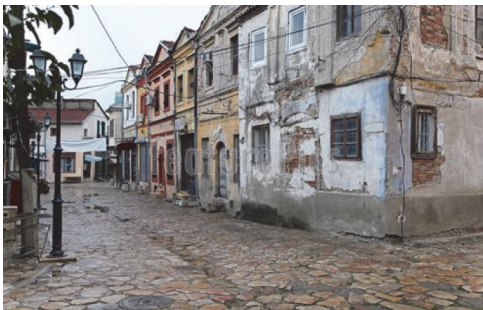
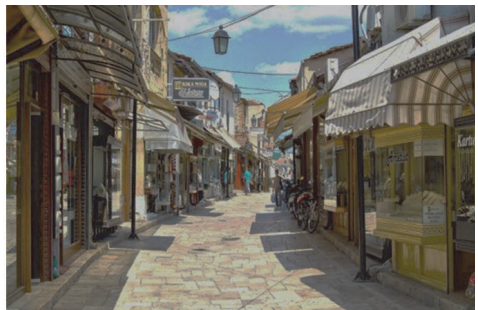
**Figure 2. Typical street in the Skopje Old Bazaar**

The urban configuration of the historic center of Skopje is characterized with huge authenticity. The buildings are placed in the irregular urban mesh, with a couple of main quite wide streets and the narrowness of the other streets and passes between them. A great percentage of the built urban stock is constituted without any earthquake resistant criteria. The masonry walls constitute the main structural elements with the timber floor slabs resulting in a very simple box-type structure. Brick and stone masonry are the most common building materials but adobe masonry with timber bracing can be found too. Regarding the geometry in height, the buildings usually are constituted by ground floor, one or two elevated floors (Figure 2).

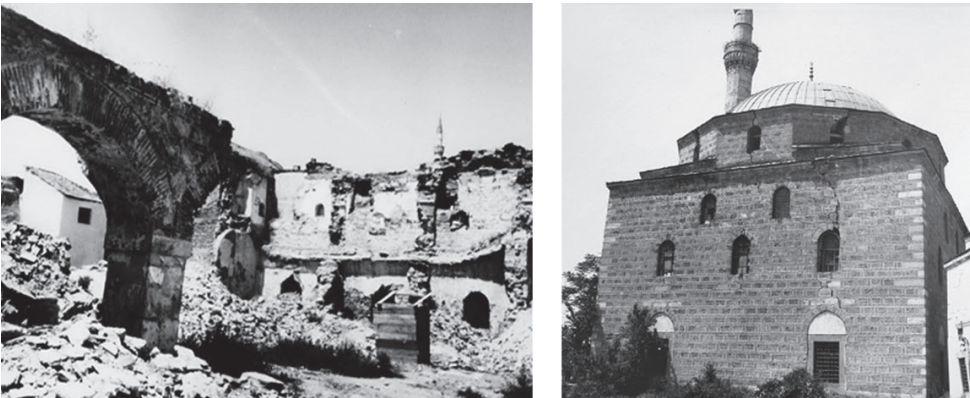
In addition to the damage to residential and public buildings the catastrophic 1963 Skopje earthquake inflicted inestimable damage to cultural monuments and historic buildings. The entire monument fund of historical center of Skopje was damaged, while part of it was destroyed. Damages were manifested by failure of individual parts of the structures, large cracks, inclination and deformations of the walls, the vaults, the columns and other structural elements (Figure 3).

Figure 3. Ruins of Suli Inn and damages on Mustafa Pasha Mosque

During the years following the catastrophic earthquake, there were works on protection of cultural historic structures considering their value and importance. Structural consolidation has been performed in the first phase, while during the renovation of the buildings, particularly those adapted to modern needs whose structural systems did not provide the necessary seismic safety, the principle of repair and seismic strengthening has been applied, involving reinforced concrete bearing structure, columns and belt courses interconnected and incorporated into the existing masonry. Cement as a material was also applied in repair of the medieval churches and monasteries through injection of the occurred cracks or rebuilding of the ruined parts and seismic strengthening.
