Shake table test of a 1:2 scale historical unreinforced masonry building

Most unreinforced masonry structures are vulnerable to seismic actions. Due to the poor shear and bending resistance of masonry walls, seismic actions can sometimes produce mechanisms that may lead to the collapse of the building. This paper presents the results of a shaking table test performed on a 1:2 scale unreinforced masonry building. The results consist of a map of cracks that appeared after the test and some numerical values regarding the dynamic characteristics. The accelerations and displacement recorded show the behaviour of the structural model and the maximum seismic capacity of the system.

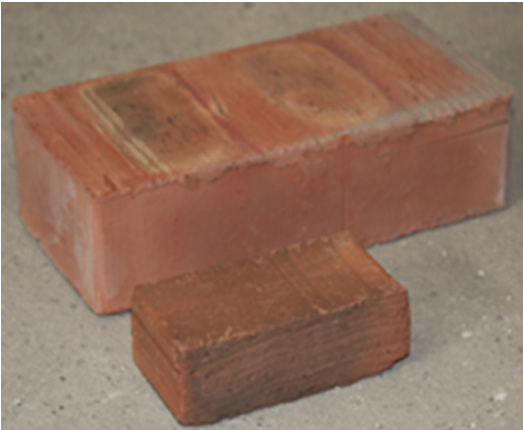
Figure 2. Normal and scaled bricks

The process of constructing the structural model had to follow the original typology of execution of heritage buildings and to respect the principles of geometric similarity that have to be considered in the case of scaled-down models. The bricks used have been designed to 1:2 scale with respect to a traditional unit standard ceramic brick. The scaled bricks represent about a quarter of the total volume of the original brick, having nominal dimensions of 117 x 62 x 36 mm (Fig. 2).

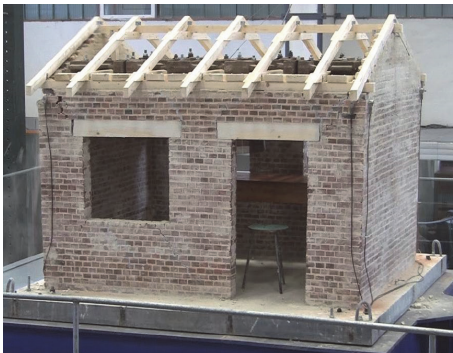
Figure 6. East wall with inclined cracks highlighted along the corners

The identified cracks were marked with different colours. Each colour used represents the moment of its occurrence: light blue - degradations occurred during the first sine beat test shown in Table 1; dark blue – the previously produced cracks widened during the second sine-beat loading scenario with increased amplitude; orange - degradations occurred during the second sine-beat loading scenario, their distribution being generally diagonal, following the path of the mortar joints; green - degradations occurred during the third sine-beat loading scenario along the mortar joint; red - degradation in bricks occurred during the third sine-beat loading scenario [6, 7].

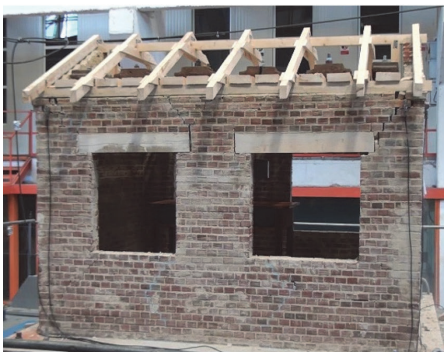
Figure 7. West wall with inclined cracks highlighted along the corners

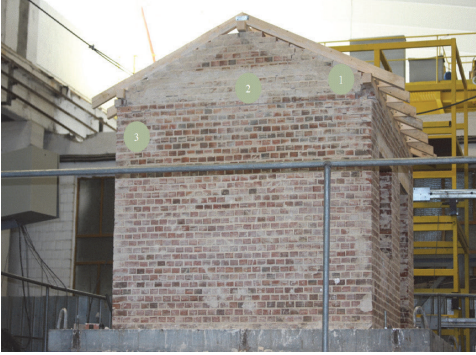
Figure 8. South wall with inclined cracks highlighted

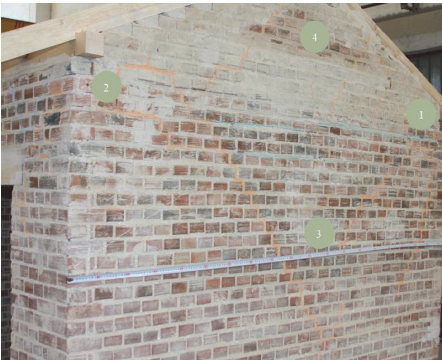
Figure 9. North wall with inclined cracks highlighted
