SEISMIC RETROFITTING OF BUILDING STRUCTURES AND MONUMENTS IN NORTH MACEDONIA – NECESSITY, SOLUTIONS AND CONSTRUCTION

Keywords: seismic retrofitting, historic buildings, monuments, multidisciplinary approach, analytical and experimental investigation

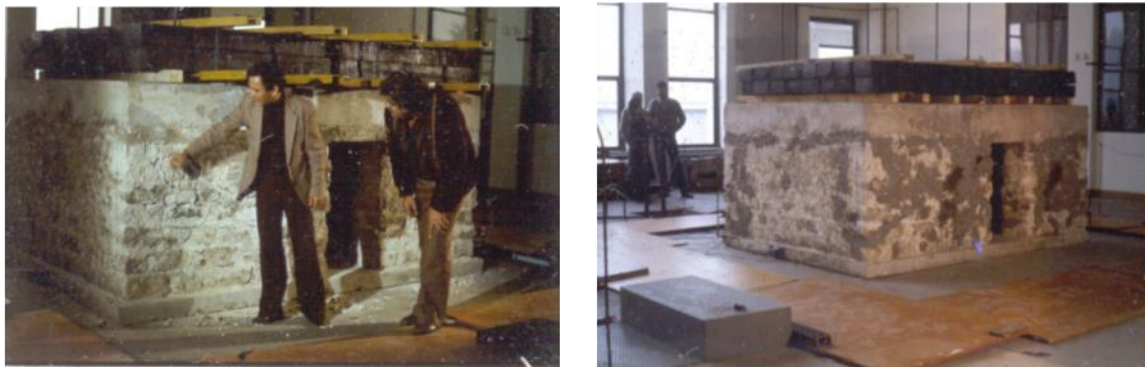
Figure 1. Original and repaired model of a typical masonry building in Budva

structural units and then the methodology for structural retrofitting was determined based on detailed studies of structural characteristics, the damage level, the built-in materials, the foundation conditions as well as local seismicity. Since the injection was the most frequently applied method, for its testing and verification a 1:2 scaled model of a typical single-story building was constructed of the same original stones and mortar and tested on the IZIIS' seismic shaking table applying the 1979 Petrovac earthquake. After testing and occurring of diagonal cracks, the model was repaired by injection and tested again, in which case the model suffered less damage, (Fig. 1). Using the acquired knowledge on the technique application, the consumption of material and the effect of applied injection, more than three hundred buildings within the old towns along Mediterranean coast have been repaired at the same time, including structural repair, repair of facade walls and the interior of each individual building, [3].

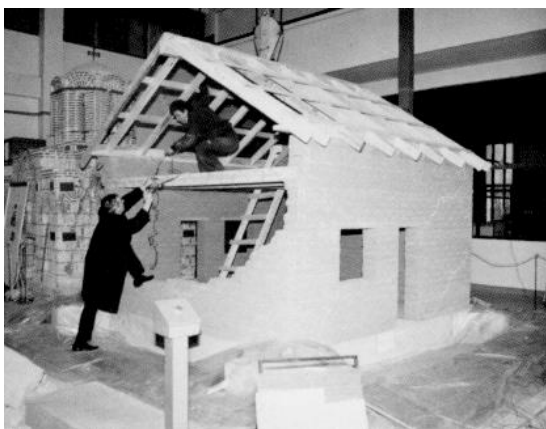
Unretrofitted Adobe Model -UAB

Retrofitted Adobe Model – RAB

Figure 2. The gable end wall after testing of the UAB and RAB model

The first model was a control model while second was retrofitted with a combination of horizontal and vertical straps, center cores, and partial plywood diaphragms. The applied retrofitting proved very effective in improving stability and preventing collapse, (Fig. 2). Based on all the results and the GCI' Engineering Guidelines a number of historic adobes structures in south California were seismically upgraded applying this experimentally verified methodology, [5].

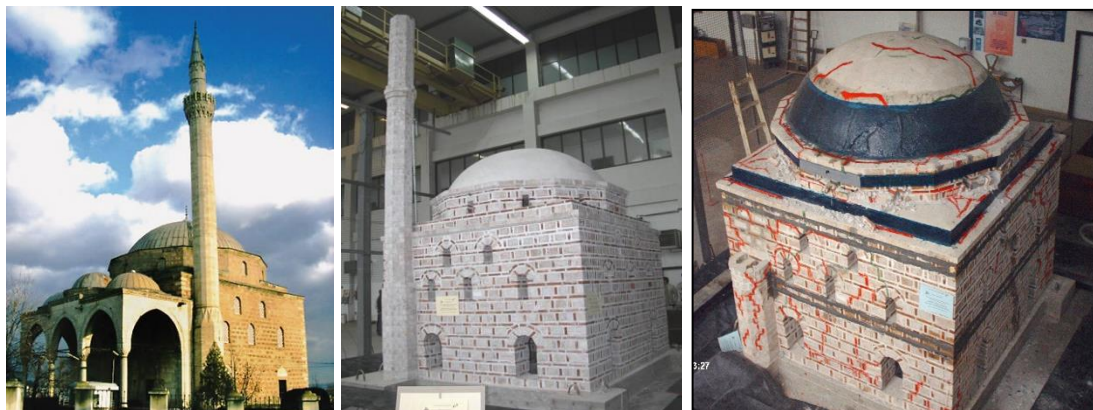
Figure 4. Mustafa Pasha Mosque: prototype (left), 1:6 scaled model (middle), phase 3 – damages (right)

Mustafa Pasha mosque in Skopje: Within the frames of FP6 PROHITECH project "Earthquake Protection of Historical Buildings by Reversible Mixed Technologies", experimental shaking table tests on the models of three important historical monuments, mosque, cathedral and church, were carried out in IZIIS. Mustafa Pasha's Mosque, one of the biggest and the best-preserved monuments of the Ottoman sacral architecture in Skopje and the Balkan, was selected as representative mosque for shaking table testing, (Fig. 4).

Experimental investigation was performed in three main phases: (1) testing of the original model under low intensity level, with the aim of provoking damage to the minaret only; (2) testing of the model with strengthened minaret, with the aim of provoking its collapse and damage to the mosque, and (3) testing of the strengthened mosque model until reaching heavy damage. The applied strengthening solution, consisting of formation of a horizontal belt course around the bearing walls by CFRP rods as well as around the tambour and at the base of the dome by CFRP wrap, has significantly improved the seismic resistance of the monument, [8].

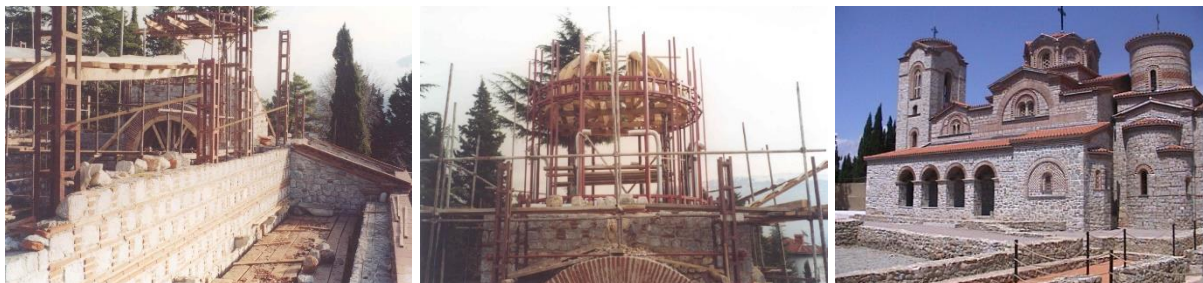
Figure 5. St. Panteleymon church: during reconstruction, (left, middle), rebuilt church (right)

In the process of conservation and rebuilding of the St. Panteleymon Church in Ohrid, having in mind the importance and specific nature of the structure representing a historic monument classified in the first category, it was necessary to design a building structure that will satisfy the stability conditions in the process of application of the conservation principles regarding shape, system, and materials, [9]. The principal structural system of the church consists of massive stone and brick masonry in lime mortar. Seismic strengthening was provided in accordance with the previously developed and verified methodology for Byzantine churches, (chapter 3.2). i.e. the horizontal and vertical steel ties were proportioned and a solution for consolidation of the foundation was given. The church was reconstructed in the course of 2001, (Fig. 5).

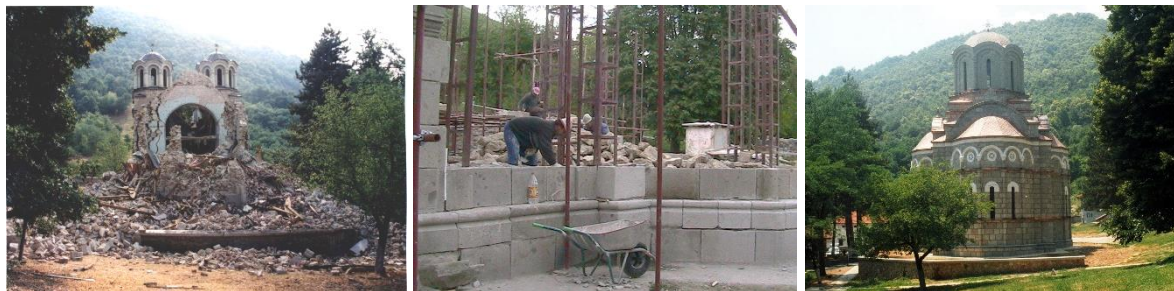
Figure 6. St. Athanasius church: after detonation, (left) during reconstruction, (middle), rebuilt church (right)

On August 21, 2001, during the armed conflict in R. Macedonia, the monastic church of St. Athanasius in Leshok experienced strong detonation, which resulted in its almost complete demolition, (Fig.6). Based on previous knowledge, there have been two approaches taken in the reconstruction of the church: (i) repair and strengthening of the existing damaged part and (ii) complete reconstruction of ruined part with strengthening elements, [10].

The solution for repair and structural strengthening of damaged existing part of the structure anticipates injection of all the cracks and incorporation of horizontal and vertical RC strengthening elements on certain levels. For the demolished part of the structure, a concept of complete reconstruction by maximum possible use of selected material has been adopted, whereat elements for structural strengthening for providing the designed level of seismic safety have also been anticipated: (i) RC belt course below the floor level, in the existing foundation walls, for anchoring the vertical strengthening elements, (ii) vertical strengthening steel elements at the ends of the massive walls and around openings, (iii) vertical strengthening steel elements into the tambour columns, (iv) horizontal steel elements along

the walls, in the base of the tambour and the dome. Due to the different treatment of the structural units constituting the integral structure, an expansion joint between them is anticipated to be constructed.

The church was reconstructed according to the designed methodology during 2005-2007. The results from the analysis show that both structural units constituting the integral structure possess a sufficient bearing and deformability capacity up to the designed level of seismic protection.

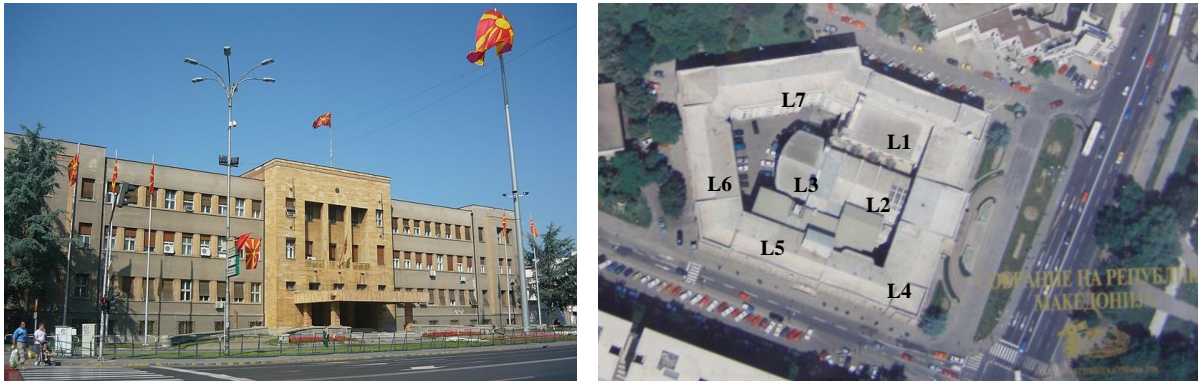
Figure 8. Parliament of Republic of North Macedonia (north facade – left, aerial view – right)

The Parliament Building of the Republic of North Macedonia was more than 70 years old, (Fig.8). As a historic building, it is protected by the Law on Protection of Cultural Heritage. Throughout its existence, a lot of changes, enlargements, adaptations, damaging during 1963 Skopje earthquake as well as post-earthquake repair and strengthening of this building have been done. Within the project on *Enlargement, Building of Another Storey and Adaptation of the Building*, the necessity for increasing the seismic safety of main structural system has been defined, [12].

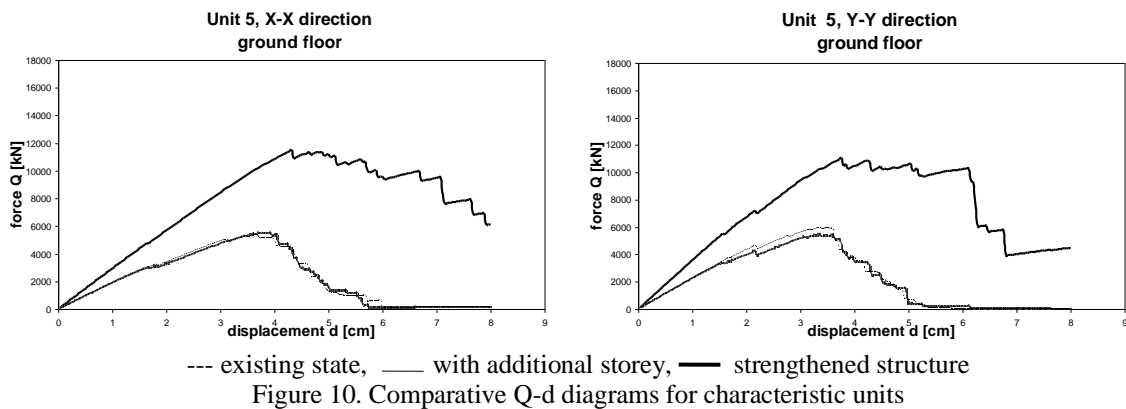
Subsequent final analysis of strength and deformability of the elements and the system as a whole has been made up to ultimate states of strength and deformability for each unit taken separately. Comparative force-displacement storey relationships for the three analysed conditions (existing, existing with additional storey, and strengthened structure) for selected unit gives a very clear insight into the effect of the selected strengthening solution, (Fig. 10), pointing to a considerable increase of both the bearing and deformation capacity of the system.

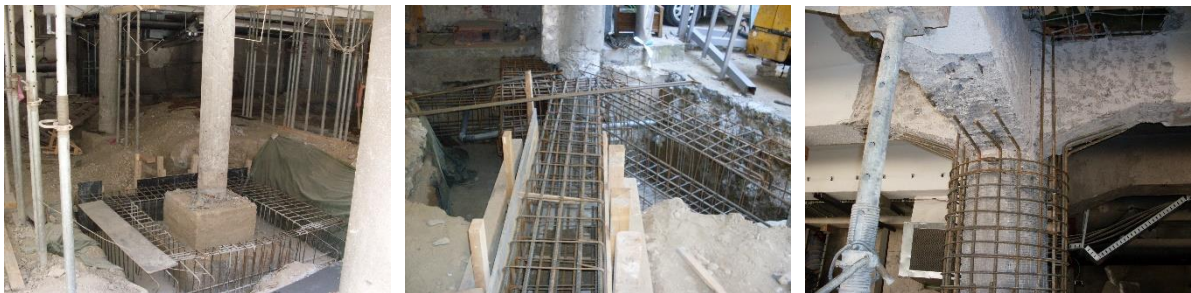
Figure 11. Strengthening of a characteristic column with a plastic hinge, unit L3

The process of strengthening while continuously functioning of the Parliament, was carried out quite successfully despite number of limitations in the period 2010-2014, (Fig. 11, 12).

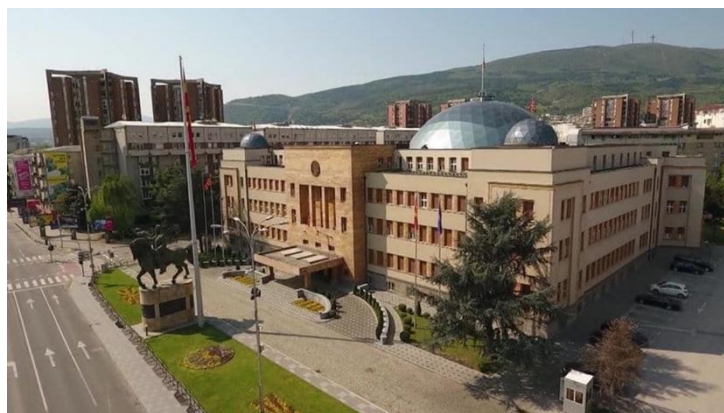
Figure 12. The Parliament building after seismic retrofitting, adaptation and building of another storey
