# EXPERIENCE ON SEISMIC VULNERABILITY ASSESSMENT AND RETROFITTING OF SUPREME COURT BUILDING

Kirti Tiwari <sup>(1)</sup>, NSET, et al. <sup>(2)</sup>

## Abstract

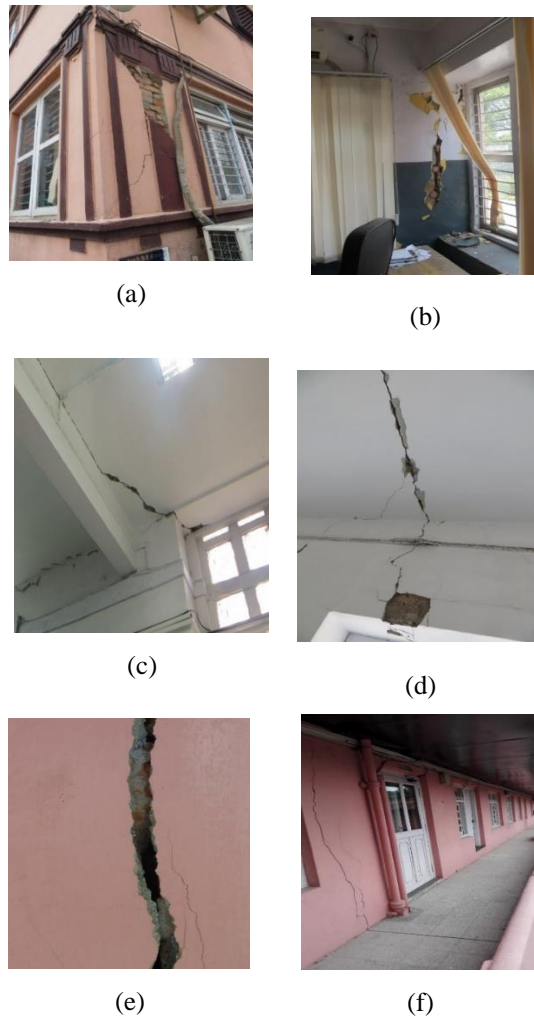
The first site survey was done on 10th June 2015 and there have been frequent visits after that to prepare the as built drawings as well as to identify and locate cracks/damages in the building. It has been identified that the building has visible cracks in the periphery walls. Most of the peripheral walls have gone diagonal cracking due to in plane action of earthquake forces. Some of the walls have deep vertical and horizontal cracks as well. There are no visible problems of settlement, tilting and cracking in the foundation. There is also a markedly visible deep crack almost along the middle length to the full height of the building. This crack extends from one face to its opposite face (front face to back face). No falling hazard was seen in the site.

Internal walls have also suffered minor to moderate cracks at different locations. At few locations, there is very deep cracks in the slab which needs serious attention. Slab at these portions have gone cracking wider than 10 mm and reinforcements have buckled. The damage picture due to Gorkha Earthquake are shown below in Fig. 2.

Figure 2. a) Heavy vertical crack in the pier; b) Vertical crack in the pier; c) Deep crack in the first floor slab;d) Crack in the slab; e) Crack width of about 20 mm in the wall; f)Vertical crack in the Wall

- Some wing walls are added at strategic locations
- Both side wall jacketing and bandage in some inner walls of wall thickness 4" to provide integrity.
- Vulnerable half brick walls built out of main grid system are tied up.

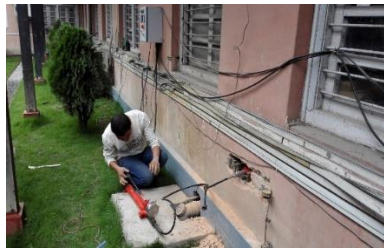
The in-situ shear test is also known as the push test. It provides a direct measurement of the shear resistance of mortar joints in masonry. The test is suitable for masonry that has relatively strong units and weak mortar so that shear cracks form in the typical stair step pattern along mortar joints and the units remain un-cracked. In this type of construction, the shear strength of the mortar joints limits the shear strength of the masonry wall. Five test locations were selected based on internal and external locations. The test was carried out at 3 locations on the ground floor and 2 locations at first floor which is shown in Fig.3a).

Figure 3 a) Conducting In-situ Shear Test on Wall

The test locations were prepared by removing the brick, including the mortar on one side of the brick to be tested. The head joint on the opposite side of the brick to be tested was also removed. This was done with caution that the mortar joint above or below the brick to be tested is not damaged. The hydraulic ram was inserted in the space where the brick was removed. A steel loading block was placed between the ram and the brick to be tested so that the ram will distribute its load over the end face of the brick. The dial gauge was inserted in the space. The brick was then loaded with the ram until the first indication of cracking or movement of the brick. The ram force and associated deflection on the dial gage were recorded. From the observation, final corrected shear strength of brick masonry is obtained as per ASTM standard and IITK- GSDMA Guideline and the corrected minimum shear strength obtained are 0.054 N/mm<sup>2</sup> and 0.036 N/mm<sup>2</sup> respectively. The difference in these values from two standards, ASTM[8] and IITK-GSDMA Guideline-EQ06[2], is due to the coefficient of friction between the brick and mortar is assumed as per the site conditions. Being on the conservative side, the value obtained from the GSDMA-EQ6 is used for checking the shear strength capacity.

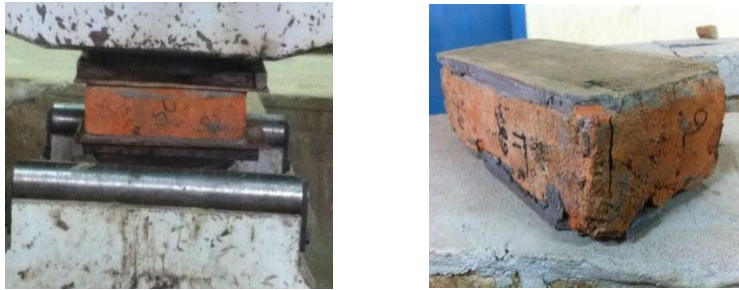
Four brick samples were taken from the building wall and compressive strength and water absorption tests were carried out at Central Material Testing Laboratory (Pulchowk Campus), Institute of Engineering which is shown in Fig.3b). The average breaking strength of the three brick samples tested is was 42.51 kg/cm<sup>2</sup> (4.17 Mpa) which indicates low strength brick. Water absorption of the three samples are 28.22%, 26.34% and 24.6%. As per the Nepal National Building Code (NBC 109), a first-class hand-made brick shall not absorb more water than 25% of its weight. The brick falls to lower category of second class [9].

Figure 3 b) Compressive Strength Test of Brick Unit performed at CMTL

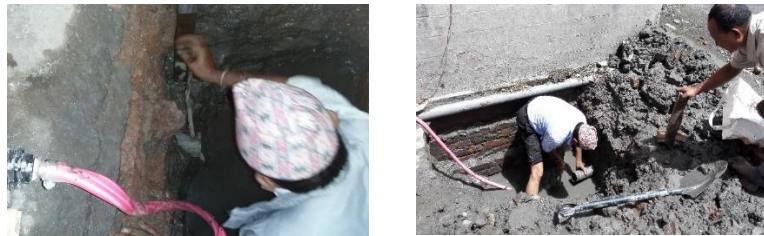
Soil samples were taken from two locations, ground excavated for foundation exploration (at the premise of Supreme Court building) to determine the shear strength of soil which is shown in Fig.3c). The cohesion ( $c$ ) and angle of friction ( $\phi$ ) of the soil below 1m from the existing ground level is found in the range of 0.1 to 0.13 kg/cm<sup>2</sup> and 24.130 to 27.140.

Figure 3 c) Soil Sampling for direct shear test of soil

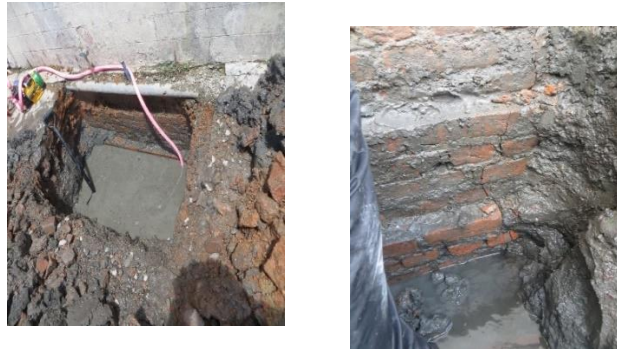
To explore the foundation details of the building, excavation was carried out at three different locations; one at the North West wing (front face) of the building, another at the North-East (back face) and the other at the East (back face) of the building. The details of the foundations is shown in Figure 3 d) and e). The building has strip footings made of brick masonry. The depth of the foundation is same at all locations. Total, depth of strip footing is 4 feet and the width is around 40 inches. There is no plinth band in the walls.

Figure 3 e) Foundation Investigation

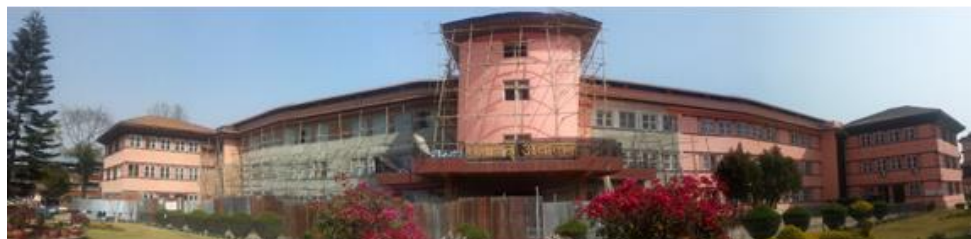
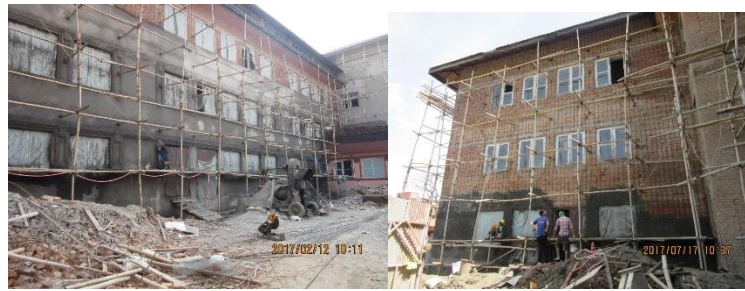
Implementation of this building was carried out which above given options. Removal of plaster in required locations, dismantling of brick work, bar mesh splint and bandage on inner and bar mesh jacketing on outer walls, micro concreting, curing, plastering were done. Few photographs of accomplished retrofit work are presented in the Fig.6 below.

Figure 6 Implementation of Retrofit Option

- Steel Jacketing with 4.75 mm  $\varnothing$  bar @ 250 mm c/c in horizontal direction.
- Steel Jacketing with 8 mm  $\varnothing$  bar @ 250 mm c/c in vertical direction
- Steel Jacketing with 8 mm  $\varnothing$  bar @ 200 mm c/c in vertical direction

Addition of tie beam 300 mm x 450 mm along all main walls to connect with the bars of jacketing.

Addition of a tying beam 300 mm x 450 mm inserted to a length of 300 mm at an interval of 1.5 m all around the peripheral tie beams.
