LESSONS OF THE LUGOVSKY EARTHQUAKE IN THE REPUBLIC OF KAZAKHSTAN

Abstract

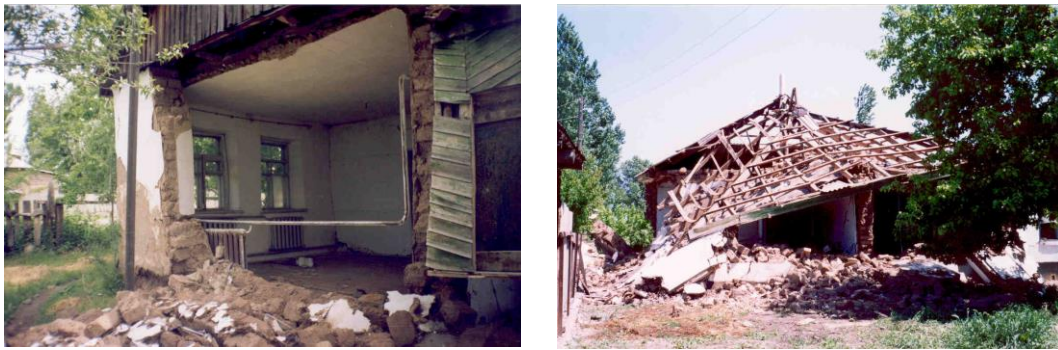
With an earthquake intensity of 5-6 points, there was serious damage. Almost all houses with adobe masonry walls were damaged at least 2 degrees during the earthquake. Approximately 50% of these houses were damaged from 2 to 3 degrees, and some - 4 and 5 degrees (complete collapse). Damage to adobe houses (see Fig. 4).

Fig. 4. Destruction of adobe houses as a result of the earthquake on May 23, 2003

Such serious damage to residential buildings with an earthquake intensity of 5-7 points is explained by the low strength of adobe blocks used in construction. The average compressive strength of adobe samples was 3 kg/cm².

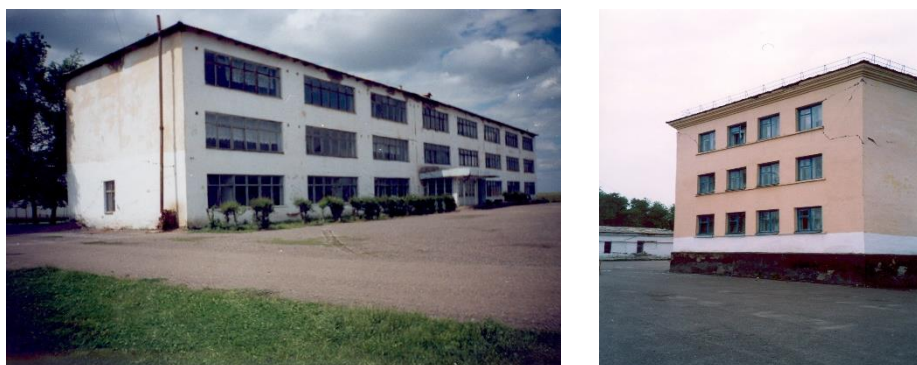
Five schools are made with load-bearing brick walls of complex construction (see Fig.7).

Fig. 7. General view of schools with load-bearing brick walls of complex construction

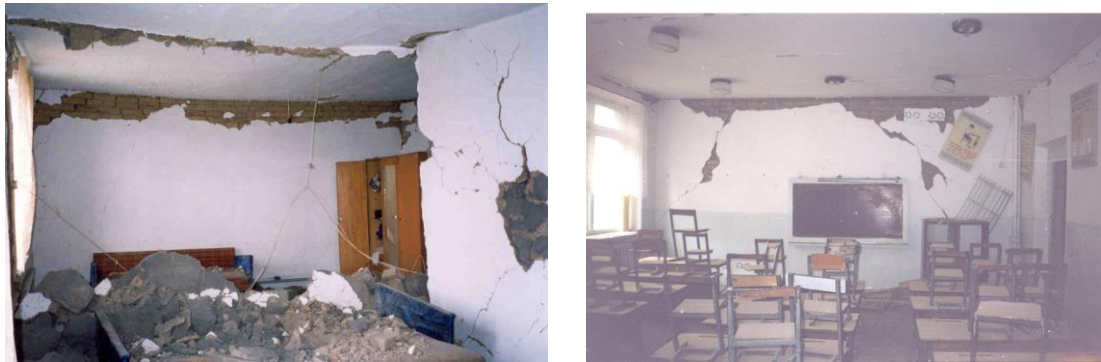
During the examination by the KazNISSA Institute, the strength of the masonry adhesion was checked in all schools with load-bearing walls made of brickwork. In all academic buildings of schools, the values of the temporary resistance of brickwork R_r varies from 0.3 to 0.7 kg / cm², which is significantly lower than those established in the norms (at least 1.2 cm²).

Within two weeks after the earthquake, the KazNISSA Institute conducted a detailed survey and developed project documentation to strengthen 15 school buildings. The survey showed that buildings with load-bearing brick walls received severe damage during an earthquake with an intensity of 7 points (see Figure 8). Buildings damaged from 3 to 4 degrees are recommended for demolition. Buildings that have received damage from 2 to 3 degrees are recommended for strengthening.

Fig. 8. Damage to schools with load-bearing brick walls.

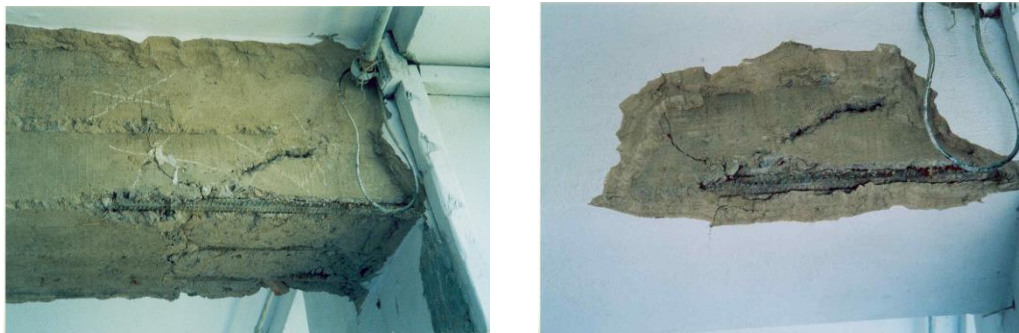
The school building in the village of Zhaksylyk with monolithic reinforced concrete frames with external brick walls. The structures of the monolithic reinforced concrete frame were severely damaged at an earthquake intensity of 6 points due to the extremely poor quality of construction (see Fig. 9).

Fig. 9. Damage to the reinforced concrete crossbar in the School building

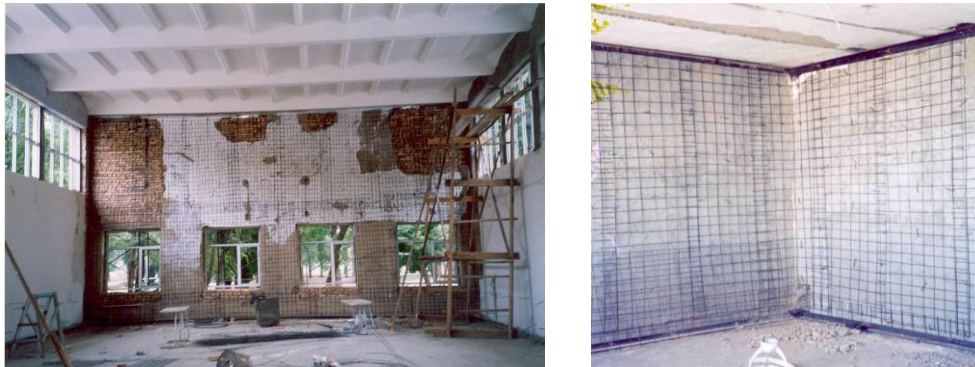
The periods of natural oscillations of buildings with brick walls before amplification were equal, about 0.45 seconds, after amplification decreased, to 0.24 seconds. Accordingly, the rigidity of buildings after reinforcement increased 3 times.

Fig. 10. Reinforcement of brick walls with reinforcement grids

- transfer load-bearing walls from non-reinforced brickwork to the category of complex structures. To do this, double-sided reinforcement of all walls with reinforcing grids should be carried out in a layer of high-strength plaster made of cement-sand mortar [5].

- to reduce the distances between the transverse walls in the compartments of the building, it is necessary to introduce additional (replacing transverse walls) into the existing structural scheme steel reinforcement frames associated with ceilings and wall structures (see Fig.10).

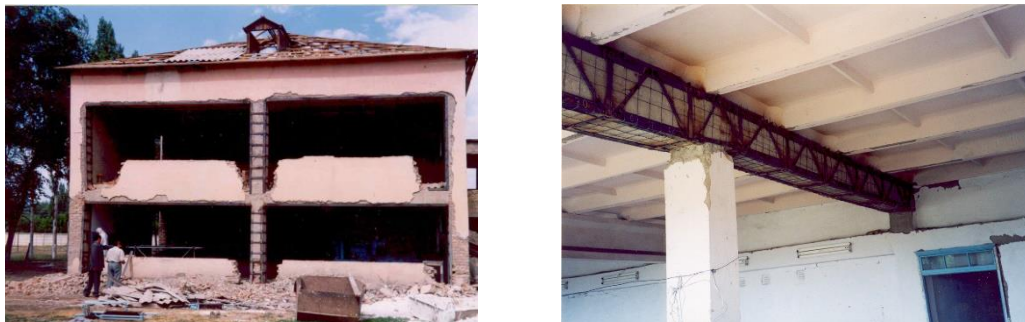
Fig. 11. Reinforcement of columns and beams with steel clips

Dynamic tests showed that the periods of natural oscillations of frame buildings before amplification were about 0.34 seconds, and after amplification about 0.2 seconds. The rigidity of the building after reinforcement increased by an average of 3 times compared to the rigidity before reinforcement [5].

Brick walls and partitions received serious damage, which absorbed the bulk of the seismic load, which saved the building from collapse. It is recommended to strengthen the buildings: a) strengthen the columns of the transverse frames of the frame with clips made of steel corners; b) strengthen the crossbars of the frames by increasing the compressed zones of the crossbar, with the device in the upper zone of additional reinforcing rods and grids (see Fig. 11).
