ARCHITECTURAL DESIGN AND EARTHQUAKE CONSEQUENCES IN BUILDINGS

Abstract

This paper focuses on earthquake consequences in buildings, analyzed in terms of architectural design choices. The Durrës earthquake of 11.26.2019 showed lot of damages of non-structural nature, in buildings of various ages, structural systems, and volumetric shapes.

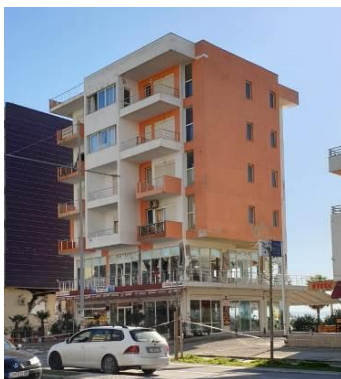
The building in Figure 3, with 6 floors and a reinforced concrete supporting structure, built during 2008-2010, is one of many buildings with the same irregularities in their configuration. The building's volatility has been high, among other issues, due to the following factors: low stiffness on the first two floors; low stiffness in twisting and irregular distribution of structural elements in the added mass of upper floors and non-uniform distribution of non-structural elements, with added mass on upper floors.

Figure 3. Non-uniform distribution of non-structural components

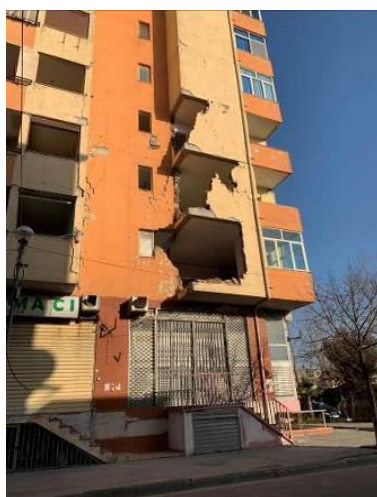
Due to the simultaneous oscillation in the vertical and horizontal direction, the cantilever volumes are in a delicate situation of balance. In the cases shown in Fig. 6 and Fig. 7, this state of the cantilever volumes is also accompanied by the lack of implementation of technical details to properly connect the walls at the ends of the cantilevers. As a result, the walls of the facade on several floors of the cantilevered volume have collapsed, exactly at the outer corners of the cantilevers.

The main cause of this damage model is the deviation from the anti-seismic design conditions, due to the irregular volume configuration with the cantilevers and the added weight of the walls in them, because the architect has chosen to treat the cantilever as a volume attached to the rest of the facade.

Figure 6. Walls collapse in the cantilever volumes

Due to their behavior during seismic events, cantilever volumes on facades are recommended to be avoided. If cantilever volumes are a must, technical measures with special construction details must be taken to avoid damage to this model in buildings. These types of damages are the result of simultaneous combinations of some of the 4 groups of causes as outlined in the introduction of this article.

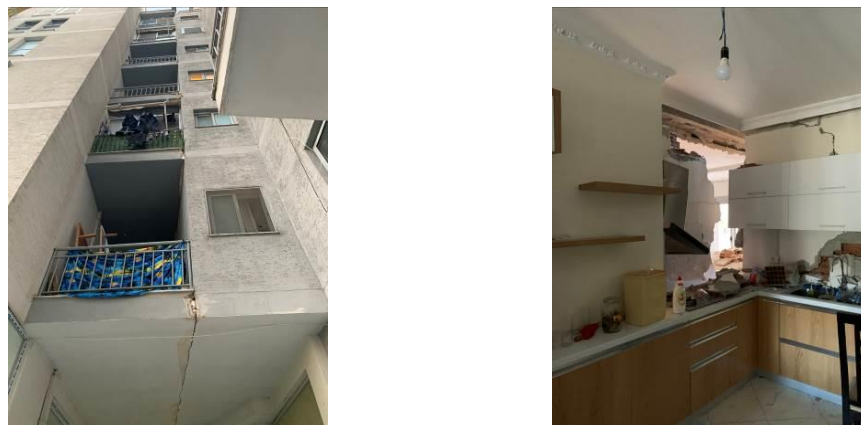
Generally, buildings that are separated by an anti-seismic joint have suffered damage in the joint area, generally due to the collision of the buildings during the seismic action. In all these cases, it is understood that their cause is the incorrect dimensioning of the joint. The case of Fig. 8, shows the breaking of the wall up to its separation (also due to the inertial forces caused by the collision of the supporting structures of the buildings). Another consequence of this cause is the damage to the neighboring buildings on the upper floors due to the collision with the greater displacement of the top floors and their uneven swaying.

Figure 8. Damage caused during the collision in the joint position

Also, both documents, [3] and [4], respectively in chapters 1 and 4, recommend the use of anti-seismic joints in cases where the building and structure deviate from the regular configuration on the plan. Anti-seismic joints should turn the building into two or more dynamically independent units, although the parts may function as a single building. The size of the joint must be designed to ensure that its parts do not collide during seismic shaking. During the design process, it is the structural engineer who decides on the position and dimension of the anti-seismic joint. In cases where parts of the building serve as a single functional unit, it is important that the architect respects the position of the seismic joint and its geometry, possibly by revising the project.

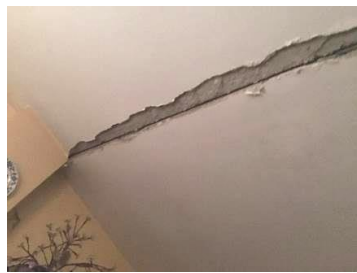
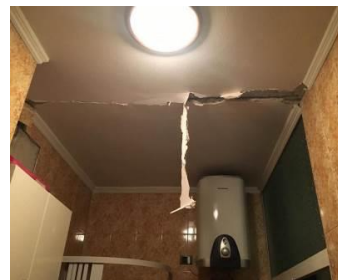
A visit to the damaged buildings was necessary after the earthquake of November 26, 2019, in order to point out the phenomenon of organizing the same functional space of the apartment over the anti-seismic joint. The photos in Fig. 9, were made in the same apartment in a multi-storey residential building built before 2000 in the center of the Albanian capital. Proving whether this choice was design avoidance during implementation was not possible, but the fact shows that the housing unit falls on the seismic joint. This either shows unfair solutions of the architect, for the above mentioned, or shows a complete lack of cooperation and coordination of the design work between the architect and the structural engineer. This must be a widespread phenomenon because the same situation of the extension of the same residential apartment over the seismic joint of 2 neighboring buildings was also found in a building in the city of Durrës. Fig. 10.

a) interior of a room

b) Interior of a sanitary unit

Figure 9. Interior view from an apartment in Tirana. Source: Marin Zaimi

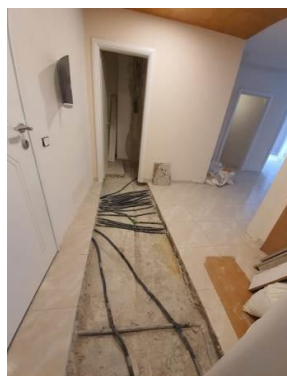
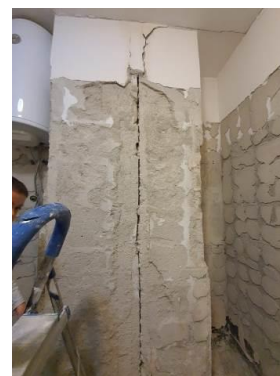
a) interior of the corridor

b) Interior of the sanitary unit

Figure 10. Interior view from an apartment in Durrës city. Source: Entela Kapllani

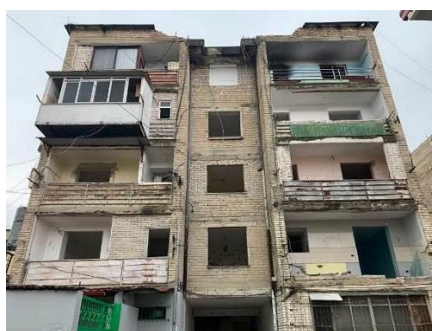
During the earthquake of November 26, 2019, there were cases of terrace parapets falling for various reasons. In Fig. 11, the case of a building whose parapet collapsed due to non-implementation of the technical detail of the brick parapet reinforcement and the thickness of the terrace layers. During the seismic event, a 20 years old girl lost her life, struck in the head by a piece of parapet going out of the building, although the building itself did not sustain significant damage.

Figure 11. Collapsed brick parapet. 1970s construction building

Gable walls and the parapets of balconies and terraces, which tend to overturn in an earthquake, should not be built out of masonry construction. They are to be made of reinforced concrete in order not to be separated from the structure. The damage of gable wall may be prevented by placing it between the frames. [13] A solution to the reinforcement of the brick parapet is given in Fig. 12.

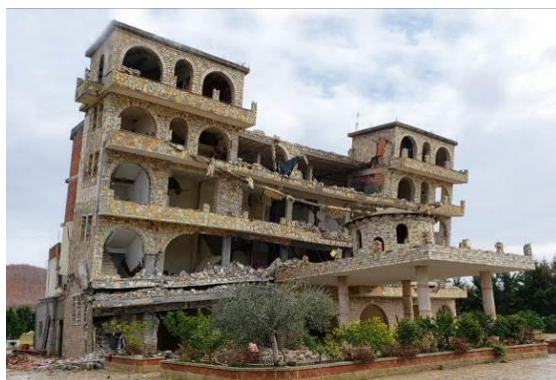
The pictures below show 2 different buildings with concrete construction to which coatings of different materials have been applied but with the same technique. In the building in Fig. 13, natural stone slabs were applied with glue adhesion on one of the facades, during the implementation and outside the forecast of the project, while in the building in Fig. 14, ceramic tiles are applied by gluing.

In the first case, not only the detachment of the stone slabs from the facade occurred, but also the structural damage of the columns in the facade covered with stones, because during the seismic event they could not withstand the increased stress as a result of the unforeseen weight of the natural stones on the facade. The destruction of the building was identified as a consequence of the deviation from the design during implementation and the loading of the structure with a weight outside of the design. In other cases of cladding facades with natural stone tiles with mortar adhesion, their detachment from the facade has also occurred.

Figure 13. Cladding with natural stone

Hence, chemical connections, such as mortar, are inconvenient, which are also prohibited in western countries prone to earthquakes. Instead of chemical connections, mechanical connections such as cramp anchorage with proper details and intervals are appropriate to be used. [9]

According to KTP-N.2-1989, Chapter 3, Point 3.4.2, the plates used for covering external walls with a surface area greater than 0.1 m^2 ... are anchored to the walls with the help of metal ties.

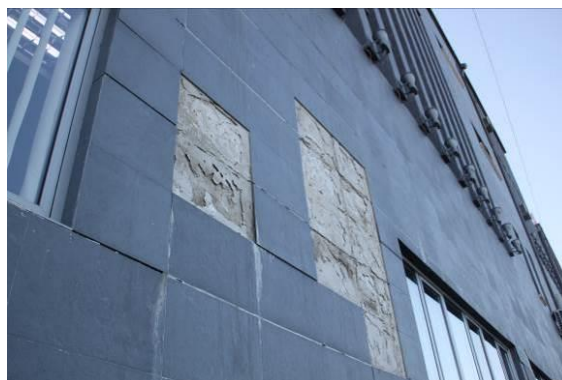
In the second case, the ceramic tiles were detached from the facade due to their gluing assembly with mortar on the exterior facade. However, the adherence, breaking and tensile strength of the mortar are restrictive. The consecutive drift movement due to earthquake forces between stories makes the mortar exceed its strength and makes the finishes separate from the walls due to properties of mortar in between. [13]

Figure 14. Cladding with ceramic tiles

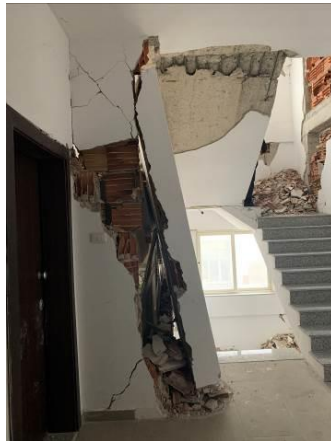
Stairs and corridors provide exits from the building. In many cases of high-rise buildings in the Durrës area, the damage to the stairs itself, accompanied by the fall of parts from the damaged surrounding walls of the stairwells, which have occupied the bases and landings of the stairs, making it even more

Figure 15. Damaged stair ramps

One of the solutions is to design fixed bearing from one corner of the staircase to the frame and unrestrained bearings from the other corners. Another solution is to separate the staircase as a separate building block with seismic joints. Hence, the staircases and the corridors of them should be surrounded by shear walls in order to form cores. [9]

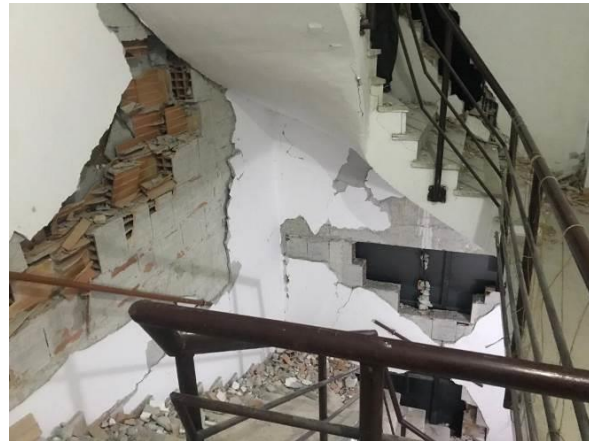
difficult to move residents during and after the seismic event. As the panic grew during the descent to quickly leave the building, many people fell and suffered physical injuries. Fig. 15, shows cases of inerts falling down stairs.

Figure 16. Inerts fallen down stairs.

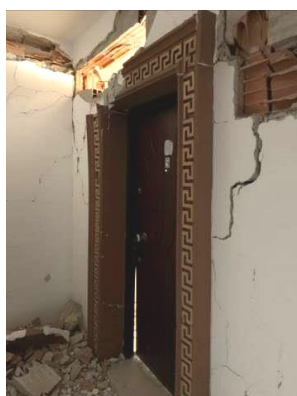
Also, due to the deformation of the walls, the door frames have suffered deformations, especially those of the outer doors of the apartments, which have blocked the opening. As a result, residents experience increased panic due to the inability to immediately leave the building during and after the seismic event and also to enter the apartment after the seismic event in the case that they went to the apartment after the earthquake. In Fig. 17, shows door with damaged lock to enable opening.

Figure 17. Exterior door with damaged lock

When the walls surrounding the doors and windows are subject to their deformation or blocking, then the solution is: appropriate framing of the cracks in the walls with reinforced concrete and the plastering of the walls is accompanied by galvanized steel mesh, as shown in Fig. 18, and Fig. 19.

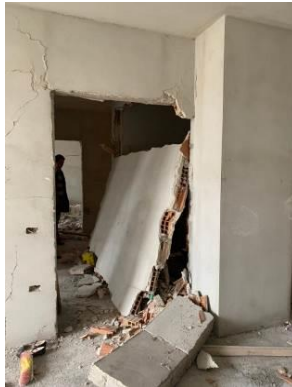
In Albania, in most buildings, the dividing walls are made of brick masonry. In many residential buildings, complete parts of the walls were detached from their initial position, similar to the case

Figure 20. Collapse of the partition wall

given in Fig. 20. Usually, rigid partitions need to be anchored top and bottom to provide lateral support or stability, against toppling. To avoid stiffening the structure, upper anchors must accommodate both in-plane and vertical movement. [16]

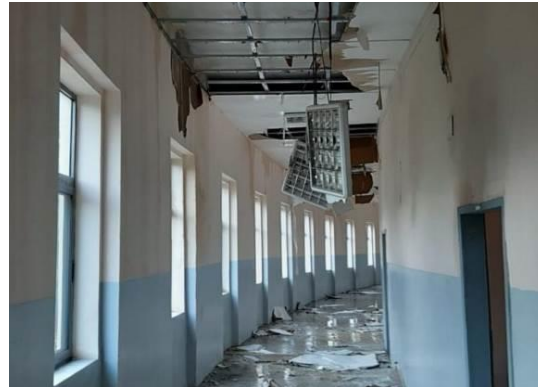
Figure 21. Collapse of suspended ceiling and light fixtures during the earthquake of September 21th, 2019. Faculty of Geology and Mining. PUT. Tirana. Source: <http://redaktori.net/?p=17147>

Since suspended ceiling often falls during earthquake, Figure 21, connections with the suspended members must be properly designed. As the suspended ceiling is subjected to horizontal movement due to seismic forces, a gap should be made at the perimeter of it in order to prevent the ceiling pounding to the walls. The suspension system for the ceiling should also minimize vertical motion in relation to the structure. [10]
