SEISMIC AND ENERGY UPGRADING OF EXISTING RC BUILDING

This paper presents the preliminary results of the project called Establishment of the national training centre for nearly Zero Energy Buildings (nZEB). The project is funded by EEA Grants (Energy and Climate Change Programme). Seismic condition assessment and upgrading of existing RC structures are presented with a case study building in Zagreb. New technologies were applied and followed by numerical modeling and verifications. A strategy for energy retrofiting will be presented. As the integrated approach should be respected in the renovation of existing buildings, this case study can represent an example of good practice in seismic and energy retrofiting.

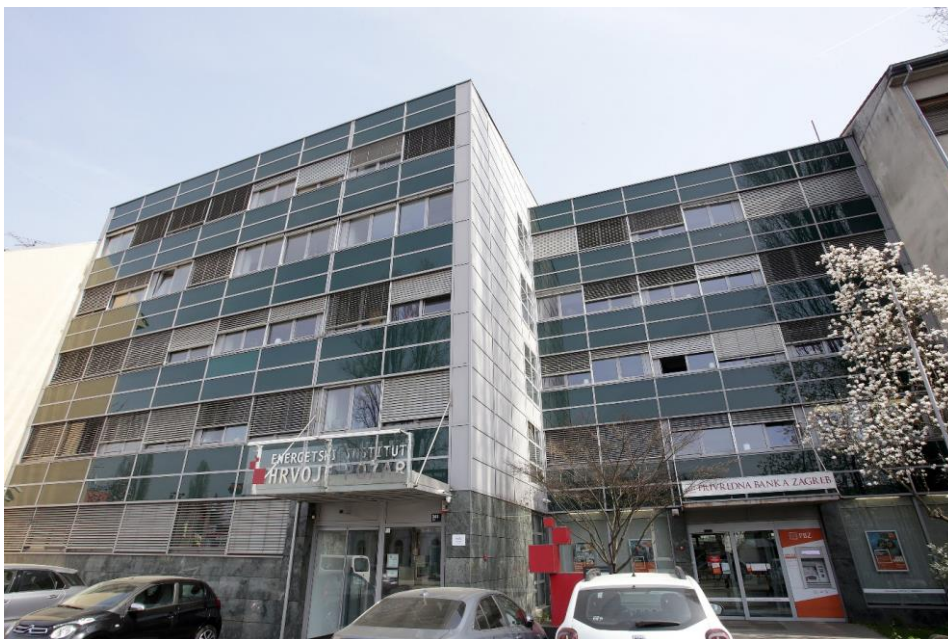
Figure 3. Front view of the case study building

The case study building is divided into three structural sections, labeled as sections A to C. The structural system of sections A and C is a combination of uncoupled shear walls and frames, while section B is comprised only of shear walls. Reinforced concrete walls are 20 cm thick (except in the basement, where the walls are 30 cm thick), and the columns have a cross-section of 30 × 40 cm on which the beams with a height of 40 cm are supported. Floor structures are RC slabs with a thickness of 14 cm. There are six stories, including the basement and attic, with a total height of 18.53 m. The foundations are constructed as pad foundations for the columns and foundation beams for the shear walls. In the following figures, the building is shown (Figure 2), followed by the laser scanning procedure with Leica Bulk 360 (Figure 3) and BIM model (Figure 4).
