SEISMIC RETROFITTING OF POST-WWII MID-RISE UNREINFORCED MASONRY RESIDENTIAL BUILDINGS IN THE BALKANS

Svetlana Brzev ⁽¹⁾, Predrag Blagojević ⁽²⁾, and Radovan Cvetković ⁽³⁾

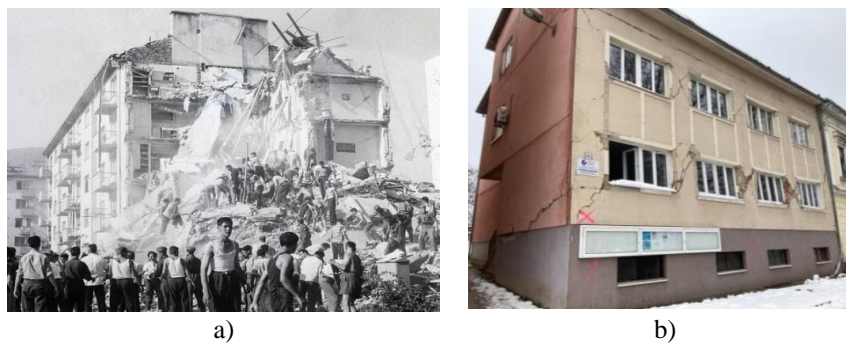
Figure 2. Performance of URM multi-family residential buildings in past earthquakes in the region: a) a collapsed building due to the 1963 Skopje earthquake (credit: Z. Milutinović) and b) a damaged building due to the 2020 Petrinja earthquake (credit: SUZI-SAE).

Buildings of this typology were exposed to several damaging earthquakes in the region, including the 1963 Skopje, North Macedonia earthquake (M 6.0) (Fig. 2a), the 2010 Kraljevo, Serbia earthquake (Mw 5.5), and the 2020 Petrinja, Croatia earthquake (M 6.4) (Fig. 2b) [4, 5]. The buildings of this type which performed poorly in the 1963 Skopje earthquake were designed according to standardized designs, with load-bearing walls provided only in one horizontal direction (longitudinal or transverse) [6].

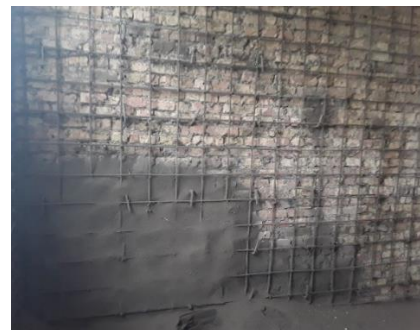
RC jacketing technique (Fig. 4) consists of constructing one- or two-sided RC jackets attached to exterior and/or interior wall surfaces [22, 27]. A jacket consists of a 3 to 8 cm thick concrete overlay with reinforcement in the form of steel mesh (usually small-sized bars, 4 to 10 mm diameter). RC jackets are usually attached to an existing masonry wall via steel anchors inserted in pre-drilled holes, which are subsequently filled with cement- or epoxy-based grout. The required size and spacing of anchors depends on seismic demand (shear force) that needs to be transferred from the jackets to the original masonry wall. Either cast-in-place concrete or sprayed concrete (shotcrete) can be used for construction of RC jackets.

Figure 4. RC jacketing: a) vertical section of a retrofitted wall in Kraljevo, Serbia and b) shotcrete application in a retrofitted school building in Kyrgyzstan [22].

Floors and roof were constructed using semi-prefabricated composite masonry and concrete system (see Fig. 4a), and were considered to act as rigid diaphragms. RC tie-beams were provided at each floor level. Since the building was constructed around 1950, seismic actions were likely not considered in the original design. The building was damaged in the 2010 earthquake. Structural damage in lower portion of the building was mostly in the form of inclined cracks due to in-plane seismic effects. Refer to [2] for more details related to seismic performance of the building in the 2010 Kraljevo earthquake and a detailed seismic evaluation of the damaged structure according to the PTN-S code and Eurocode 8.
