IMPROVEMENT OF BUILDING'S WALLS BEARING CAPACITY AFTER AN EARTHQUAKE

Alush Shala ⁽¹⁾, Jelena Bleiziffer ⁽²⁾

The example that is used for discussion is a building that has suffered significant damage from the 2019 earthquake in Albania. The paper will present the calculation of the performance and load-carrying capacity of this building with the load-bearing walls made of clay and silicate bricks after an earthquake of magnitude $M=6.2$ Richter. The building comprises load-bearing walls and was built in the 1960s-70s. The materials characteristics used in calculations are derived from laboratory tests and on-site non-destructive testing. The results obtained from the calculation of the building before and after the earthquake and after the reinforcing of the building will be compared. The strengthening of walls is made using cement-based materials. The calculations are performed using SAP2000 and ETABS software and include static and dynamic performance.

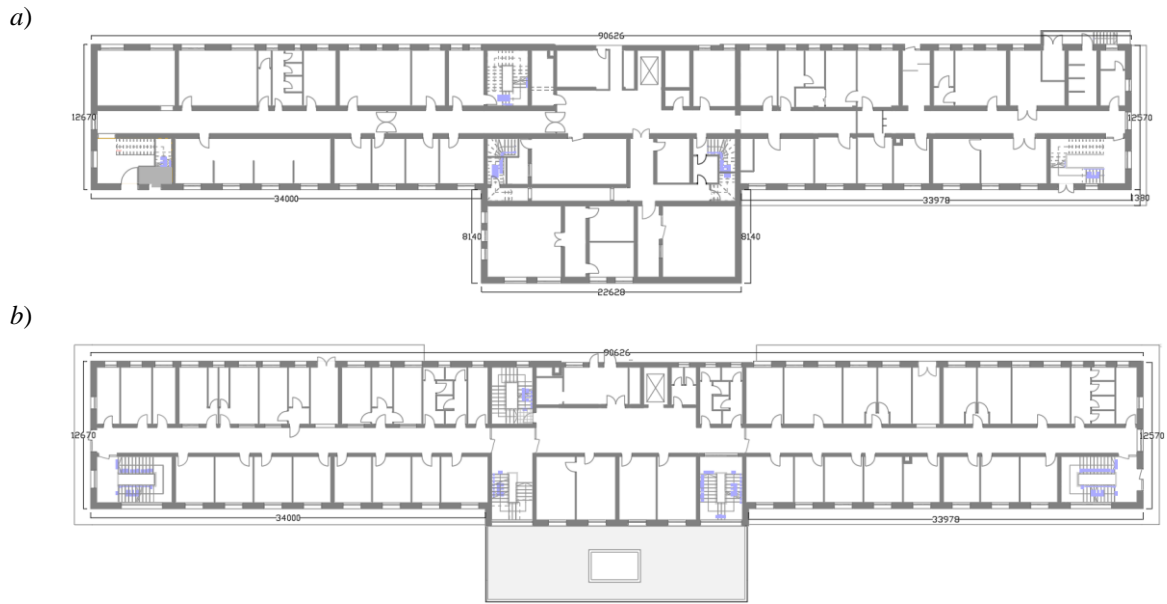
Figure 1. Design of the old building: a) Basement story, ground story; b) First story, second story.

The plan view of the old existing building is shown in Fig. 1, while Figs. 2 and 3 show some photos of damage after the earthquake, prior to and after the mortar layer was removed. Before removing the mortar, vertical cracks, tending diagonally, can be seen, and they were temporarily closed until the building was completely repaired. After the mortar was removed, diagonal cracks can be seen.

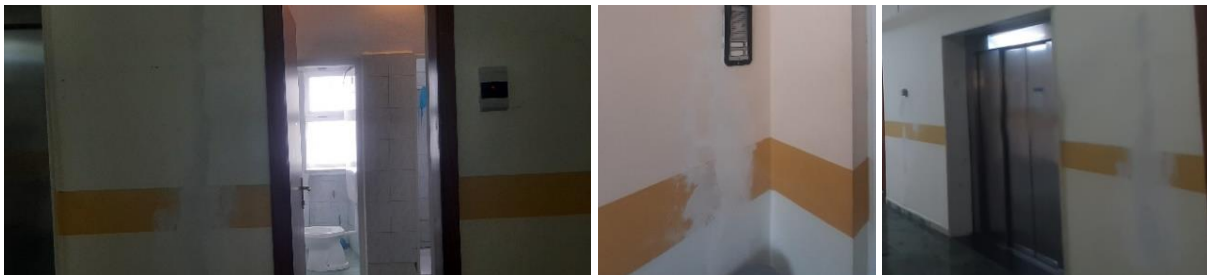
Figure 2. Cracks in the wall from the earthquake in 2019 Tirana, Albania.

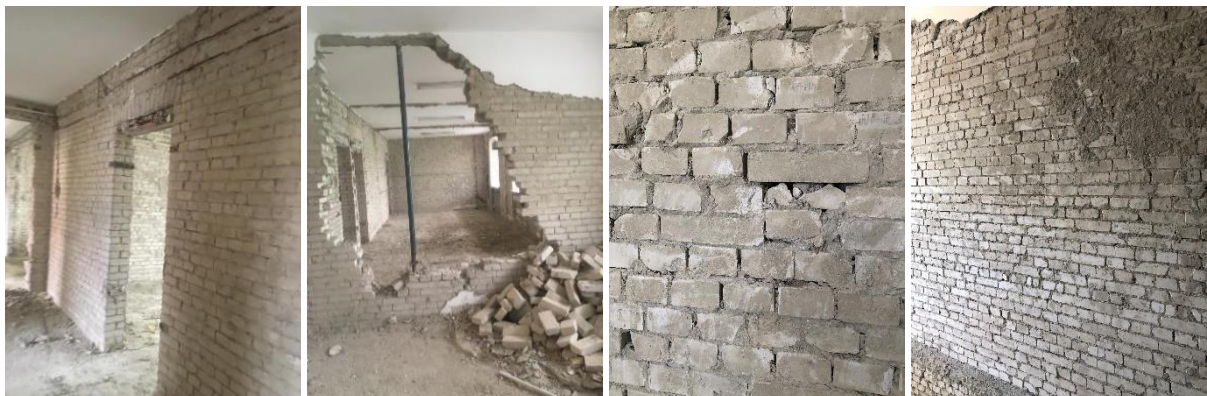
Figure 3. Wall after demolishing mortar.

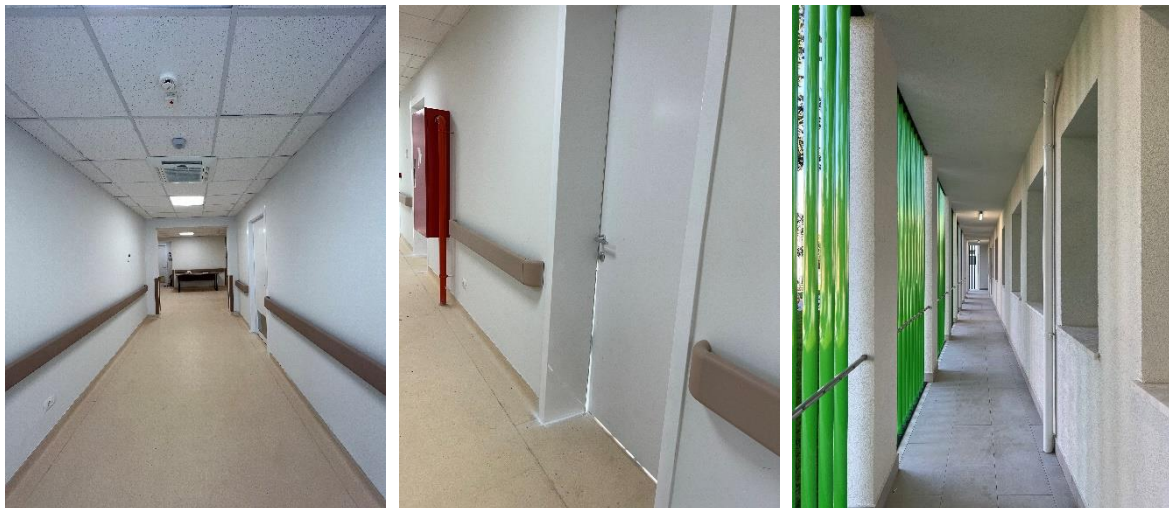
Figure 5. Renovated building.

During the renovation, it was taken as a basis that the materials that will be used in the floor and the tertiary or dividing walls should have a lighter specific weight. Partition walls are taken from Knauf walls, and now we have a floor load reduction of $g=2.80\text{ kN/m}^2$ on floors and of $g=1.50\text{ kN/m}^2$ on the roof. The other walls were not damaged, they were only reinforced with two layers of compressed or cast plaster with a thickness of $t=25\text{ mm}$, class C-25/30. Fig. 4 shows the renovation design plans with the walls' changes. Fig. 5 illustrates the renovation execution of the building which is the subject of the analysis.

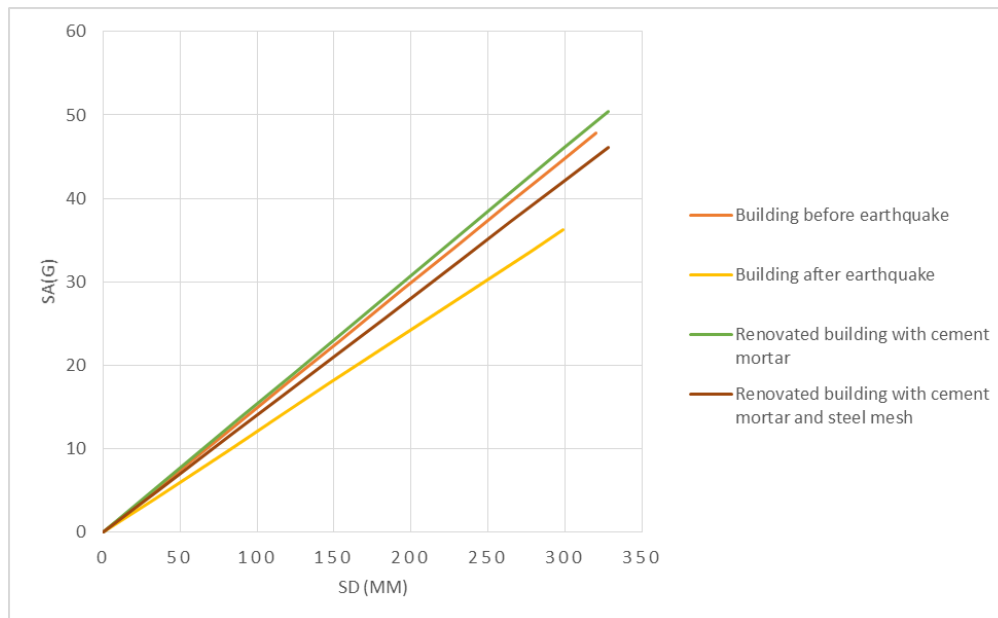
Pushover capacity curves in y direction, from ETABS and according to EC8, are shown in Fig. 8 for four considered cases. Y-direction is presented because stiffness is lower in that direction than in x direction, and most major damage during the earthquake in Tirana, Albania came from the earthquake action in y direction. Comparison of capacity in percentage at the target displacement in y direction is provided in Table 6. Target displacement is read from ETABS 19, and is according to EC8 2004. Shear forces and performance percentages are calculated for the target displacement.

Figure 8. Pushover capacity curve SD-spectral displacement vs SA-spectral acceleration as EC8 2004.
