SEISMIC PERFORMANCE OF MASONRY POINTED VAULTS – CASE STUDY OF ST. ANTHONY CHURCH IN BARBAN, ISTRIA

Paulo Šćulac ⁽¹⁾, Davor Grandić ⁽²⁾, Toni Šaina ⁽³⁾

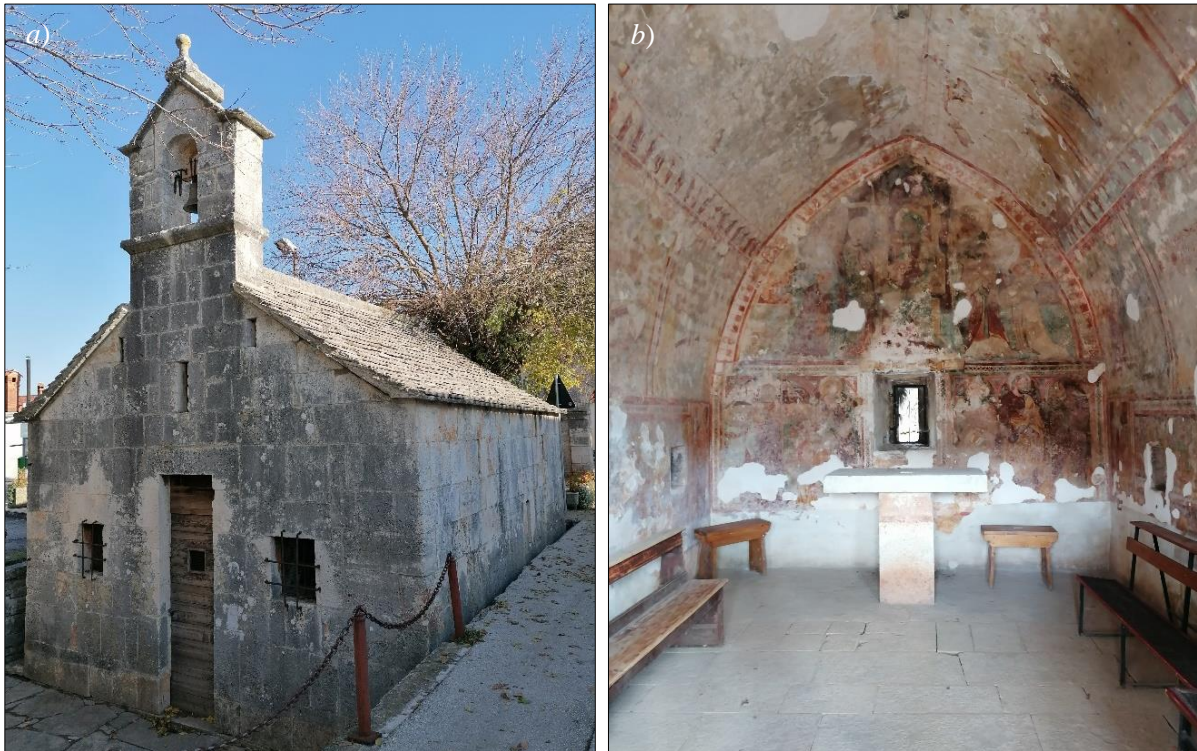
The walls are made of regular square stone blocks in lime mortar with very thin joints (not plastered on the outside). The thickness of the walls is 75-80 cm. On each façade a small narrow window is present; the front western façade also contains two square windows and a bell gable. Roof is covered with slate tiles (Fig. 1).

Figure 1. St. Anthony church in Barban: a) front view; b) Interior view.

The church of St. Anthony in Barban is located in the immediate vicinity of the entrance gate and the walls of the former fortified castle (Fig. 1). It is a small single-nave Gothic building with rectangular ground plan (7,7 x 5,8 m) and a pointed barrel vault (Fig. 2), built at the turn of the 14th to the 15th century. Due to its preserved medieval frescoes the object is inscribed in the Croatian Register of Cultural Properties as a protected cultural heritage.

The area around the church has been raised afterwards by more than one meter thus making a basin around the church (Fig. 1). The walls of the church are separated from the surrounding elevated terrain by a narrow space; only in front of the western (entrance) façade there is a flat stone-paved area, reached by stairs. Due to the raised terrain, during heavy rains rainwater overflows from the nearby road and parking lot, which is retained in the area in front of the church. In this way, the walls of the church are filled with capillary moisture, which damages the structure of the wall, as well as the wall paintings inside the church.

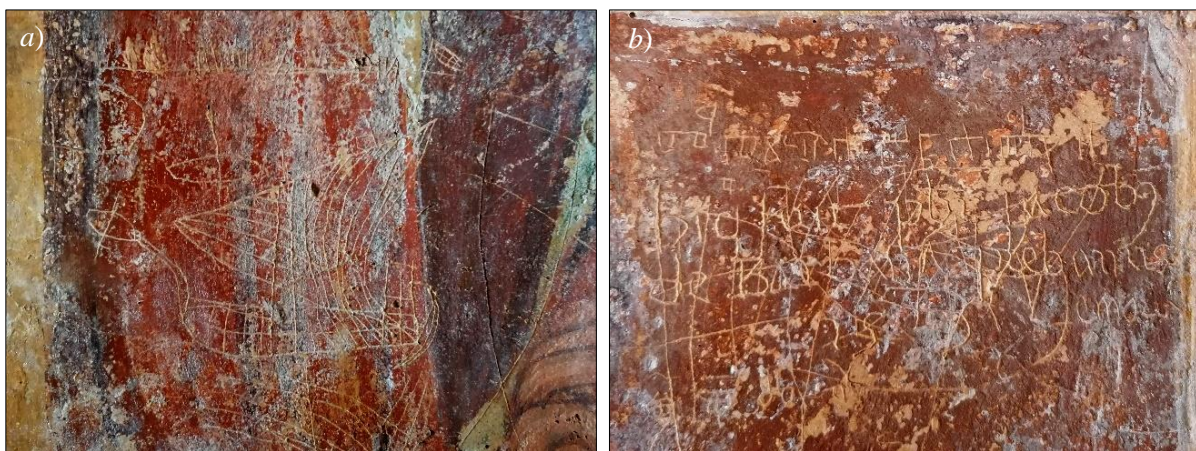
Figure 3. a) Drawing of a ship; b) Glagolitic graffiti.

At the beginning of the 15th century its interior was painted with 15 scenes from the legend of St. Anthony the Abbot, the patron saint of the church, shown in two opposite bands on the north and the south wall. The western and the eastern walls were also painted with depiction of the Virgin Mary with the Child and images of various saints important to the local community. On all surfaces of the preserved wall paintings we can find incised numerous Glagolitic graffiti, depictions of architecture (fortified towns, bell towers and churches), figural drawings, depictions of ships and stylized ornaments (Fig. 3). The time of painting can be determined by the oldest graffiti, dated before 1429 [4].

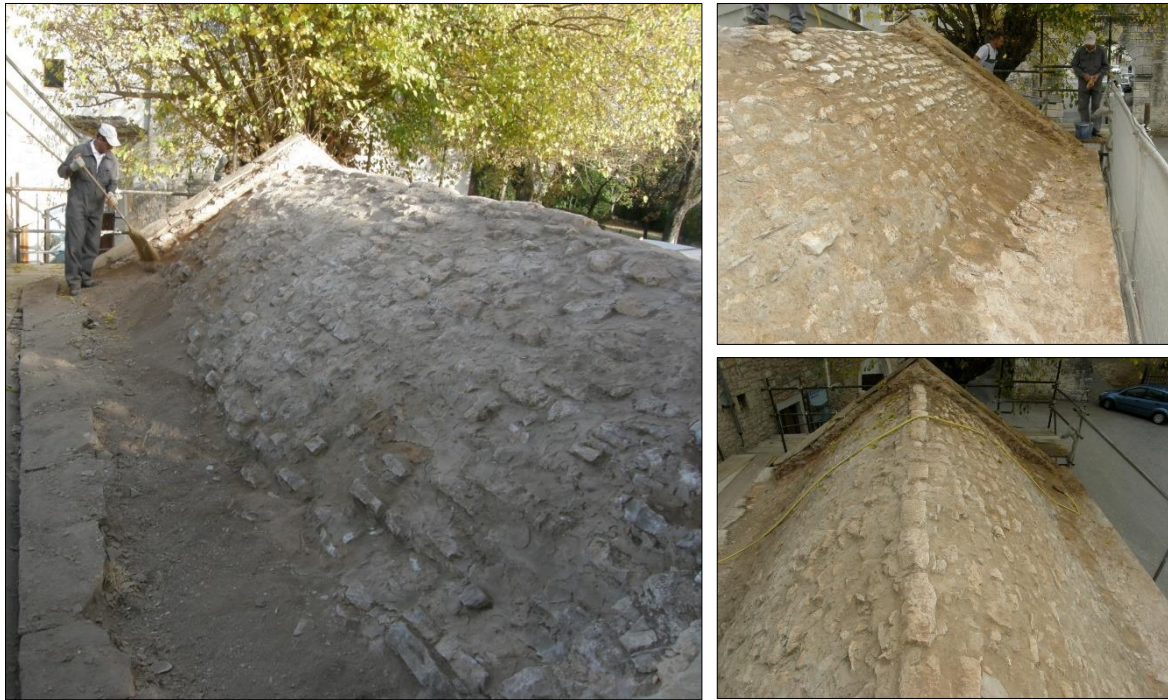
Figure 4. Extrados of the vault during the replacement of the roof tiles in 2008 [6].

The effect of infill at the connection with the walls (see Fig. 4) was not taken into account in the analysis. Since the infill has a favourable effect on the behaviour of the vault [21], the seismic capacity would be even higher.
