EXTENSION OF SYSTEMS FOR SEISMIC SECURING OF HEAVY FAÇADES THROUGH REFURBISHMENT, STRENGTHENING AND RETROFITTING

Abstract

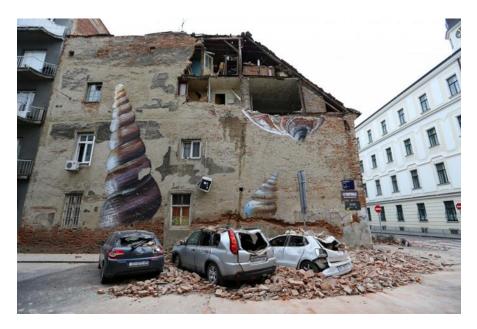
Figure 1. Masonry façade damage - Zagreb 2020 (Photo credit REUTERS/Antonio Bronic).

Hairline cracks and other minor damage can occur to masonry facades as a result of earthquakes. Although the aesthetics of the building will be compromised, such damage does not usually pose an imminent hazard. However, major damage, such as the partial or total collapse of a façade, creates greater risks and hazards for occupants attempting to escape and for emergency services trying to access a building. As well as the imminent danger from falling masonry, important access routes in and around the building may be blocked. Damage to facades and falling stones is evident in post-earthquake photographs from Christchurch (2011) and Zagreb (2020), see Figure 1.

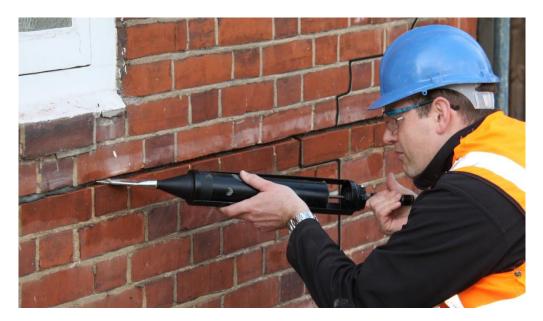
Figure 3. Thixotropic cementitious grout applied to a horizontal slot in preparation for insertion of helical bar.

One method of repairing cracked masonry is to insert long twisted (helical) stainless steel bars into horizontal mortar joints and grout them in place (see Figure 3). The helical bars and thixotropic cementitious grout bond tightly to the existing masonry, redistributing the tensile load down the length of the panel and minimising the occurrence of cracks. With careful consideration of the mortar to be used in the grouting process, façades can be repaired technique in a very aesthetically sympathetic manner.
