SHAKE TABLE TESTING OF U-SHAPED MASONRY STRUCTURES: OUT-OF-PLANE RESPONSE TO VARYING GROUND MOTION SIGNALS

Babar Ilyas ⁽¹⁾, Dario Vecchio ⁽²⁾, Nuno Mendes ⁽³⁾, Paulo B. Lourenco ⁽⁴⁾

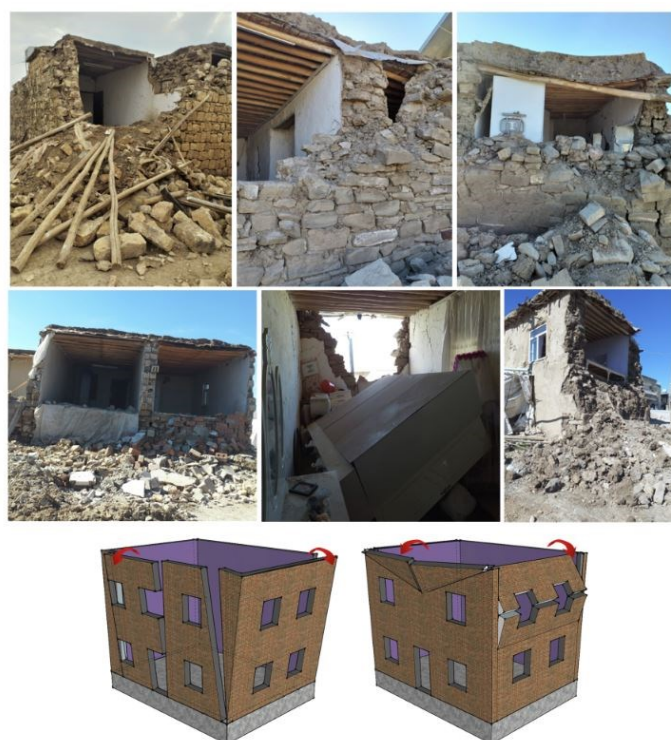
Figure 1. OOP failure mechanisms observed in URM structures [8].

One-way bending mechanisms are due to either poor lateral connection between two elements or the presence of an opening. Upon the existence of such a configuration, a wall/panel may undergo a sustained rocking motion over the base, after the creation of a three-hinge system. Two hinges are formed at the top and the bottom boundary conditions, while the latter forms along the height of the wall/panel [9]. This failure was also observed in isolated walls which have insufficient later support along the vertical edges. As a result, they exhibit significant rotational displacement, which leads to the complete overturning of the wall, especially when the slenderness ratio is high [10]. In contrast, two-way bending mechanisms involve both horizontal and vertical bending, creating more complex displacement patterns and rotational behavior. The two-way mechanism has been observed in wider facades, supported by structural elements or boundary conditions that prevent free OOP displacements, but allow rotations on both vertical and horizontal edges [7].

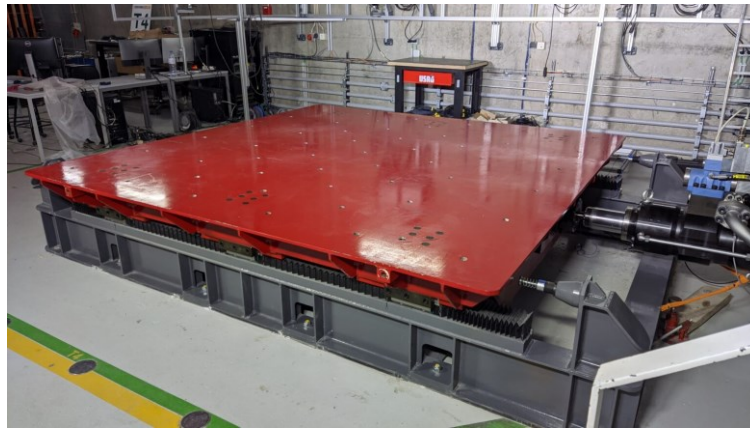
Figure 4: The 1DOF shaking table installed at the University of Minho (PT).

The shake table facility available at the Structural Laboratory at the University of Minho, (PT) was used for this extensive experimental campaign. The shake table has a platform of 2.9 m x 2.9 m, with one degree of freedom (DOF), i.e., unidirectional. The shake table is operated by a hydrodynamic actuator, working up to a pressure of 300 kN, thus allowing the construction of specimens up to 3 tons. Note that the shake table weighs 3 tons. The shake table can work within a frequency range of 0-50 Hz, which covers the typical relevant frequency range for civil engineering structures. The main features of the shake table are given in **Table 1**. The shake table is equipped with a control station comprising two chassis. The primary chassis manages system operations, including the actuator's hydraulic system, while the secondary chassis offers expansion capabilities for additional instrumentation as needed. The surface of the shake table is provided with a grid of M27 holes, enabling bolted connections to anchor specimens directly to the platform, which is critical for simulating realistic seismic conditions without slippage or unintended movement. **Figure 4** shows a view of both the shake table and actuator.

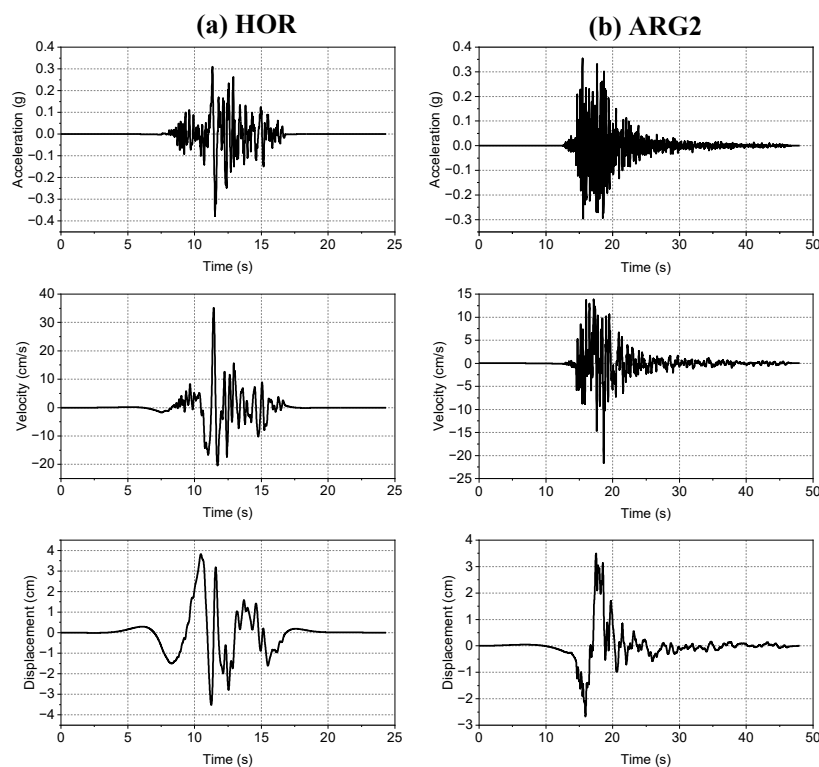
Figure 6: Time histories of the signals: (a) HOR, (b) ARG2.

Using this classification, two signals were selected to provide the targeted OOP responses: one moderately impulsive signal and one less impulsive or vibratory signal. The first signal, recorded during the Azores Earthquake in 1998 (HOR), exhibited characteristics of a moderately impulsive event, making it suitable for testing immediate and forceful OOP responses. The second signal, from the 2014 Western Greece (ARG2) earthquake, represented a non-impulsive event. **Figure 6** shows the acceleration, the velocity, and the displacement time histories for each signal. By combining the results of the NLTHAs and regression-based impulsivity classification, this selection of two contrasting signals, one moderately impulsive and one non-impulsive, which supports the assessment of URM structures under variable seismic conditions.
