# INTEGRATED NON-DESTRUCTIVE APPROACH FOR THE DIAGNOSIS OF HISTORIC MONUMENTS

This paper presents the non-invasive methodology carried out to one Byzantine monument – the church of St. Nikita near Skopje, North Macedonia, using the available Non-Destructive Techniques (NDTs): visual inspections, microscopy, infrared thermography, 3D laser scanning and ambient vibration tests. The use of the above mentioned NDTs enabled to evaluate the current condition of the monument in a relatively short time without affecting its authenticity, which is especially significant for this type of buildings. Additionally, the use of the 3D laser scanner generated digital documentation of the monument, accessible at any time.

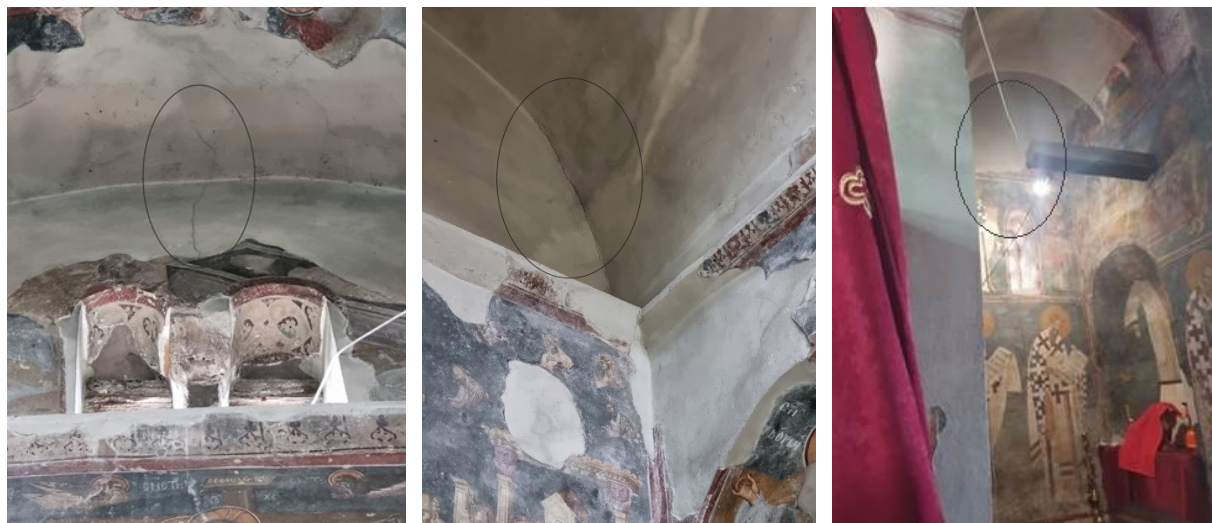
The interior of the church is completely plastered and covered with frescoes, preserved on a larger scale; therefore the condition of the structure materials cannot be investigated. Fine cracks were observed in several spots of the upper zones in the walls and vaults. It was also noticed that one of the wooden ties was disrupted, (fig. 3.2).

Figure 3.2 Damage in the upper zones of the church

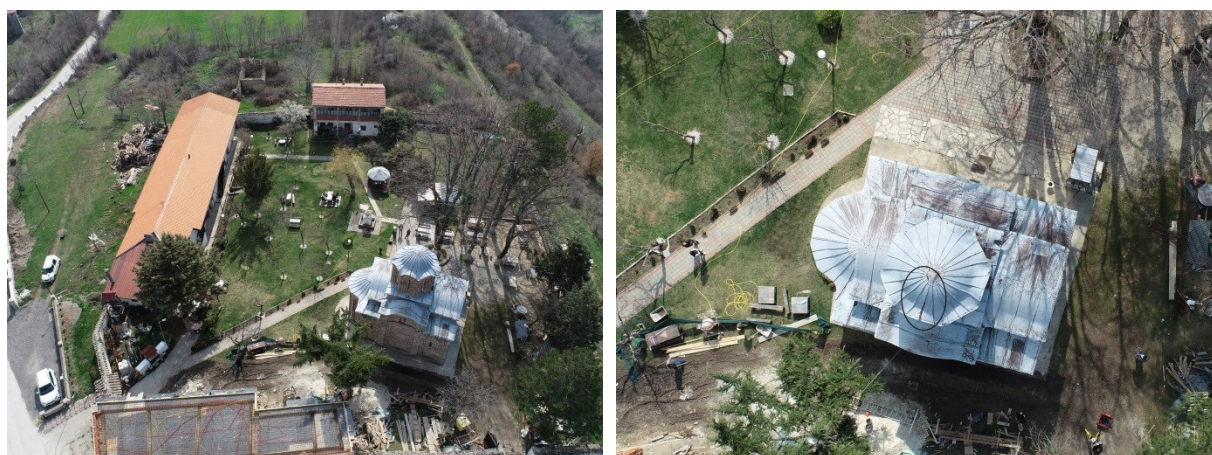
Use of the drone enabled to investigate some challenging areas that were difficult to access during visual inspections. The high-quality photographs from an aerial perspective presented the wider context of the church within the surrounding and also provided an opportunity to investigate the roof's covering. The lead sheet (cover material) is well preserved, apart from the segment of the dome (fig. 3.3 right) where some cracks were noticed, probably due to unprofessional fixing of the joints.

Figure 3.3 Aerial perspectives of the church

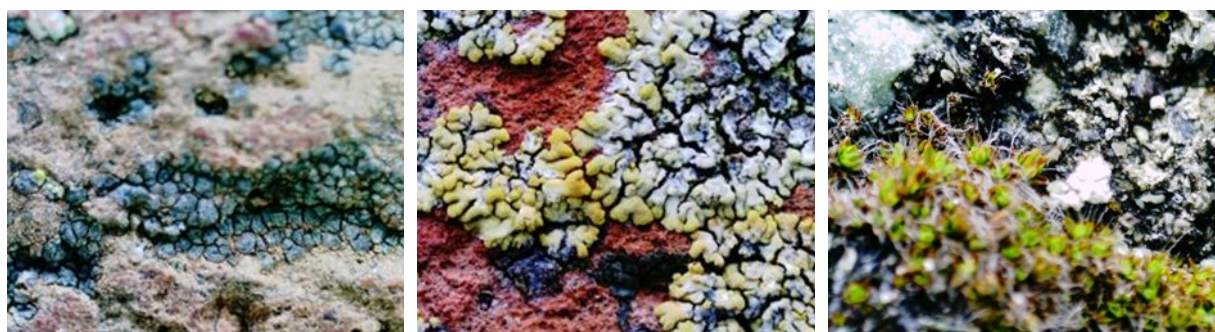
The images from the microscope (magnification 40x) allowed more detailed view of the different types of lichen that are present on the facades of the church, (fig. 3.4). The presence of the lichens can be correlated to some minor micro cracks on the facades, but had not significantly affected the condition of the materials. Additionally, most of the lichens form kind of crust that firmly attach to the substrate; therefore their mechanical removal on large areas is particularly difficult and could damage the original materials. So, at this point, removing the lichens would cause more damage than benefits.

Figure 3.4 Different types of lichens present on the facades of the church (magnification 40x)

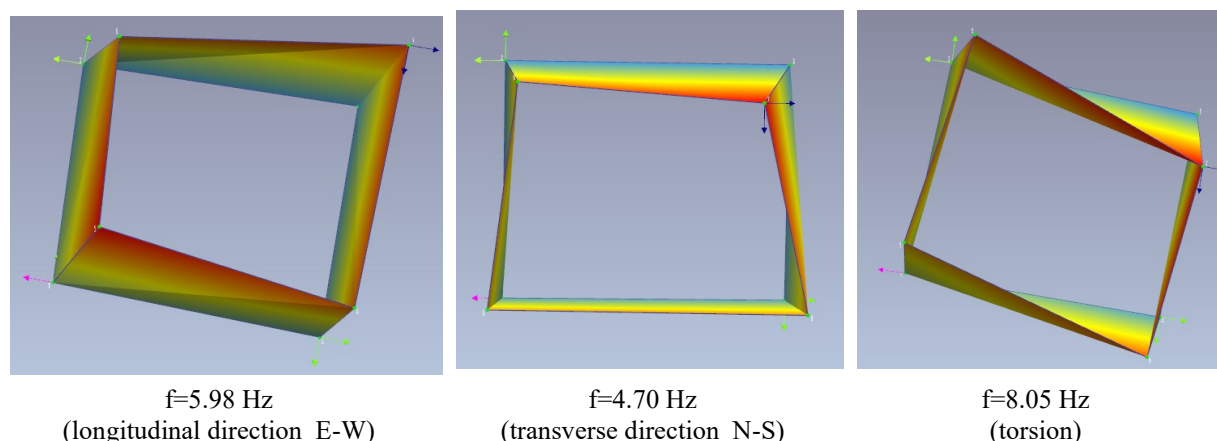
The tests enabled to obtain the natural frequencies in both orthogonal directions:  $f_{E-W}=5.98\text{Hz}$  and  $f_{N-S}=4.70\text{Hz}$ , and sequently the characteristic periods  $T_{E-W}=0.167\text{sec}$   $T_{N-S}=0.212\text{sec}$ .

The mode shapes (fig. 3.12) indicate synchronized behavior of the facade walls which contribute to the overall stiffness and stability of the building as one global entity. The displacements in both, longitudinal and transversal directions are generally translational with insignificant presence of rotation more pronounced in the longitudinal direction. Such forms are expected considering the lack of symmetry due to the presence of the semi-circular apse at the altar area.

Fig. 3.12 Frequencies and mode shapes

The results of this research compared to data from similar tests conducted in 1990s -calculated mode shapes were  $f_{E-W}=6\text{Hz}$ ,  $f_{N-S}=4.8\text{Hz}$  (project "Conservation, rehabilitation and strengthening of Byzantine churches in Macedonia", [2]), indicate that there were no changes in the dynamic parameters of the building's structure in the past 30 years, i.e. the past earthquakes, especially the earthquake of 2016 in Skopje did not cause additional damages to the church's structure.
