ASSESSMENT OF THE PHYSICAL CONDITION OF BYZANTINE CHURCHES IN NORTH MACEDONIA

This paper presents the investigation campaign carried out on 50 Byzantine churches in North Macedonia that included archival searches, review of church documentation and field inspections. The main objective was to assess the current state of the buildings, based on previously defined methodology and criteria for physical condition assessment. This research resulted in a data-base for Byzantine churches and their classification to several criteria: construction period, typology, previous intervention, current condition and authenticity. The collected data enabled to propose the future measures for their protection, graded as: monitoring, regular maintenance, repair or emergency protection.

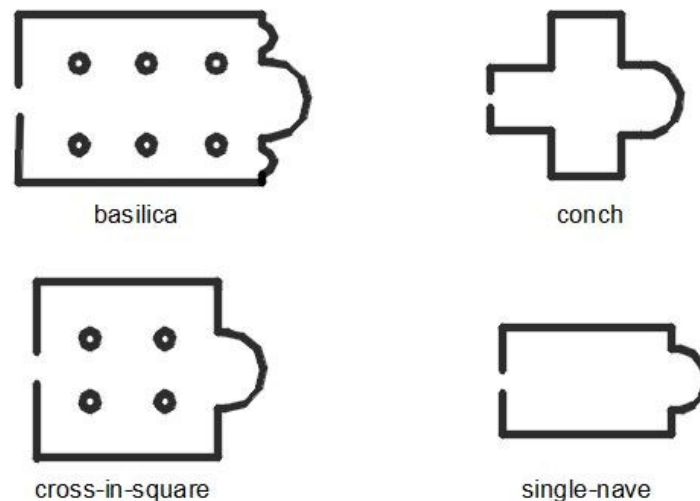
Figure 2.1 Main concepts of the Byzantine churches

Byzantine churches are one of the most preserved and numerous medieval monuments in the territory of North Macedonia. So far, 54 Byzantine churches have been registered, built between from 9th - 14th century. These churches appear in several different concepts—basilica, conch, cross-in-square and small single-nave structures, (fig. 2.1). Although there are some variations, generally, the structural system of these buildings consists of peripheral walls, inner columns and vaults. The vaulted (roof) structure generally rests on a system of arches, pendentives and columns, except for the single-nave churches where the vaulted structure rests directly on the walls. In most churches there is also an additional wooden system of horizontal belts placed into the walls and visible timber ties in the interior upper zones. This wooden system improves the stability of the structure, especially during seismic actions, [4][5].

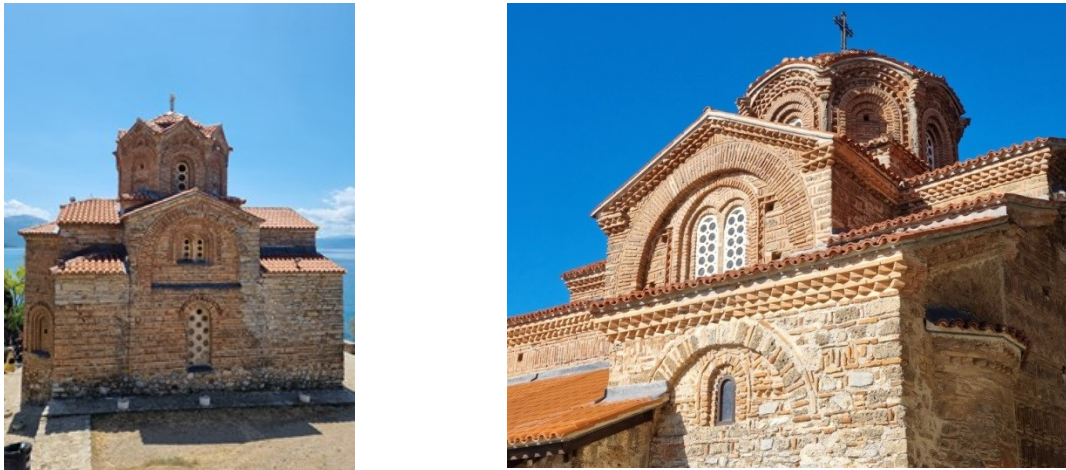
Figure 2.2 Dynamic facades of the Byzantine churches in the Ohrid region

The facades of the churches (fig. 2.2) are characterized by vibrant and dynamic appearance, combining pilasters, arches, niches and cornices with three-dimensional effects. In some Byzantine churches the facade surfaces are formed in a so called "cloisonné" technique, where alternating rows of stone and brick are combined with two vertically placed bricks in the joints to create a distinct pattern. In the church of St. John the Theologian in Ohrid this technique is most consistently implemented. The rich ornamentation of the facades (fig. 2.3) is mainly achieved using bricks placed in different patterns - horizontally, vertically, inclined, which creates different forms of fishbone, zigzag stripes, rhombs, letter shapes etc. Combination of bricks and limestone is used for shaping the decorative arches and inscriptions. The polychromatic effect is gained using stones in diverse colors and mortar ranging from white to light rose, [4][6].

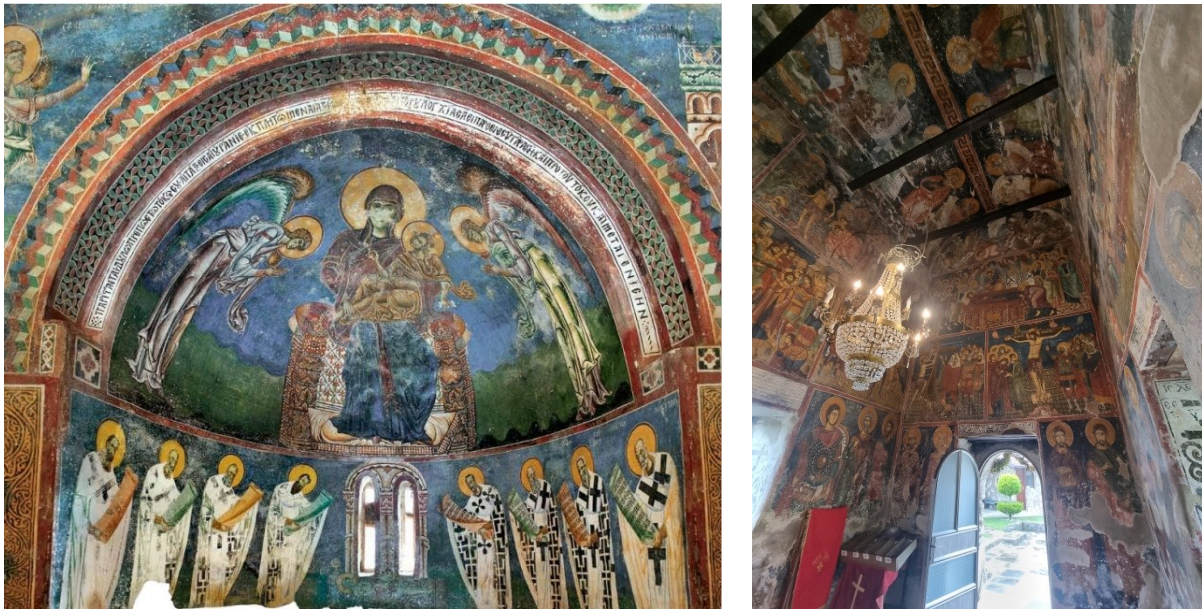
Figure 2.4 Interior of the church of George, Kurbinovo (left) and of St. Nicholas in Varosh, Prilep (right)

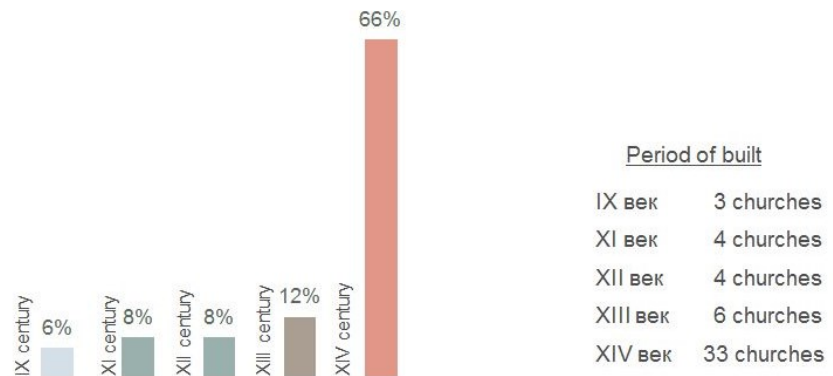
Figure 3.3 Classification of the churches - period of built

The churches were built between 9th and 14th century (fig. 3.3). Among the oldest are the first phase of the church of St. Leontius in the village of Vodocha (7th -9th century), St. George in the village of Goren Kozjak (9th century), St. Sophia in Ohrid (11th century), St. Holy Mother Eleusa in Veljusa (11th century) and St. George in Staro Nagorichane (11th century). Few churches were built during 12th and 13th century and most of the churches (over 60%) were built in the 14th century.

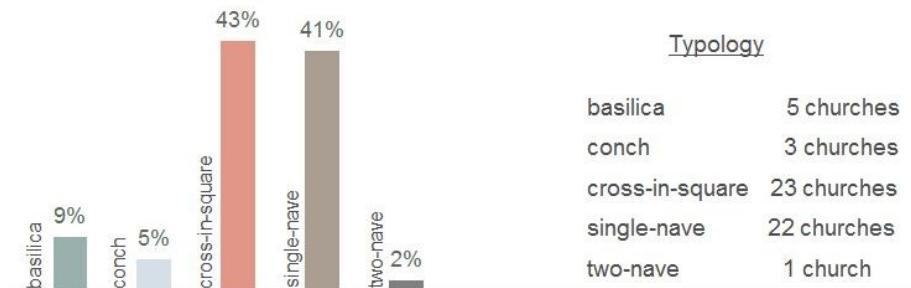
Figure 3.4 Classification of the churches – typology

In relation to their typology, the most numerous are the domed cross-in-square and the small single nave buildings, (fig. 3.4). In the Skopje region most of the churches belong to the typology cross-in-square (fig. 3.5) – St. Nikita in Banjani, St. Panteleimon in Nerezi, St. Nicholas in Ljuboten, St. Holy Mother in Matka etc. Many examples of the small single-nave churches could be found in Ohrid region (fig. 3.6) - St. Cosmas & Damian, St. Demetrius, St. Holy Mother Bolnichka, St. Nicholas Bolnichki, Small St. Clement etc. Basilicas are rarely present. The church of St. Sophia in Ohrid and St. Nicholas in Mariovo belong to this typology. The conch churches appear as three-conch (St. Andrea in Matka and St. Holy Mother in Leshok) and four-conch (St. Holy Mother Eleusa in Veljusa). The only example of a two-nave concept is the church of St. Holy Mother Chelnichka in Ohrid. Some of the churches are combination of two typologies - inscribed cross and basilica, like the churches St. George in Staro Nagorichane, St. Holy Mother in Drenovo and St. Leontius in Vodocha.

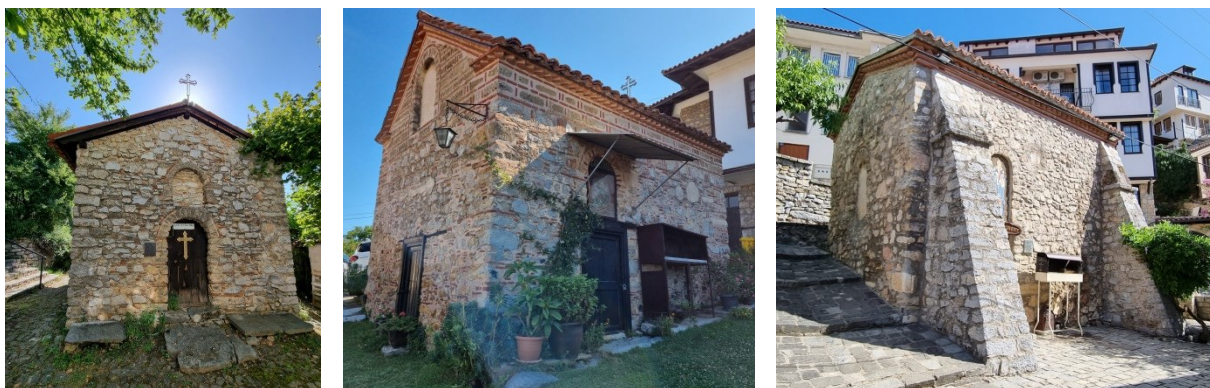
Figure 3.6 Single-nave churches in the Ohrid region

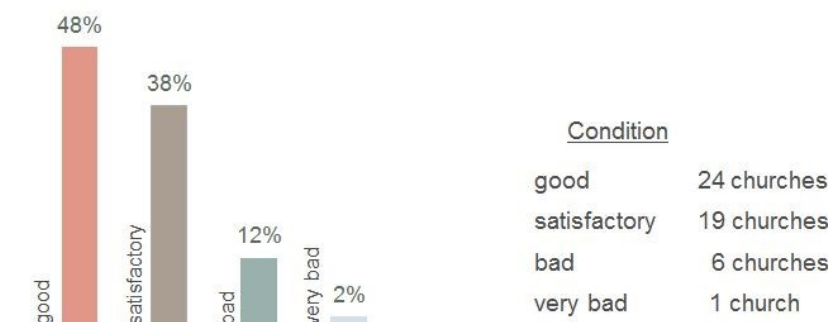
Figure 3.7 Classification of the churches - condition

Field inspections enabled to visually assess the condition of the churches and to identify some visible damage/irregularities on the exterior and interior surfaces. Although these churches existed for centuries it was noted that most churches (around 85%) are in a “good” or “satisfactory” physical condition, fig. 3.7. More severe damages, such as: structural cracks, material degradation or poor structural connections were observed at six churches - St. John the Baptist in Shtip, St. Stefan in Konche, St. George in Staro Nagorichane, St. Holy Mother in Drenovo, St. Holy Mother in Treskavec Monastery and St. Nicholas in Shishevo. The condition of these buildings was assessed as “bad”. The one church in a “very bad” condition is located in the Prilep region – church St. Atanasius in Varosh, (fig. 3.8). This building is completely abandoned and overgrown with vegetation. The roof structure and the upper parts of the walls are completely destroyed and the wooden elements in the walls are burnt and rotted due to previous fire. Since the building is in high risk, emergency measures are proposed.

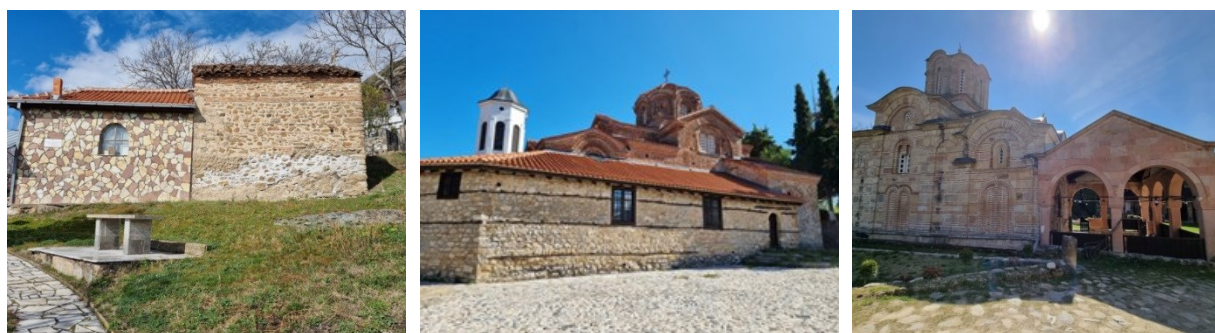
Figure 3.9 Additions from later periods in form of narthex and porch

The documentation review and the visual inspections indicated that all churches have undergone some past interventions on a smaller or larger scale. Additions in form of porch or narthex were often built in the later periods, fig. 3.9. Facade, structural and interior interventions were also performed. These interventions range from minor protective works (replacement of the roof or floor material, rearrangement of the cornices, injection of cracks, forming drainage channels), up to extensive works (structural strengthening with reinforce concrete, reconstruction of damaged parts, partial or complete replacement of the roof structure etc.). Such extensive works were noted in a few churches – St. Panteleimon in Nerezi, St. Holy Mother Perivlepta in Ohrid, St. Sophia in Ohrid, St. Holy Mother in Drenovo, St. Archangel Michael in Varosh, St. Nicholas in Mariovo and St. Holy Mother in Trescavec Monastery. The church of St. Athanasius in Varosh is the only church with no records for past conservation activities or other interventions.

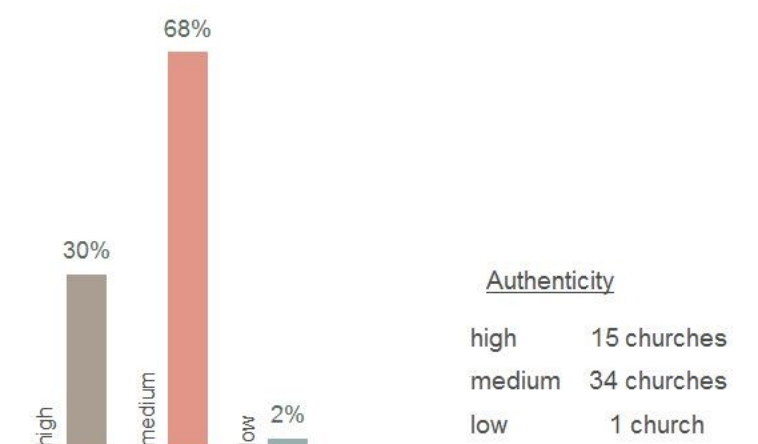
Figure 3.10 Classification of the churches - authenticity

The authenticity of these churches (fig. 3.10) is directly related to the scope and type of the past interventions. Part of the churches (30%) are preserved true to their origins in terms of materials, forms and structure, so these churches have high level of authenticity (St. Archangel Michael in Shtip, St. John the Theologian in Ohrid, St. Nicholas in Varosh, St. Nikita in Banjani, etc). Most of the churches (over 60%) have medium level of authenticity, due to later additions or conservation efforts that somehow impacted the original appearance of the monuments. The only church with low level of authenticity is the church of St. Panteleimon in Ohrid since it was completely rebuilt in 2002 on the remains of the original walls and modern materials were used.
