## EXPERIMENTAL IN-SITU TESTING OF AN EXISTING BRIDGE

This paper presents the results of experimental in-situ tests conducted on a steel bridge. The experimental activities were divided into two phases. The first phase involved determining the dynamic characteristics of the bridge using the ambient vibration method, while the second phase focused on evaluating the bridge's behavior under static and dynamic loading. The equipment used for determining the dynamic characteristics included accelerometers, a data acquisition system, and a computer. For the static and dynamic loading tests, strain gauges, accelerometers, and linear potentiometers were used.

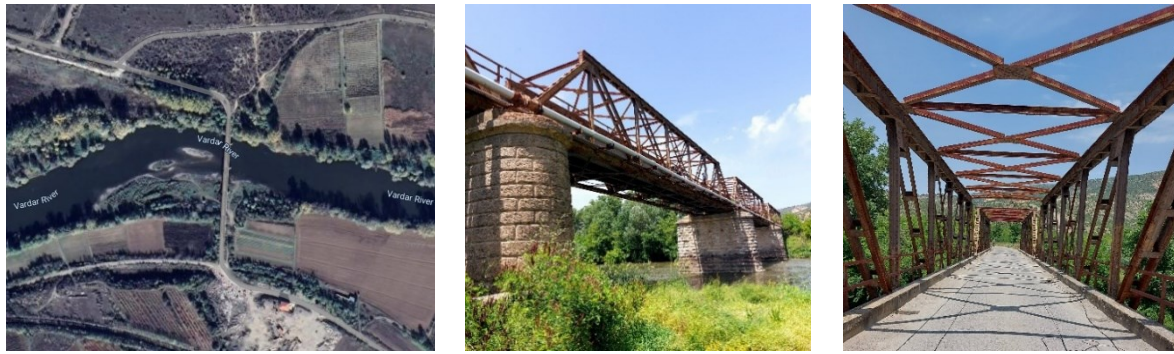
Figure 1. View of the bridge

The bridge is a steel structure built in the 1940s, using construction techniques typical of that time (Fig. 1). The structure is straight, with two traffic lanes and steel railings on both sides. It provides a reliable crossing over the Vardar River, connecting the local road from the Krivolak military area to surrounding areas, ensuring the safe passage of motor vehicles.

The bridge consists of five spans, each representing a static simply supported beam system. Each span measures 34.0 meters in length. The main load-bearing elements are two longitudinal steel trusses, divided into seven sections, each 4.85 meters long. These trusses are interconnected by transverse girders and braces on the upper side, as well as transverse and longitudinal girders and braces on the lower side.

On the lower longitudinal and transverse girders, a steel sheet is placed, over which a reinforced concrete slab is cast. The total height of the truss is 5.0 meters, and the distance between the two main trusses is also 5.0 meters. All components, including the main trusses, longitudinal and transverse girders on both the upper and lower sides, are made of steel "L," "U," "I," and plate elements. These are connected to form complex cross-sections. The elements of the bridge are interconnected using rivets, providing rigid connections.

The main girders are supported on bearings that are fixed on one side and movable on the other. The usable width of the bridge is 4.0 meters, with an open bridge deck. The deck structure consists of a composite reinforced concrete slab over trapezoidal steel sheeting and a finishing layer of cast asphalt. The thickness of the reinforced concrete slab is 40 cm.
