## EXPERIMENTAL ASSESSMENT OF EXISTING BRIDGE STRUCTURE

Experimental tests performed on an existing concrete bridge built in the 90s are presented in this paper. The bridge is a single-bay structure with a simply supported beam structural system and a 12.8-meter span. The testing process was divided into two phases. In the first phase, the dynamic characteristics of the bridges were evaluated using the ambient vibration method, while the second phase focused on assessing the bridges' behavior under static and dynamic loads. More in detail, the second phase was carried out through static and dynamic load testing. To measure dynamic characteristics, accelerometers, data acquisition systems, and a PC were employed, whereas strain gauges, accelerometers, and linear potentiometers were used for static and dynamic loading tests.

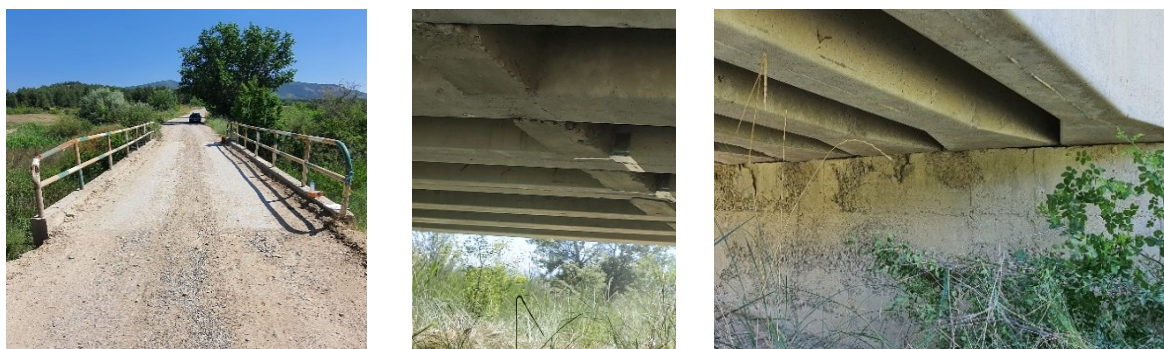
Figure 1. Location and appearance of the concrete bridge.

transitions into a rectangular shape with dimensions of 50/80 cm. The reinforced concrete slab consists of the flanges of the girders, which are tightly positioned to each other, and a leveling layer of concrete of 5 cm, over which a layer of asphalt is applied. The primary longitudinal girders are interconnected by transverse girders, positioned at each quarter of the span of the main girders. The main girders are positioned directly on the end columns, which has resulted in localized detachment of surface concrete layers, (Fig. 1).
