SEISMIC VULNERABILITY ASSESSMENT OF PART OF HISTORIC CENTER OF SKOPJE

Abstract

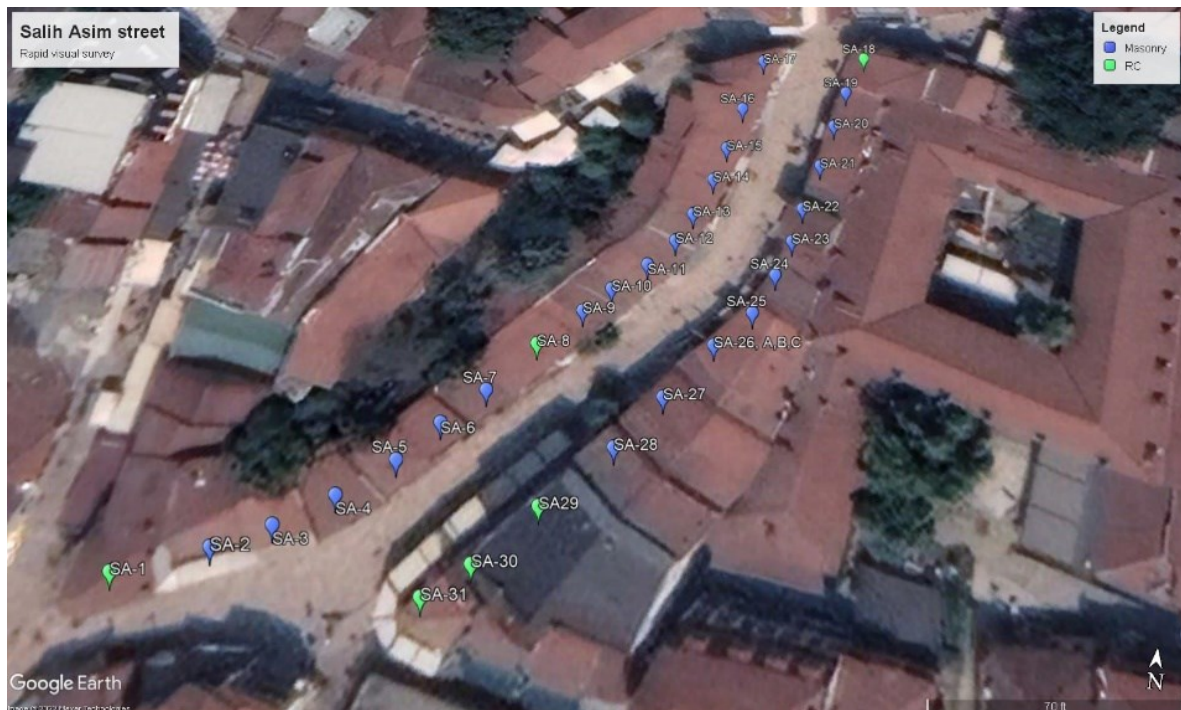
Fig. 5 The assessed urban area with marked buildings – Salih Asim street (Skopje old Bazaar)

The methodology applied herein, and results obtained are presented resourcing to a Google Earth application. Figure 5 shows the assessed urban area with marked buildings.

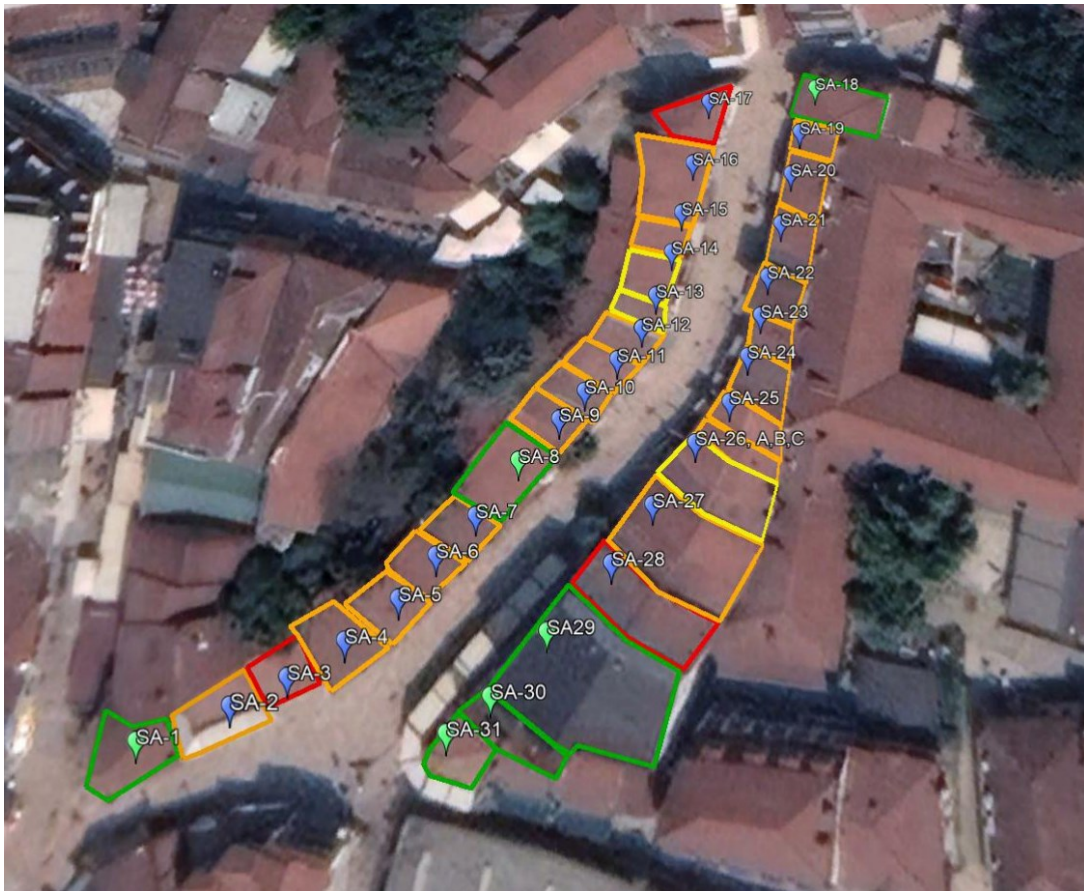
Fig. 6 The assessed urban area with marked buildings – Salih Asim street (Skopje old Bazaar)

The proposed damage for this work, according to the vulnerability, is presented to table 7. Figure 6 presents the spatial distribution of the vulnerability index values for the whole study area and, also presents the damage scenario for seismic intensity IMS-98= IX.
