## ENGINEERING EXPERTISE ASPECTS DURING DISASTER RESPONSE – A CASE STUDY OF FLOODS IN FBiH

*Keywords:* urban search and rescue, INSARAG, SET module, flash floods, damage assessment

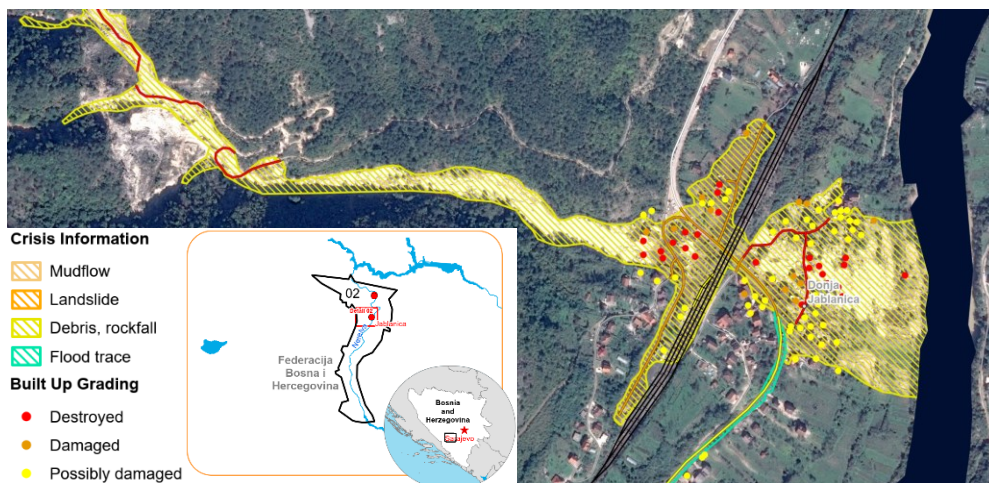
The most severe structural damage was documented in Donja Jablanica (Fig. 1), with residential buildings primarily consisting of masonry structures of varying construction quality. Older homes were built with stone masonry or earthen walls, whereas newer houses primarily used hollow clay brick, sometimes incorporating reinforced concrete tie beams. Most houses numbered one or two stories with a semi-buried basement. The roofs were typically wooden and often in a deteriorated condition.

Figure 1. Copernicus emergency management service satellite image of the affected area in Donja Jablanica (source: Copernicus EMS, EU)

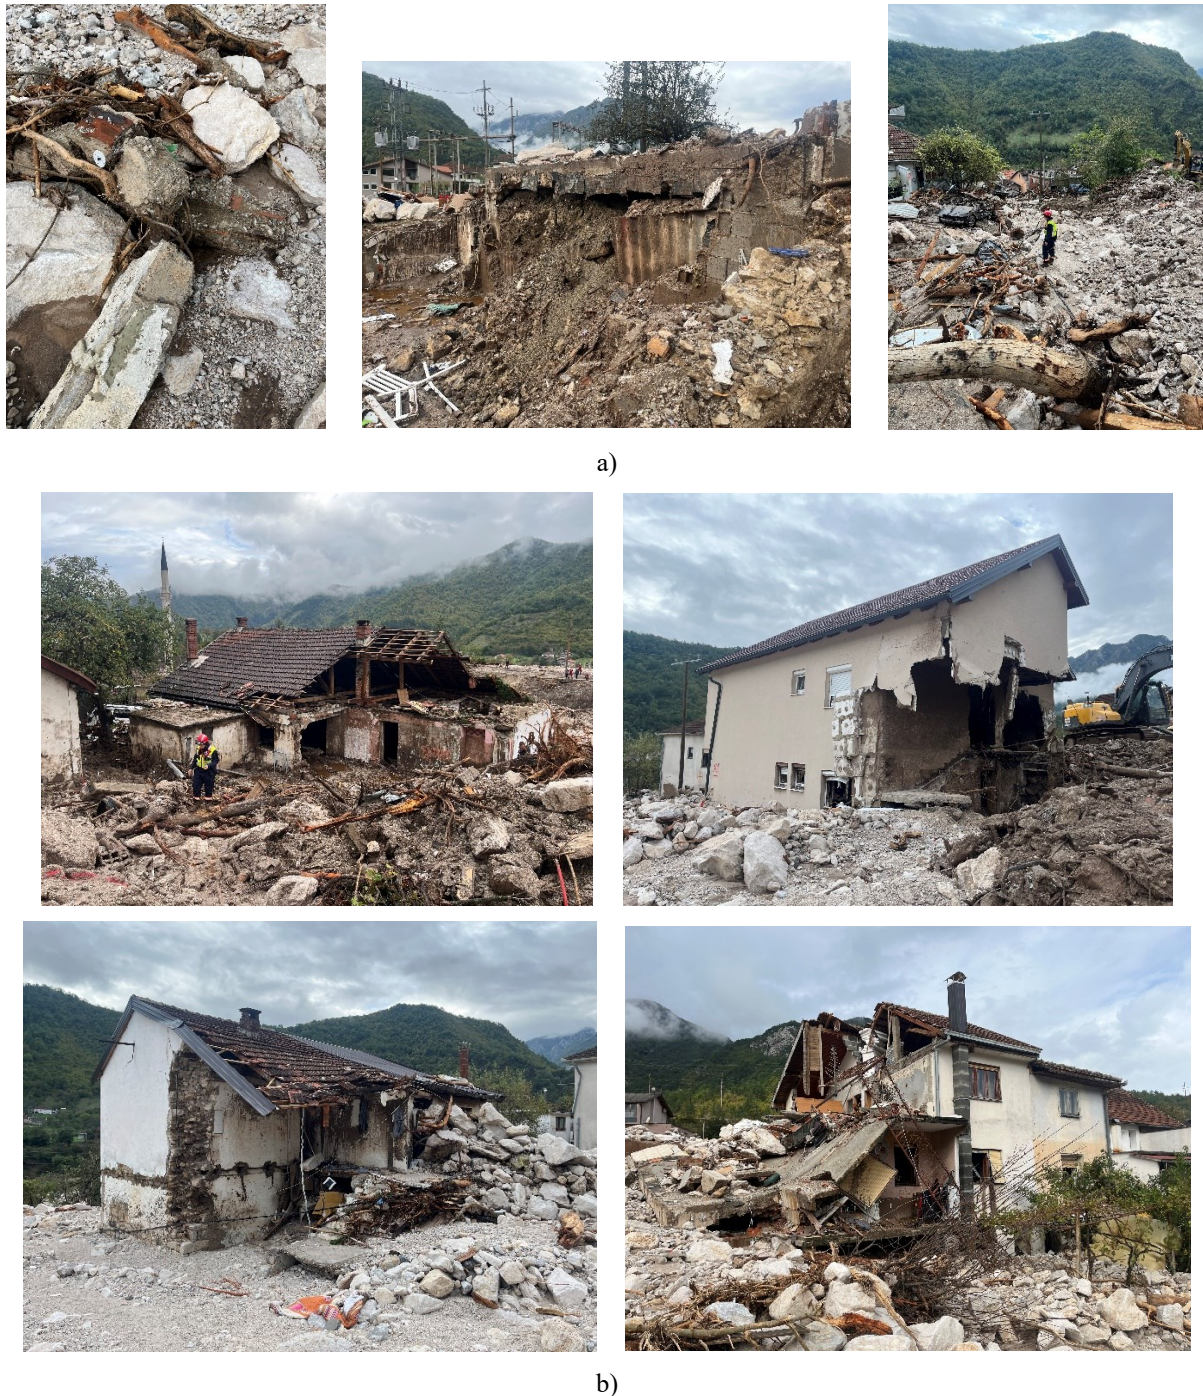
The floodwater and rockfall subjected buildings to extreme lateral forces, both from the impact of dislodged boulders originating from a defunct quarry and the stationary dynamic pressure of the flash flood [5]. Structural failure mechanisms varied. In some cases, shear failure at the RC foundation level led to the displacement of entire buildings above the foundation over distances of up to 100 meters. Where foundations were weak or shallow—often consisting of stone or poorly compacted soil—entire

structures collapsed, with individual building elements carried away by the water current, making identification of original structures difficult. Total structural collapse, where individual elements became fully detached and unrecognizable, can be classified under the *debris heaps* collapse type according to INSARAG (International Search and Rescue Advisory Group) worksite triage categories [6] used by USAR teams for designating potential worksites. Partially collapsed buildings that remained on-site could also be classified under INSARAG as either *debris heaps*, where collapsed structures shifted onto adjacent parcels, or *overhanging elements*, where partial ground-floor collapses left upper floors cantilevered, posing a significant risk of secondary collapse (Fig. 2). Other INSARAG collapse types (*overturning*, *pancake*, and *inclined layers*) were not observed in Donja Jablanica.

Figure 2. INSARAG collapse types observed in Donja Jablanica; a) debris heaps, b) overhanging elements

The observed collapse distribution significantly deviates from that of seismic events, such as the 2023 Türkiye earthquake, where *pancake* collapses and overturning of RC frame structures were predominant [7]. Furthermore, the damage patterns of individual elements differed from those typically seen in earthquake-induced failures. No diagonal shear cracks were observed in masonry walls, as these are characteristic of seismic loads. Instead, geotechnical effects, including differential settlement and horizontal cracking, were the primary structural response mechanisms.

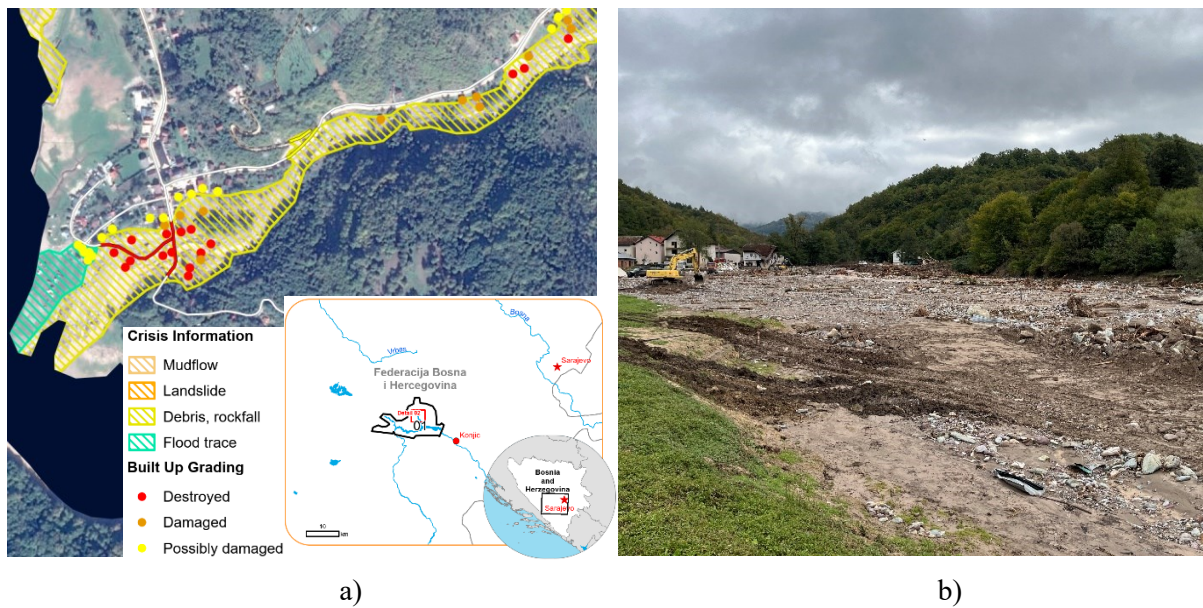
The reconnaissance efforts extended to Buturović Polje, a smaller settlement located along a river bend in the area of Jablanica Lake (Fig. 3), characterized by soft sediments. The flash flood significantly reshaped the terrain, eroding an entire stream branch that once extended to the bend and broadening the channel. The flood impact was not confined to Buturović Polje. Upstream settlements, including Trusina, also suffered significant damage, contributing to the mass of debris that was deposited through Buturović Polje into Jablanica Lake.

Figure 3. a) Copernicus emergency management service satellite image of the affected area around Buturović Polje (source: Copernicus EMS, EU); b) photograph of the reshaped terrain along the river bend

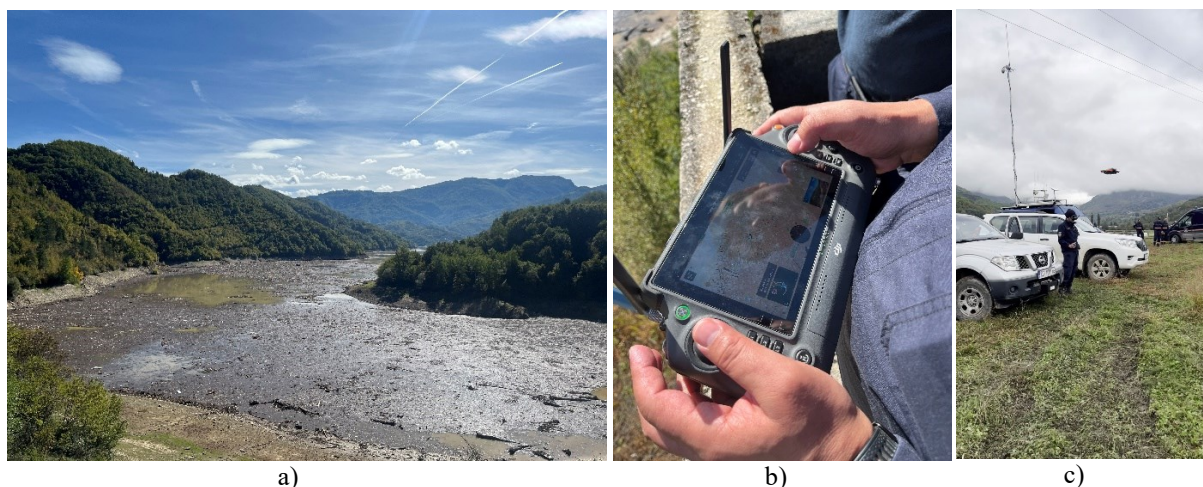
While primary responsibilities of structural engineers were limited in this non-urban area, an opportunity arose to evaluate the UAV-assisted search operations techniques. UAVs designed for large-area reconnaissance are valuable to SET modules for broad assessments, especially in the initial phase of sectorization of the affected area. They offer advantages such as joystick-based control interfaces that provide intuitive maneuverability over broad landscapes, longer range and better battery life. However, they could prove less effective for the specific needs of structural engineers when assisting USAR operations, as they cannot inspect the interior of buildings [8]. Instead, the deployment of smaller UAVs with enhanced maneuverability appears as a more viable option (Fig. 4). Such UAVs, equipped with headset controllers, enable precise navigation within confined spaces and allow for structural reconnaissance of the interiors of partially collapsed buildings, providing real-time assessments of internal structural conditions without requiring personnel to enter unsafe areas. This approach would enhance responder safety while improving the accuracy of damage assessments in future urban disaster scenarios. Consequently, integrating both large-area reconnaissance UAVs for sectorization and assessment purposes and compact, high-maneuverability drones for evaluating structural integrity into SET modules could improve operational efficiency and safety assessments in structural reconnaissance efforts.

Figure 4. a) A large debris-filled area of the Jablanica Lake for large-area reconnaissance; b) Joystick-controlled UAV for large area surveillance; c) Light UAV with a headset controller for building interior reconnaissance

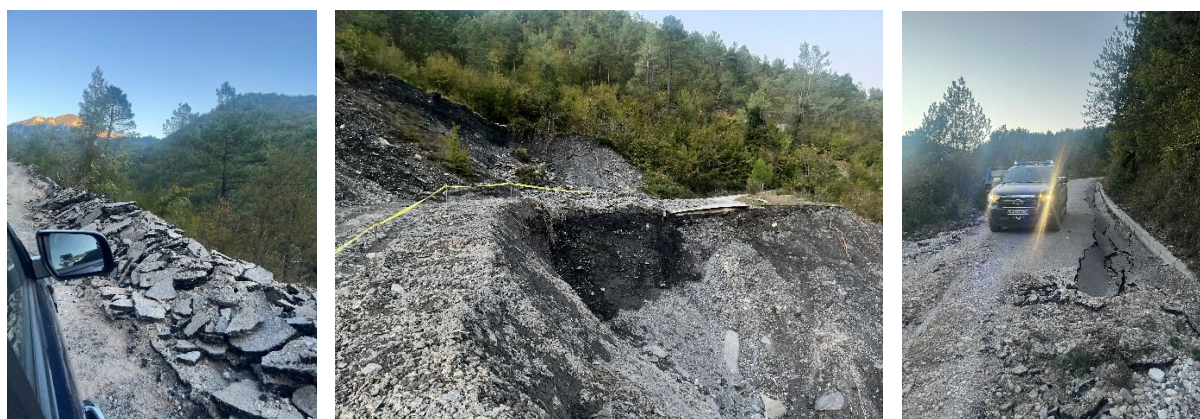
The roads between the locations where our team was deployed were severely impacted by the flash floods, with debris such as rocks, soil, and vegetation obstructing the roadways. Many embankments and roadbeds were displaced by landslides, and in some cases, the roadway was washed away, rendering it impassable. Damage to the pavement surface included Longitudinal cracking of pavement surface and settling of the road edges has been observed (Fig. 5). The priority of the local authorities was to maintain road access, and by the time our team arrived, all main routes had been cleared, although they remained in a compromised condition. This rapid restoration of access was critical, as it enabled the continuation of emergency operations and evacuation efforts. However, the provisional routes were susceptible to further landslides, particularly in the context of anticipated rainfall.

Figure 5. State of the roads in the affected area connecting the main disaster sites

These conditions highlight the importance of transportation engineering expertise in post-disaster assessments, especially as part of a SET module. Transportation experts can evaluate road stability for heavy vehicle use, provide timely and accurate assessments of road conditions, guide the establishment of safe alternative routes, and recommend necessary repairs or reinforcements. Including transportation engineers in SET modules is crucial to ensuring the safety and efficiency of disaster response operations and supporting the host nation's recovery efforts.

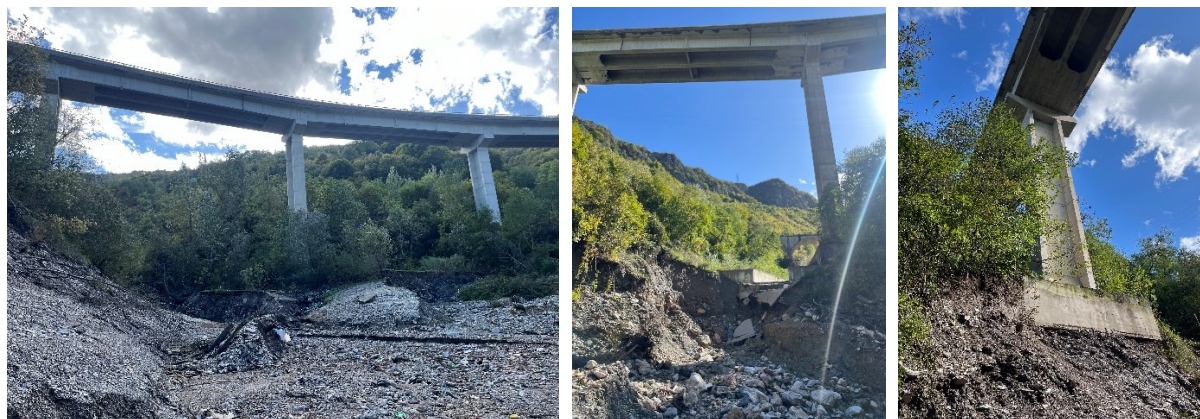
Local authorities requested our USAR team to dispatch structural engineers to assess three road RC beam bridges between Buturović Polje and Jablanica (Fig. 6). These bridges were suspected of instability due to erosion and landslides, which had washed away substantial material beneath the bridges and altered the terrain around the foundations of the piers. Despite these concerns, traffic continued to flow across the bridges, making it crucial to ensure that the flow remained safe and uninterrupted, as these are key transportation routes in the area.

Our inspection indicated that the piers were founded on piles extending to bedrock, with adequate anchorage. This conclusion was supported by the absence of visible displacement or damage to the pile caps, as well as to any other structural elements of the bridges, including the pavement surface. Based on these observations, we recommended verifying the pile length and depth from the original construction drawings. Additionally, a geotechnical expert should be engaged to assess the stability of the soil beneath the foundations, with subsequent recommendations for reinforcing measures, if necessary, to ensure the long-term safety and functionality of the bridges.

Figure 6. Photographs of key structural elements of the inspected bridges and the eroded terrain in the area of pier foundations
